## SERVICE INFORMATION BULLETIN

**APPLICABILITY:** All 2026MY Vehicles Equipped w/ Gen4 Telematics

**NUMBER:** 07-240-26R

**SUBJECT:** DTC B2A20 Diag Strategy & Service Impact Verification

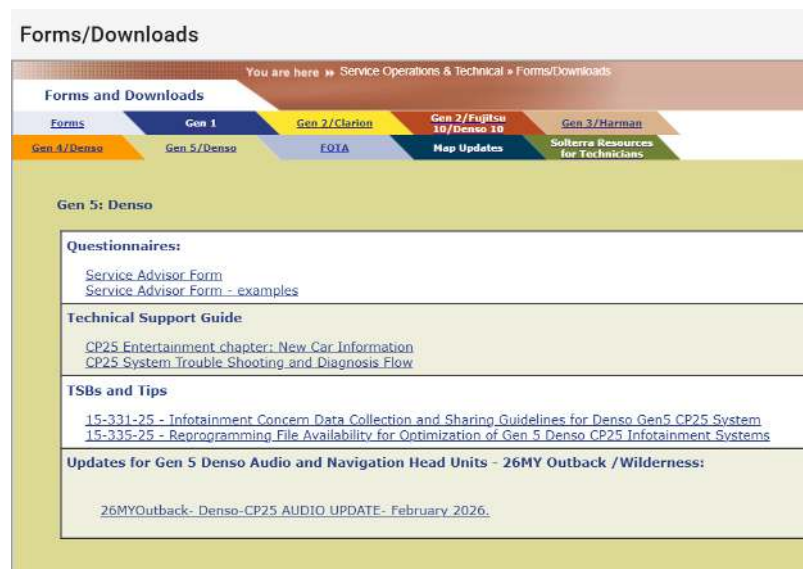
- Current DTC might impact SSM5 interaction with CCU resulting in complications for CP25 software update covered by TSB 15-335-25. In that case, please follow applicable diagnostic procedures for each DTC as well as apply information presented earlier.
- Additional resources for CP25 diagnostic are available on Subarunet: Service Operations & Technical-> Forms/Downloads as shown below.
