# Technical Service Bulletin

## 87 Various HVAC system malfunctions, DTC B11AF07 and/or B109207 stored in the climatronic module or the BCM 1

87 20 03 2055257/5 February 19, 2020. Supersedes Technical Service Bulletin Group 87 number 19-02 dated December 9, 2019 for reasons listed below.

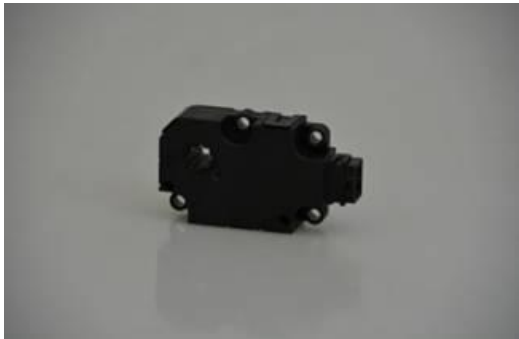
| Always check with your Parts Department and/or ETKA for the latest information and parts bulletins. | | |
|---|---|---|
| 4M0820511A | <br>Motor for adjustment | As necessary |
