# Service Bulletin

Bulletin No.: 20-NA-100

Subject: Engine Control Module Calibration for T1 L3B Engine with DTC P26BB Set

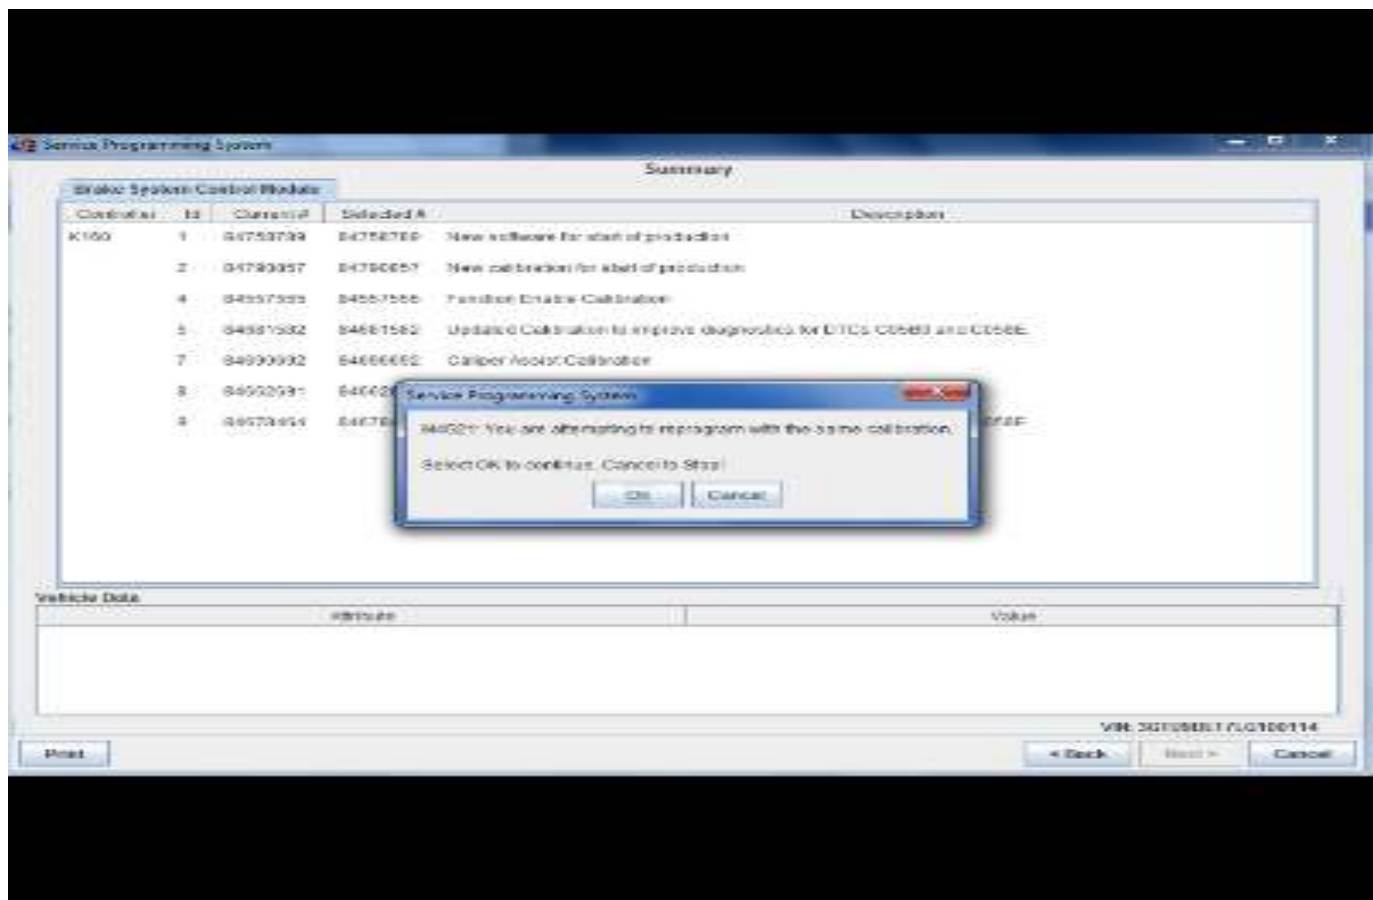
5431207

Important: TIS2WEB screen shown. Techline Connect screen is similar and will be included soon.

Important: If the Same Calibration/Software Warning is noted on the SPS screen, select OK and follow screen instructions. After a successful programming event, the WCC is located in the Service Programming

System dialogue box of the SPS Summary screen. No further action is required. Refer to the Warranty section of the bulletin.

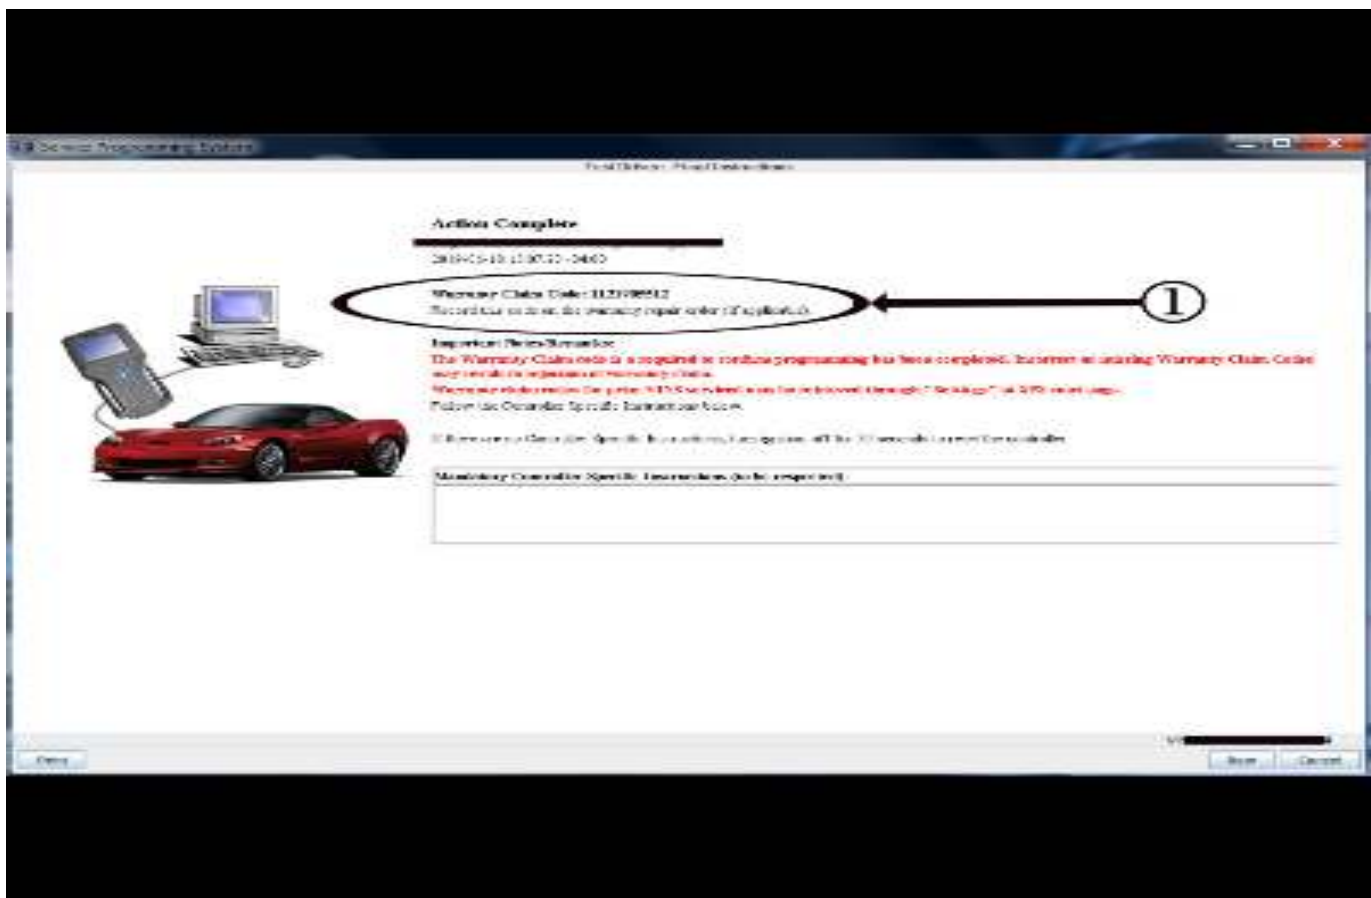
5431209

Important: TIS2WEB screen shown. Techline Connect screen is similar and will be included soon.

The VIN, Warranty Claim Code and Date/Time will be listed on a roster of recent programming events. If the code is retrievable, dealers should resubmit the transaction making sure to include the code in the SPS Warranty Claim Code field.
