# Service Bulletin

Bulletin No.: 20-NA-174

Subject: Malfunction Indicator Lamp (MIL) Illuminated with DTC P037C

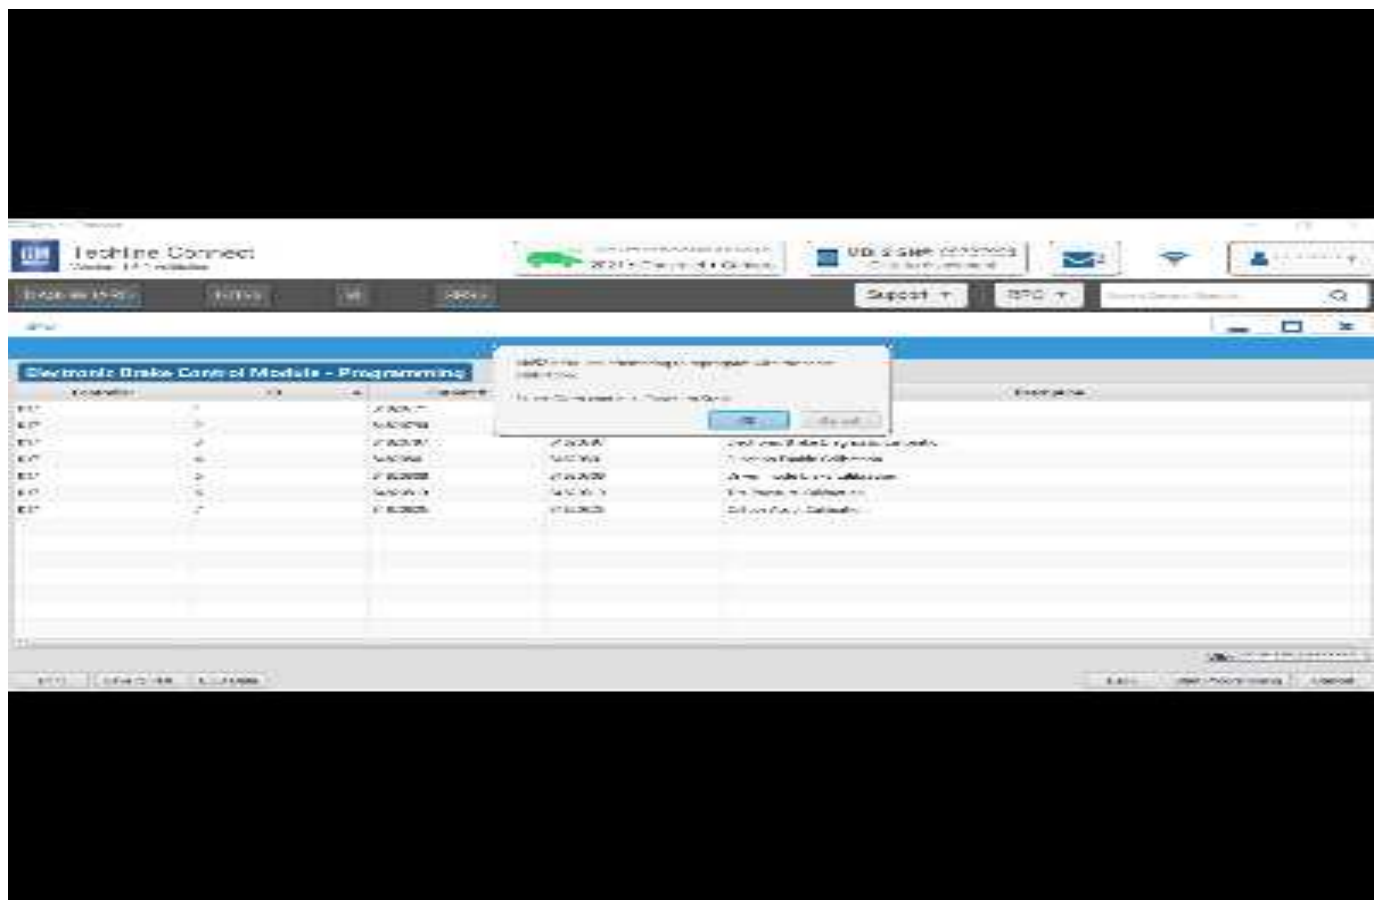
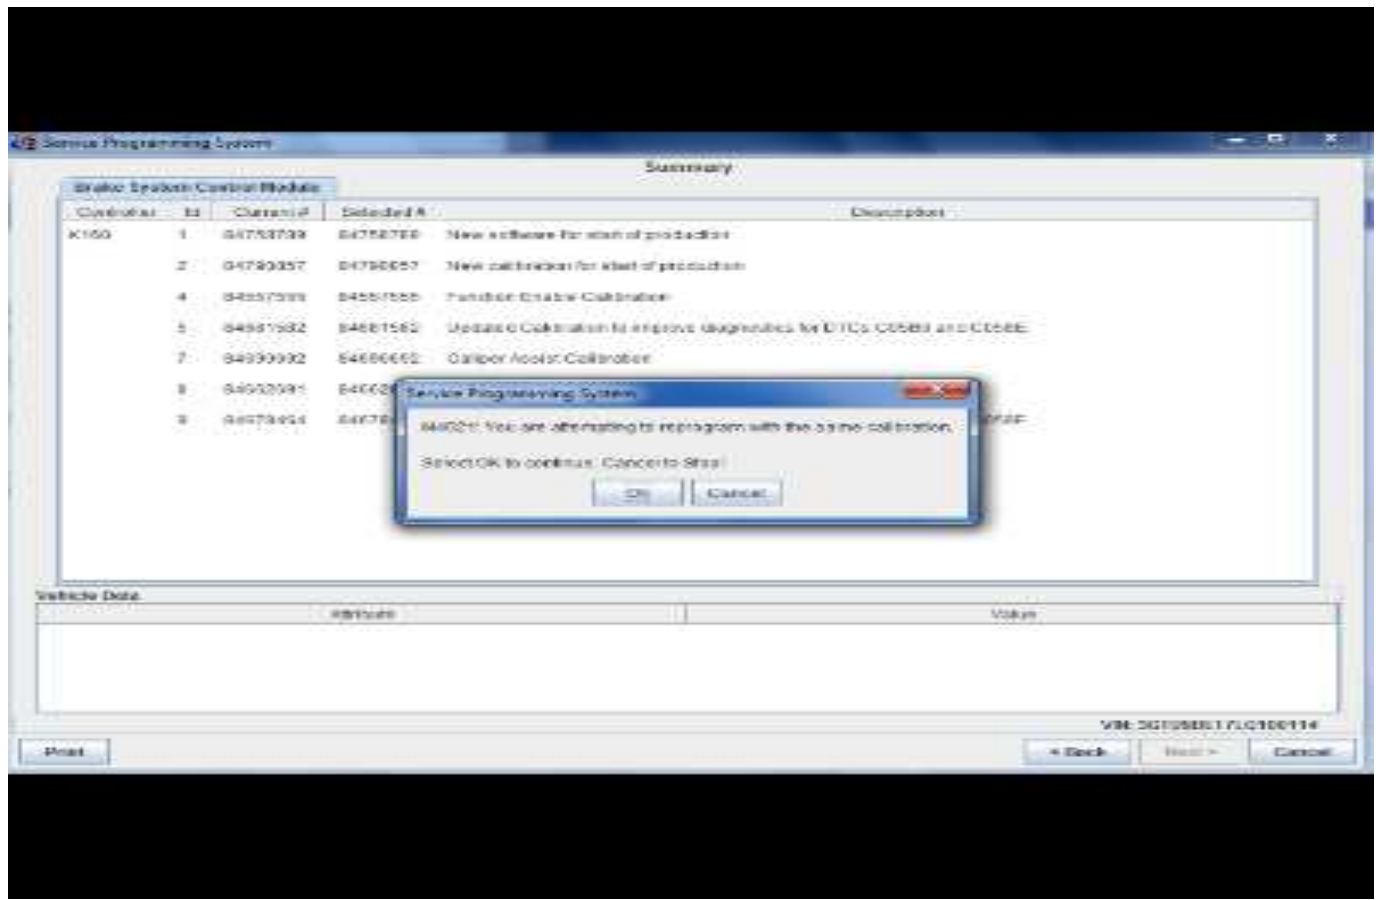
Important: Techline Connect and TIS2WEB screens shown above.

Important: If the Same Calibration/Software Warning is noted on the TLC or SPS Summary screen, select OK and follow screen instructions. After a successful programming event, the WCC is located in the Service Programming System dialogue box of the SPS Summary screen. No further action is required. Refer to the Warranty Information section of this bulletin.

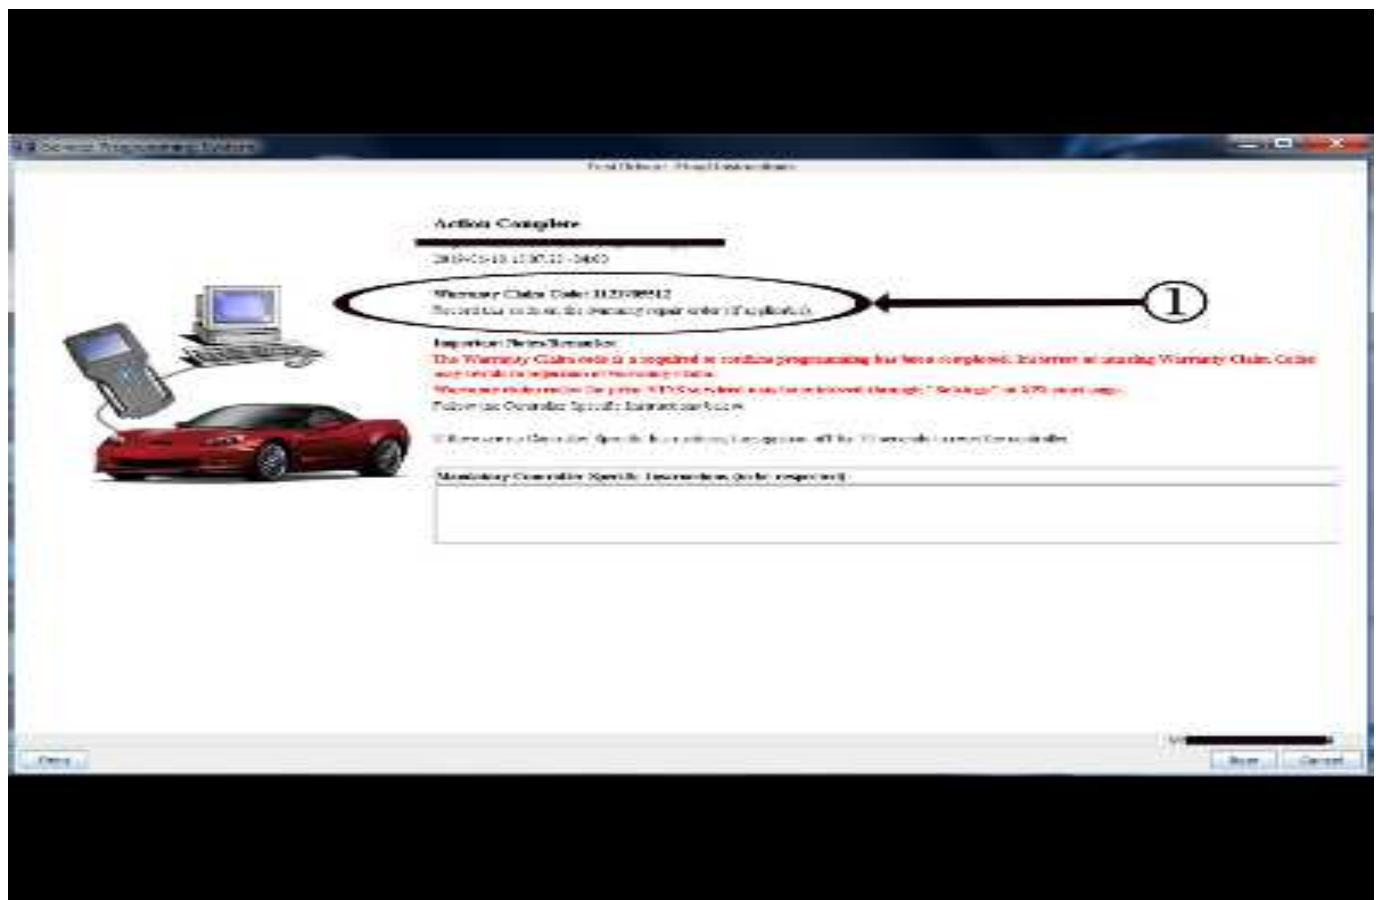
5431209

Important: To avoid warranty transaction rejections, you MUST record the warranty claim code provided on the SPS Warranty Claim Code (WCC) screen shown above on the job card. Refer to callout 1 above for the location of the WCC on the SPS screen.
