# Service Bulletin

Bulletin No.: 20-NA-190

**Subject:** Service Power Steering Message Displayed in DIC, DTC U3000 44

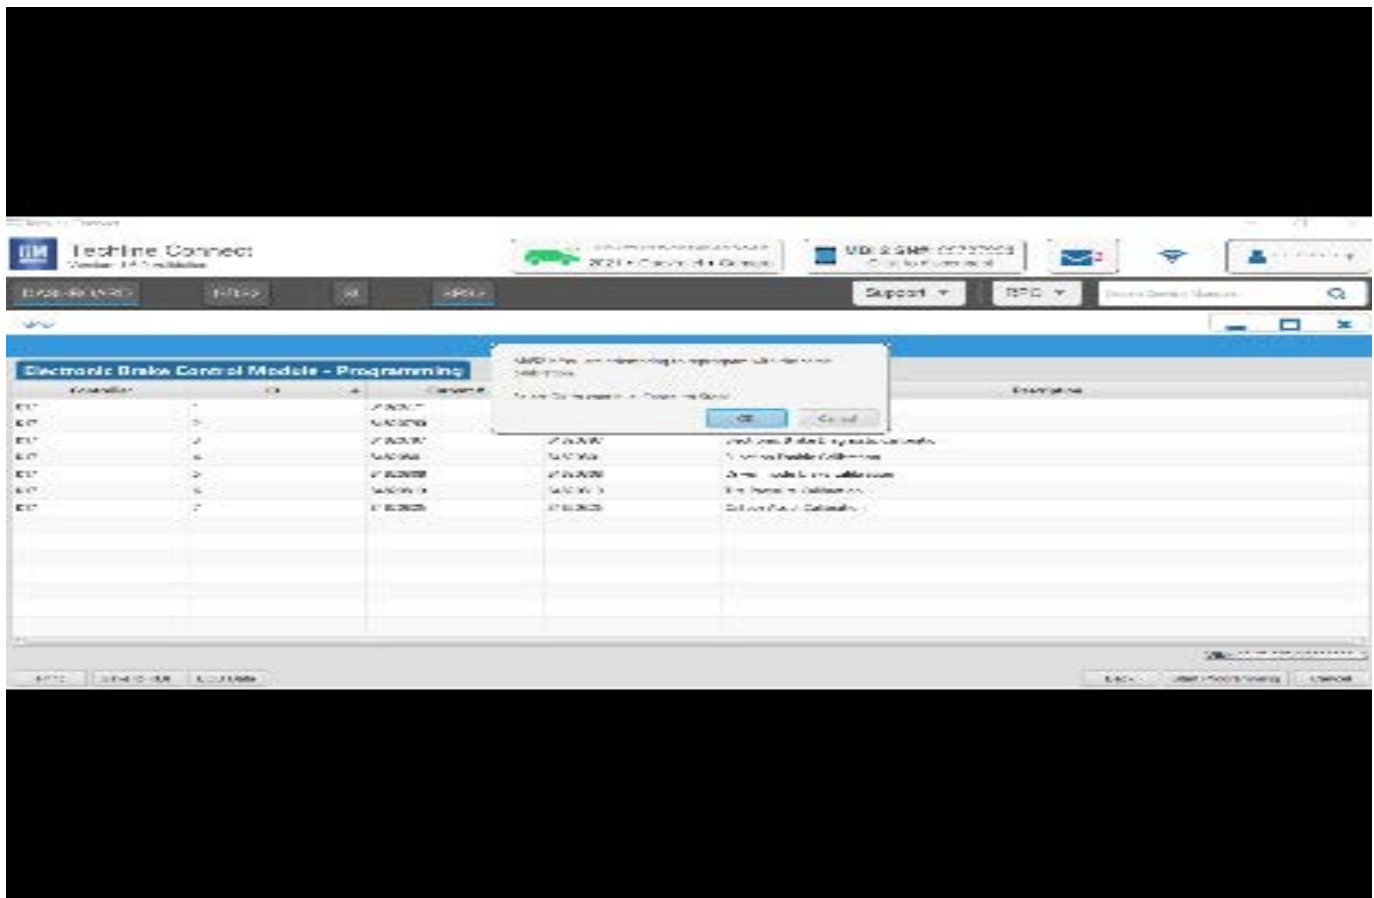
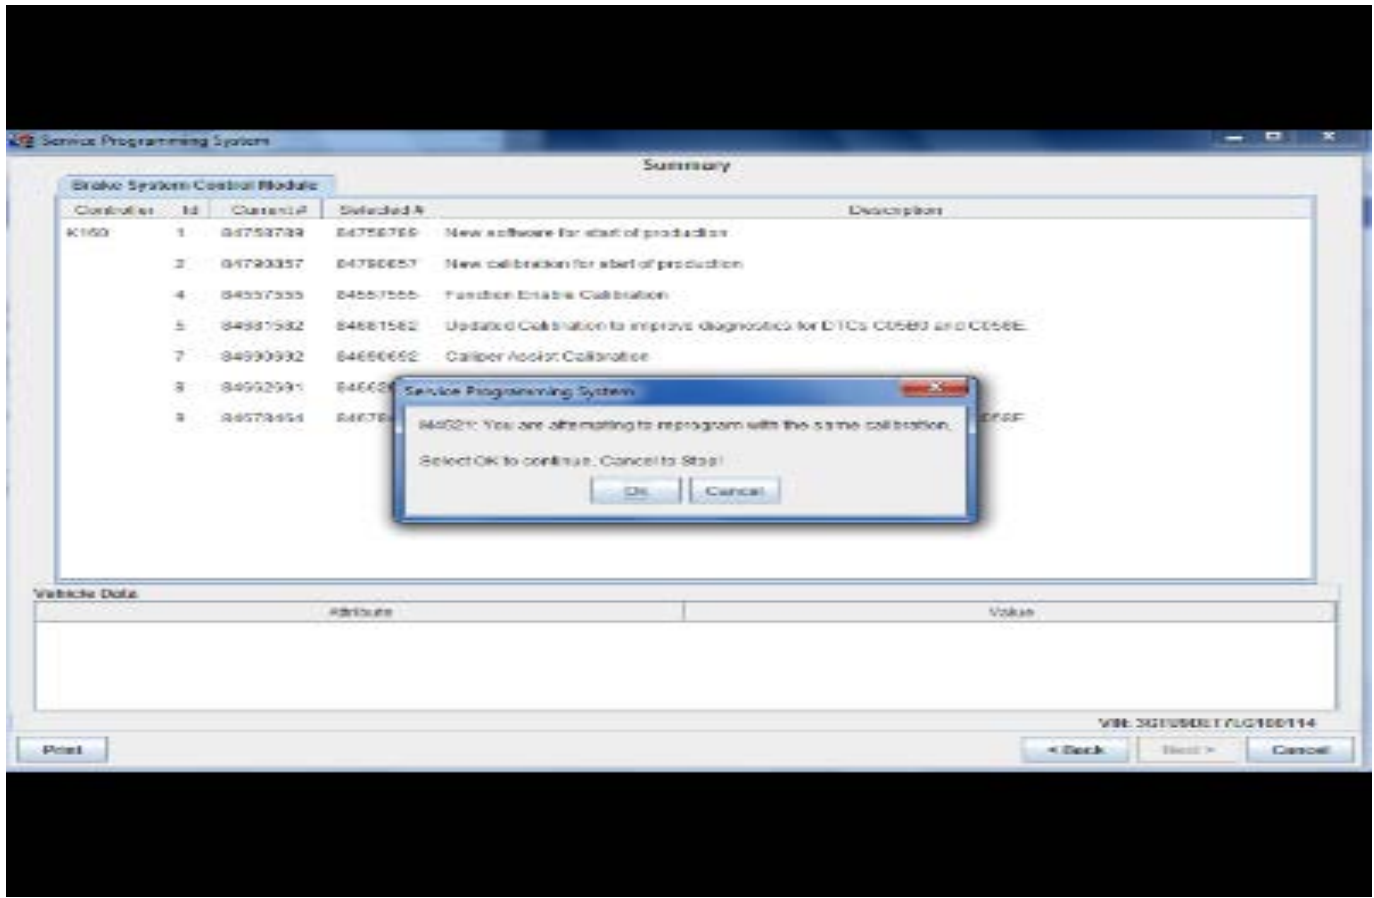
**Important:** Techline Connect and TIS2WEB screens shown above.

**Important:** If the Same Calibration/Software Warning is noted on the TLC or SPS Summary screen, select OK and follow screen instructions. After a successful programming event, the WCC is located in the Service Programming System dialogue box of the SPS Summary screen. No further action is required. Refer to the Warranty section of the bulletin.
