| <b>HYUNDAI</b><br><b>Technical Service Bulletin</b> | GROUP<br><b>CAMPAIGN</b> | NUMBER<br><b>20-01-041H</b> |
| | DATE<br><b>OCTOBER, 2020</b> | MODEL(S)<br><b>IONIQ PLUG-IN (AE PHEV)<br/>IONIQ HYBRID (AE HEV)<br/>SONATA HYBRID (DN8 HEV)</b> |
| <b>SUBJECT:</b> NAVIGATION SOFTWARE UPDATE<br>(SERVICE CAMPAIGN T5J) | | |

**Description:** Certain 2020 MY Ioniq Plug-In (AE PHEV), Ioniq Hybrid (AE HEV), and 2020 - 2021 MY Sonata Hybrid (DN8 HEV) may exhibit a check engine light ON with a DTC P17A0 (Navigation Control Module). This bulletin describes the procedure to install an Audio Video Navigation (AVN) software update to address the condition stated above.

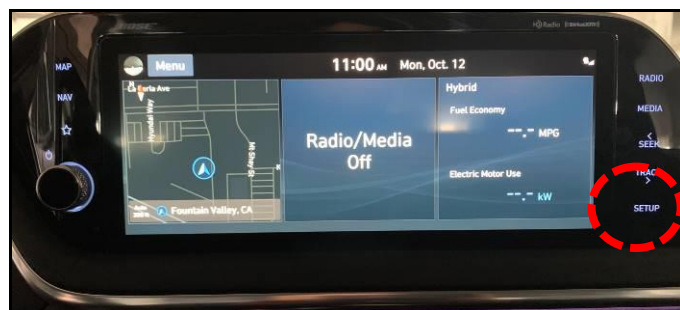
Press and hold the **SETUP** button until the software version screen is displayed.

**Follow Steps 2 - 3 to access the Software Version.**

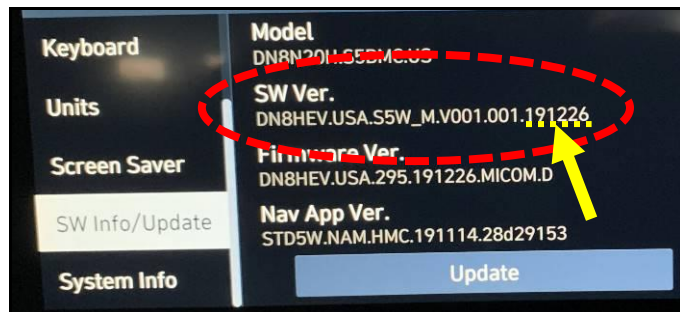
3. Verify the last six digits of the S/W version on the screen are lower than the number listed below. If the S/W version is higher, then it is not necessary to perform the software update.

In the example to the right from a SONATA HYBRID (DN8 HEV), the last six digits are 191226 which is lower than 200702. This vehicle qualifies for the software update.

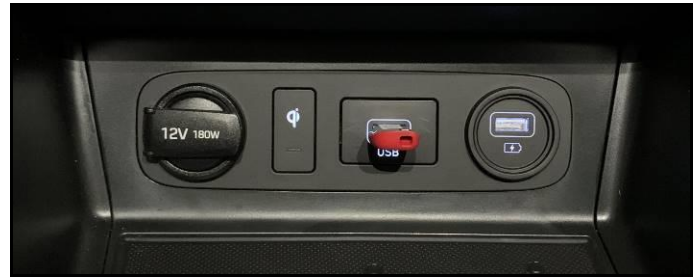
4. Insert the **S/W Update USB** into the USB port.

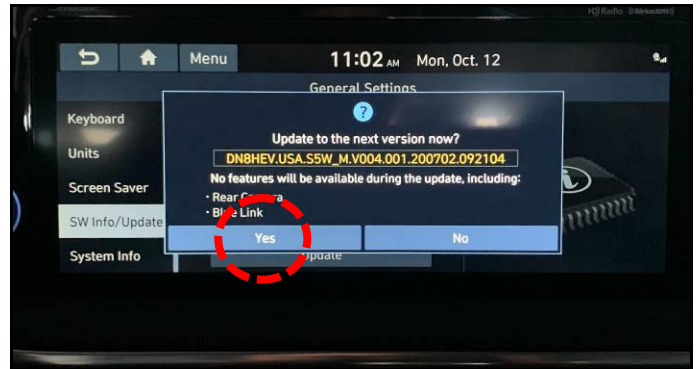
5. The **“Update to the next version now?”** message will appear.

Select **“Yes”**.

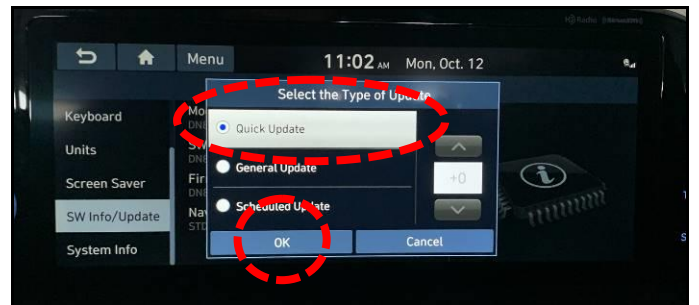
6. Select **“Quick Update”**, and then select **“OK”**.

Depending on the vehicle current software level, a different pop up message may appear which will provide the following type of update choices: Update Now, Background Update, and Scheduled Update. Select **“Update Now”**.

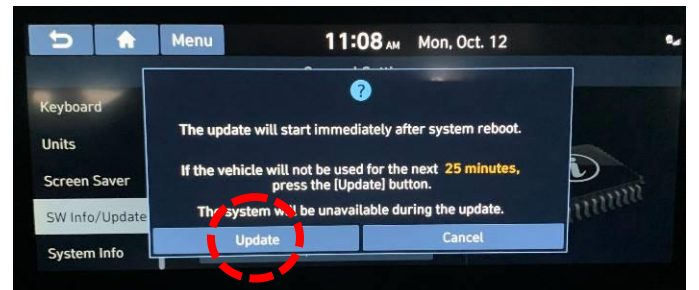
7. The update prompt message will appear.

Select **“Update”** to begin.

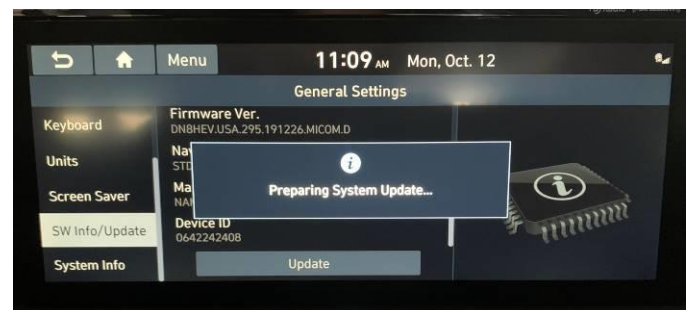
The system update will occur.

The update will take approximately 30 minutes.

Do not press buttons on the center console, remove the USB stick, or turn vehicle **OFF** while the update is running.

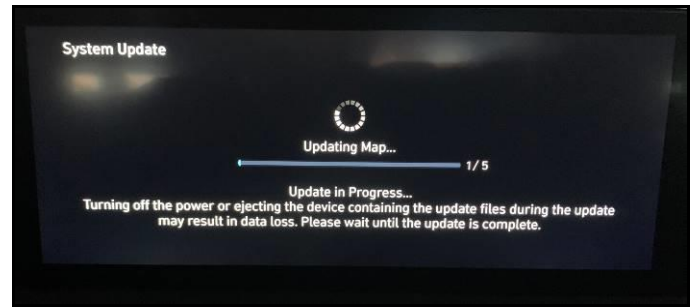
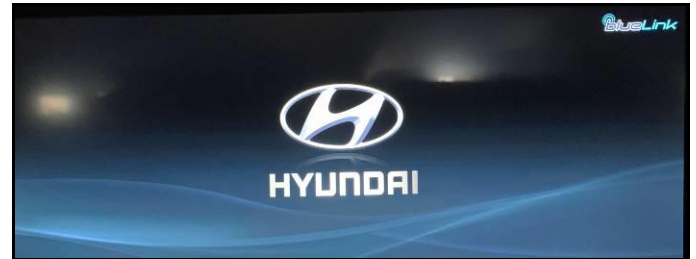
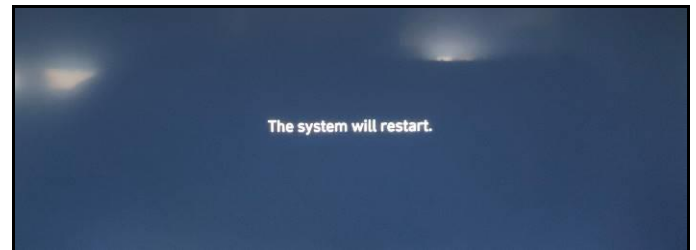
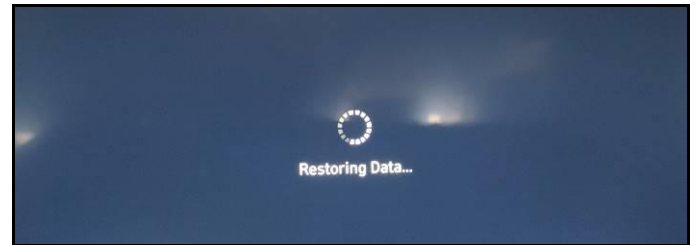
During the updating process, the system will auto reboot.

Some vehicle alerts such as parking light ON, certain lights in the instrument cluster may flash, and audio beeping may occur during the update.

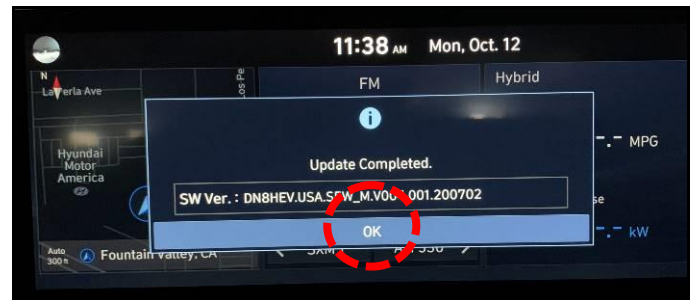
8. The update is completed when an **"Update Completed"** message appears on the screen.

Select **OK**.

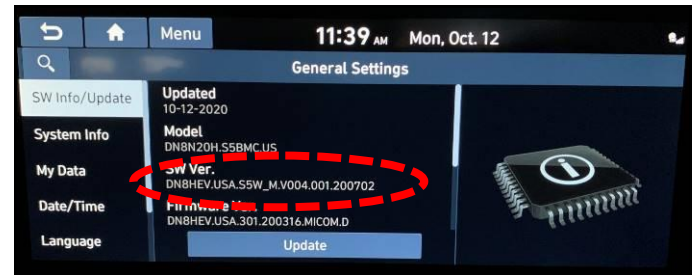
This example is for DN8 HEV

9. Even though the Software Version appeared on the Update Completed message, double check the Software Version number.

The new version should now be:

**DN8HEV.USA.S5W\_M.V004.001.200702**
