| | GROUP<br><b>CHA</b> | MODEL<br><b>2021MY<br/>Seltos (SP2)<br/>Soul (SK3)</b> |
| <b>TECHNICAL SERVICE BULLETIN</b> | | |
| <b>SUBJECT: SERVICE ACTION: EPS LOGIC IMPROVEMENT<br/>FOR DTC C160404 (SA466)</b> | | |

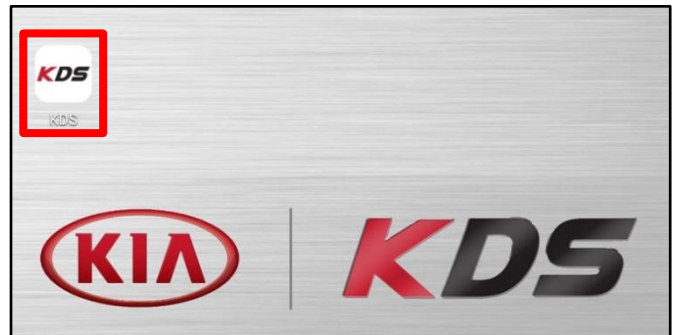
2. With the ignition ON, turn ON the KDS tablet. Select **KDS** from the home screen.

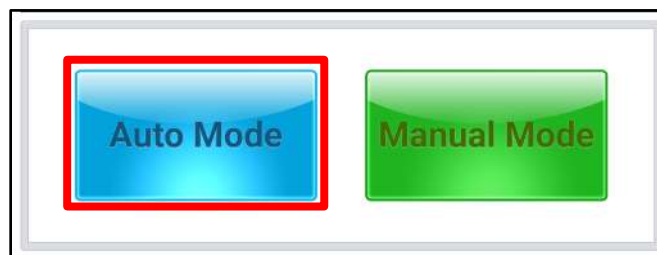
6. Select **Auto Mode**.

Do NOT attempt to perform a Manual Mode upgrade UNLESS Auto Mode fails. Always follow the instructions given on the KDS in either Auto or Manual mode.
