## Technical Service Bulletin

21-01-026H

Venue (QX)

MDPS ECU UPDATE FOR DTC C125901 AND C111201  
(SERVICE CAMPAIGN T6D)

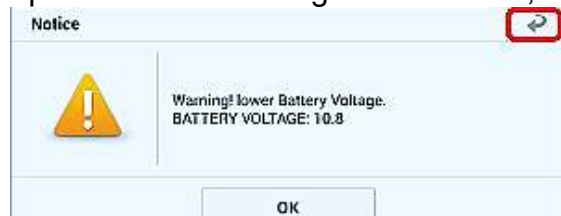
**! WARNING****GDS Vehicle Battery Voltage Warning:**

If voltage is below 12 volts as per the below GDS warning, then select **Back** and run the vehicle for at least 20 minutes to ensure an adequate battery state of charge for reliable update results. Turn ignition back on, and then retry the ECU update again.
