# SERVICE CAMPAIGN BULLETIN

NTB12-100a

## VOLUNTARY SERVICE CAMPAIGN 2009 – 2011 VERSA SPEEDOMETER AND ODOMETER REPROGRAMMING

**APPLIED VEHICLES:** 2009 – 2011 Versa (C11)

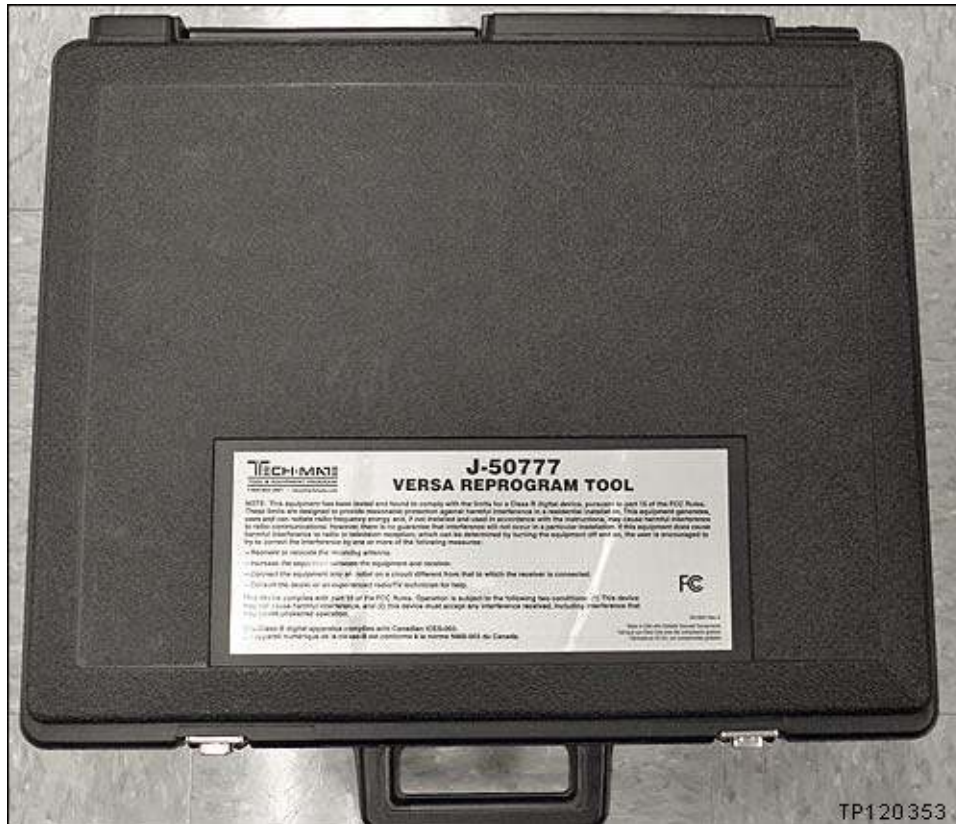
## REQUIRED SPECIAL TOOL – Versa Reprogram Tool (J-50777)

- Each dealer will be shipped, at no charge, one Versa Reprogram Tool.
- Additional tools can be ordered from Tech-Mate at 1-800-662-2001.

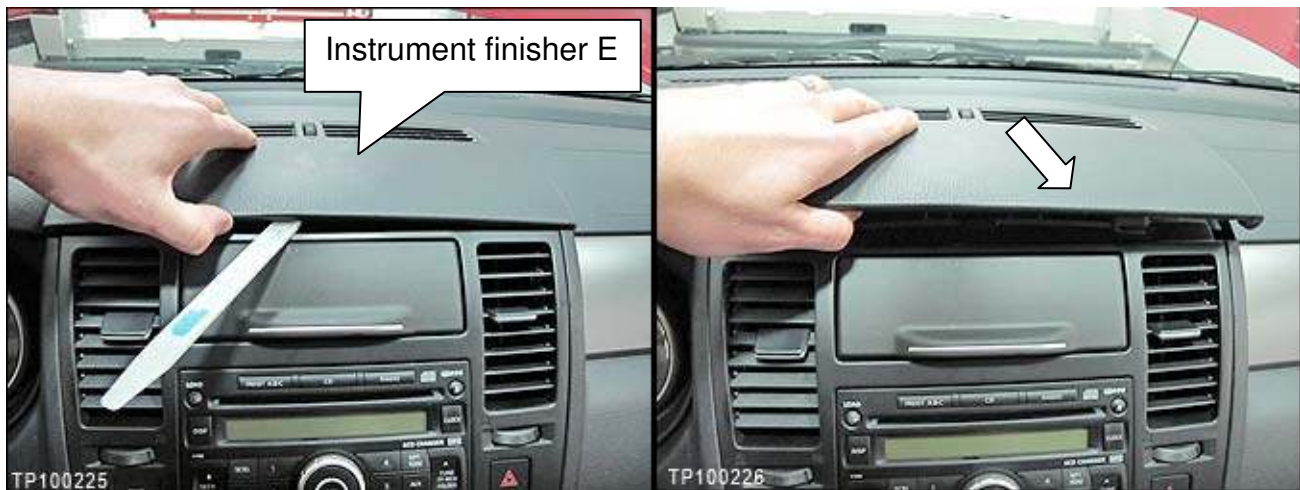
Figure 1

1. Adjust and lock the steering column to the Full Down position.
2. Remove instrument finisher E as follows (see Figure 1).
  - a. Use a plastic trim tool to raise the front edge.
  - b. Grasp and pull rearward (toward you) to unsnap and remove.

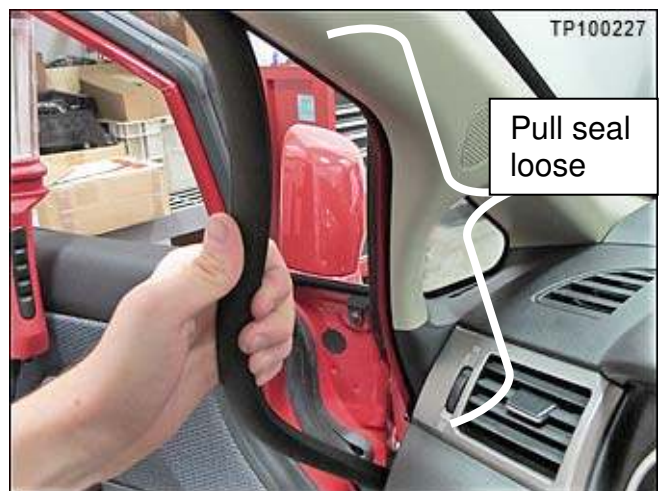
Figure 2

3. Pull the driver's door seal loose in the area shown in Figure 2.

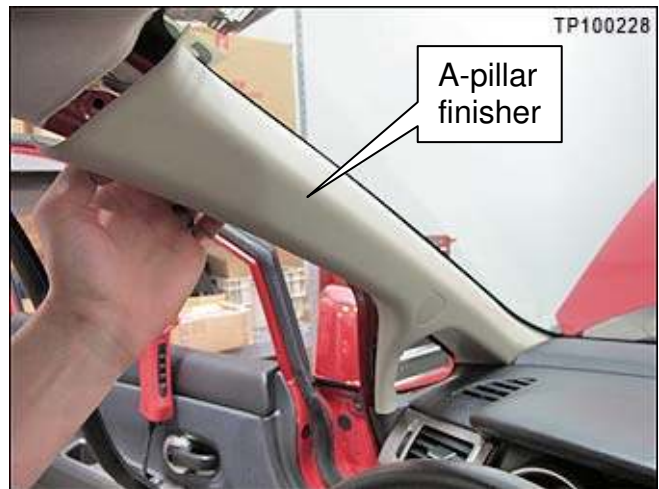
Figure 3

4. Snap loose and remove the A-pillar finisher.
  - Use a plastic trim tool as needed.

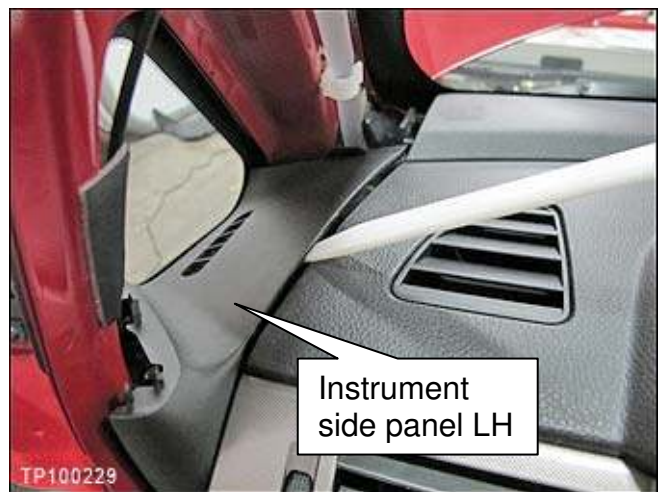
Figure 4

5. Snap loose and remove the instrument side panel LH.
  - Use a plastic trim tool as needed.

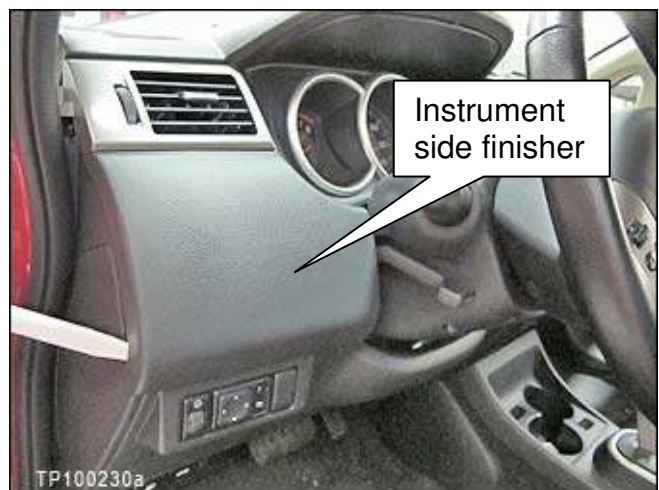
Figure 5

6. Snap loose and remove the instrument side finisher.
  - Use a plastic trim tool as needed.

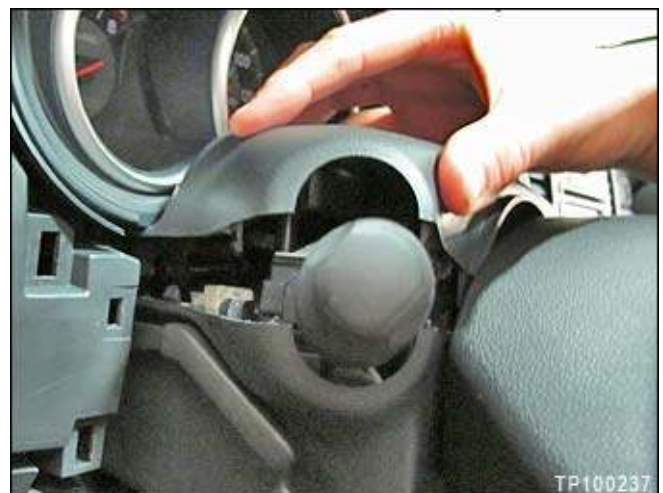
Figure 10

- Snap loose and remove the steering column upper cover.

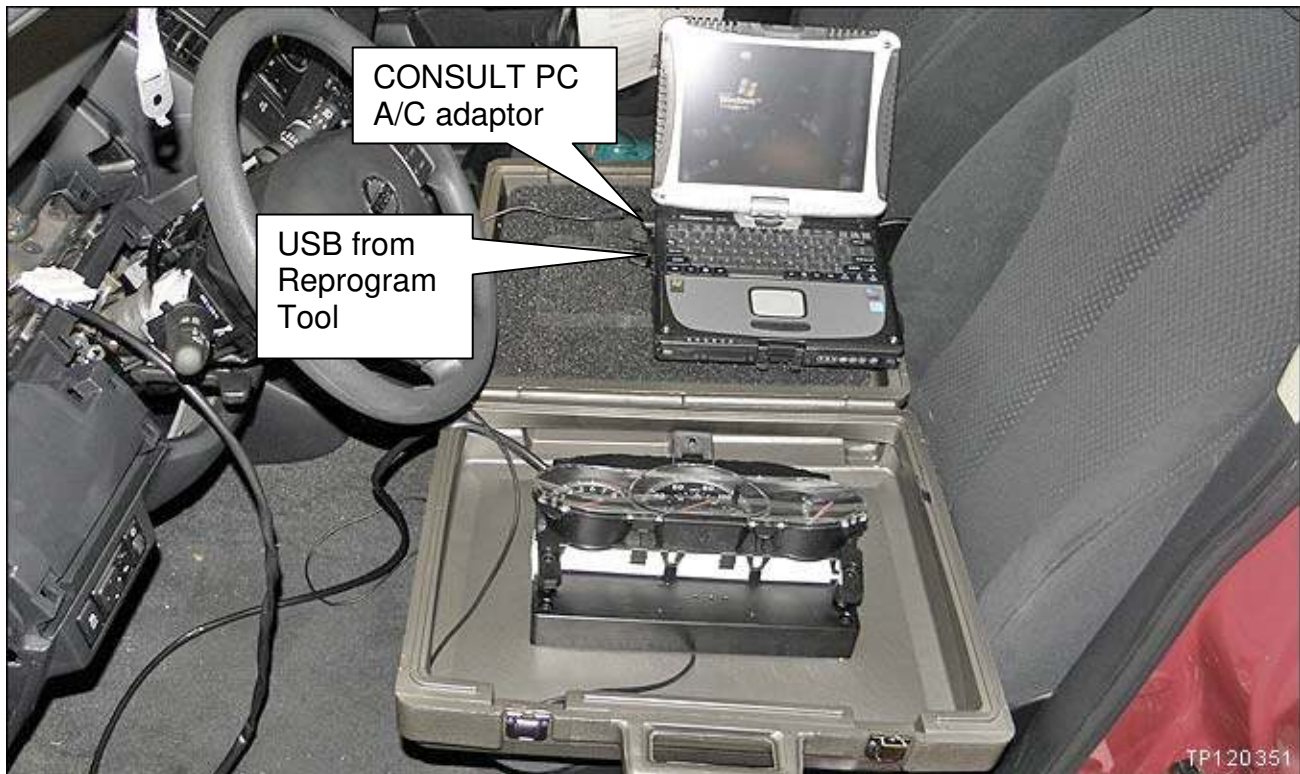
Figure 19

2. Connect the USB cable from the Reprogramming Tool to the CONSULT PC (see Figure 19).
3. Connect the AC Adapter to the CONSULT PC (see Figure 19).

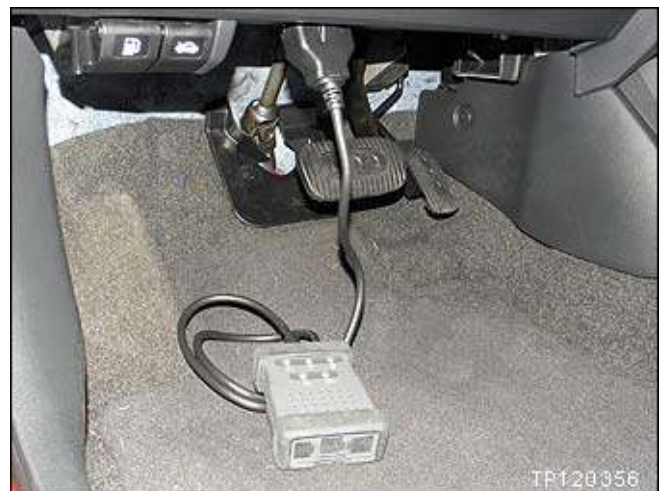
Figure 20

4. Connect the C-III plus VI to the vehicle.
