ITB10-065a

**VOLUNTARY SERVICE CAMPAIGN  
2007 – 2008 FX WITH ICC  
SPEEDOMETER AND ODOMETER PROGRAMMING ERROR**

**CAMPAIGN ID#:** P0332**APPLIED VEHICLES:** 2007 – 2008 FX (S50) with Intelligent Cruise Control (ICC)

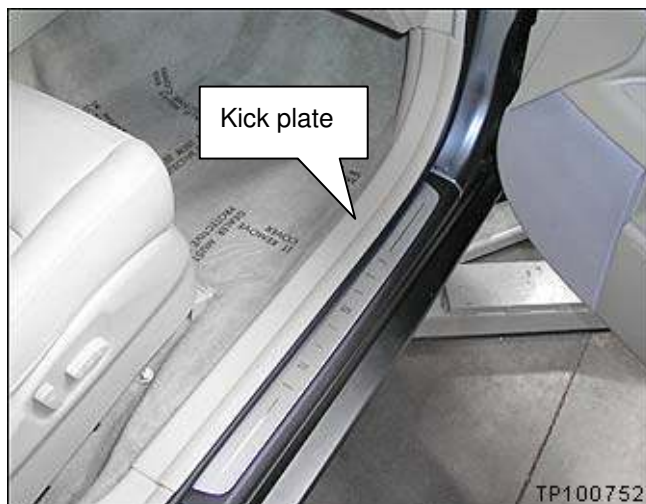
Figure A

1. Turn the Ignition OFF.
2. Remove the front passenger kick plate.
  - Snap loose to remove.
  - Use a plastic trim tool as needed.

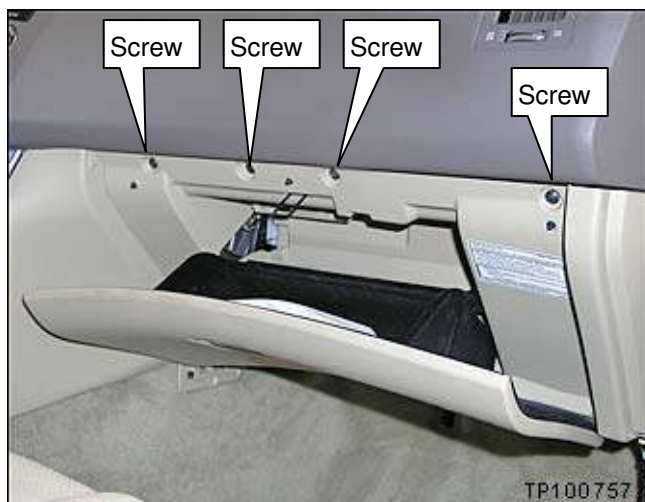
Figure F

7. Remove the 4 screws from the top of the glove box.

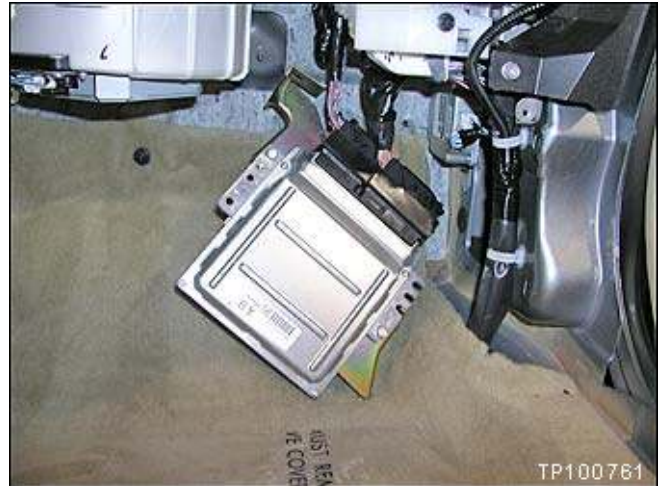
Figure I

10. The ECM can remain in this position while you replace the ICC unit.

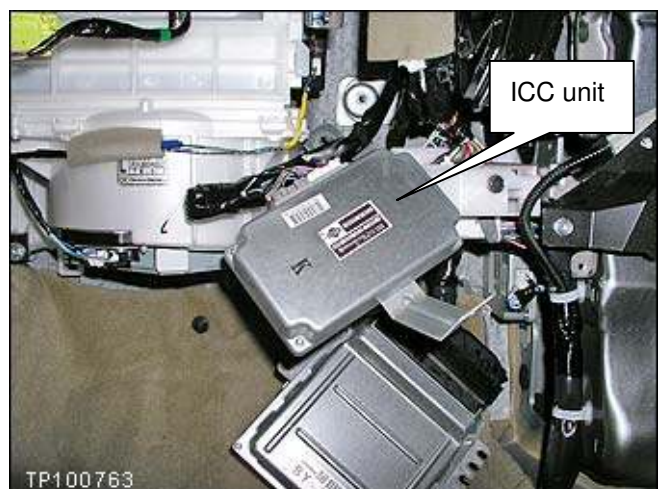
Figure K

12. Carefully maneuver the ICC unit from behind the harness junctions.

13. Replace the ICC unit with a new one listed in the Parts Information of this bulletin.

14. Install the new unit and all other parts removed in reverse order.

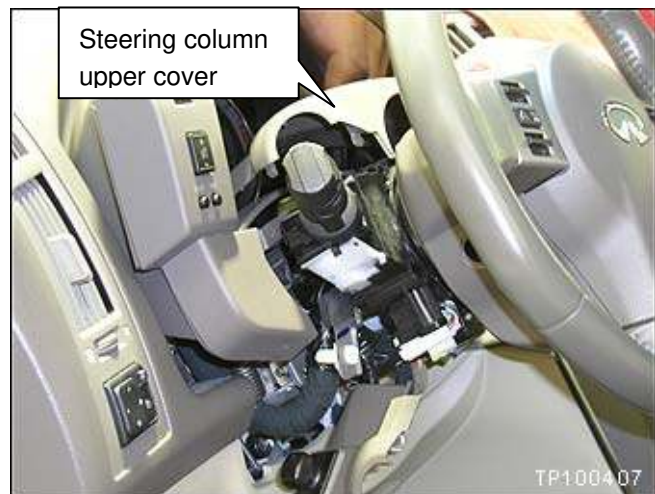
Figure 3

3. Remove the steering column upper cover.

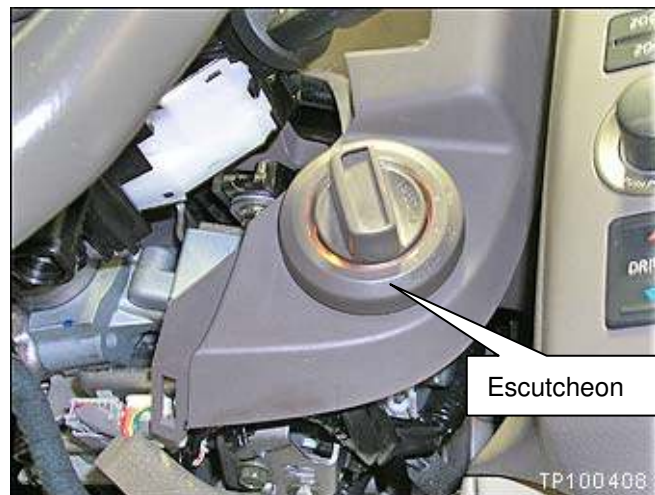
Figure 4

4. Remove the steering lock escutcheon.
  - Use a plastic trim tool if needed.
  - Pull the escutcheon to remove it.

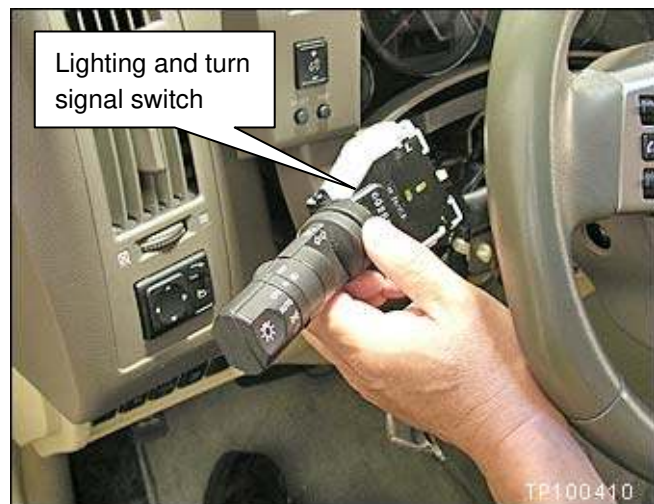
Figure 6

6. Remove / unclip the lighting and turn signal switch.

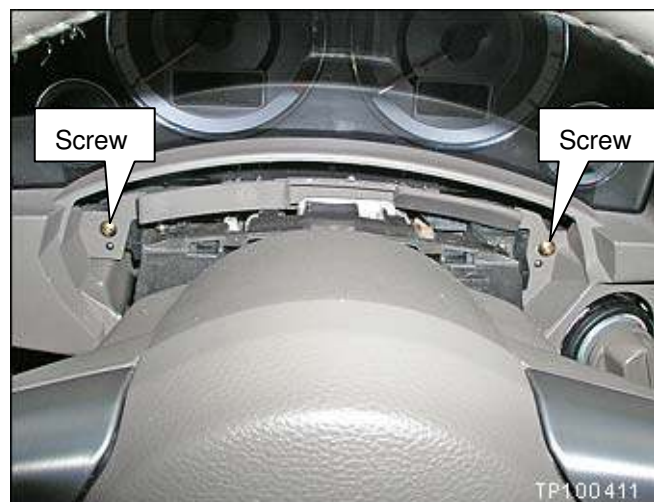
Figure 7

- a. Remove the 2 screws shown in Figure 7.

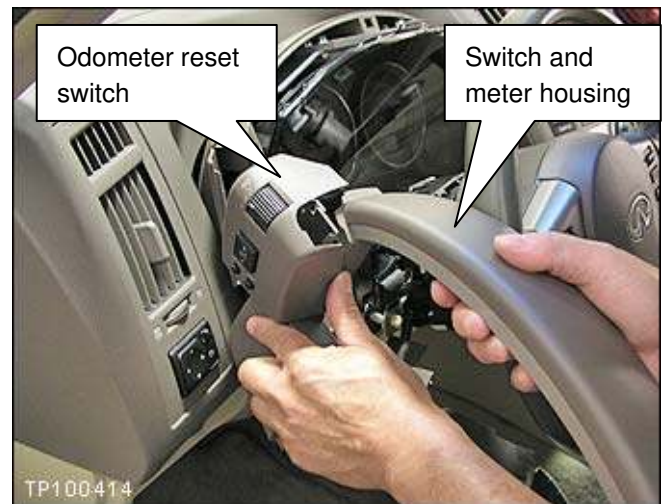
Figure 10

- b. Carefully separate the switch from the housing.

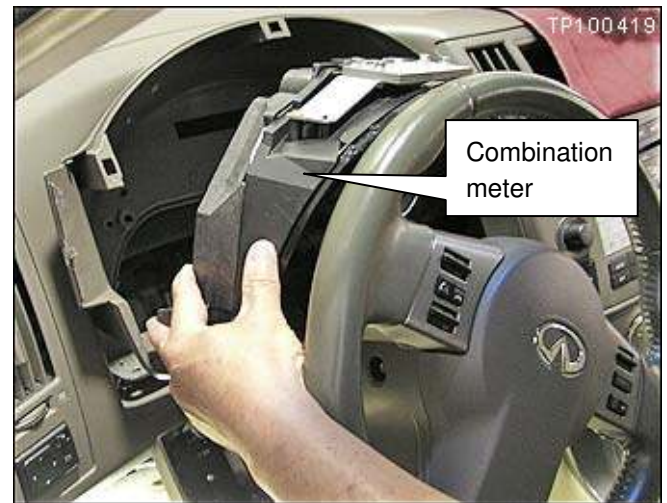
Figure 15

- c. Carefully pull the combination meter out far enough to access the harness connector.

- Do not scratch the clear plastic meter lens.
- Use a cover if needed.

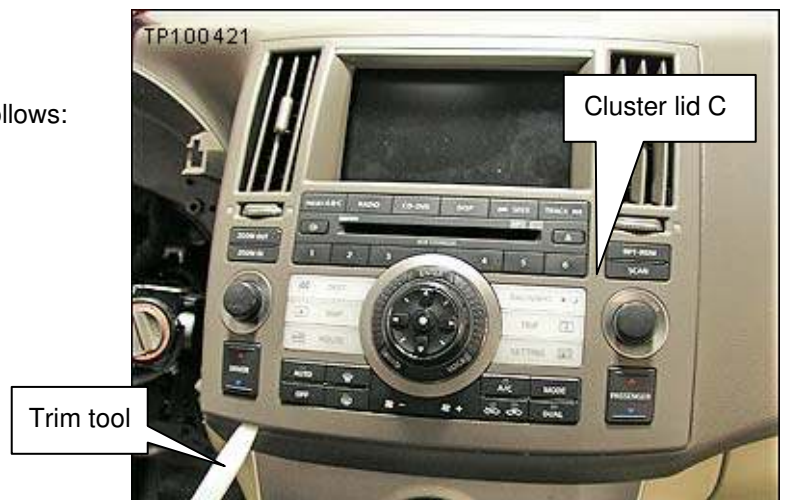
Figure 17

11. Snap loose and remove cluster lid C as follows:

- a. Use a plastic trim tool as needed.

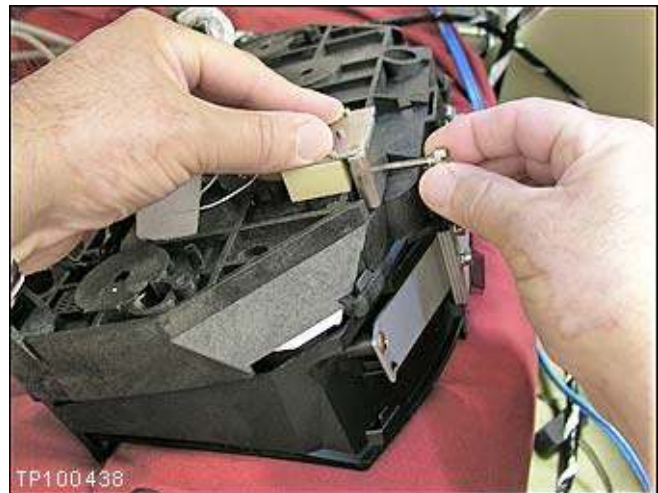
Figure 29

- Push and hold the Meter Probe into the back of the combination meter, and then tighten the lock screw.

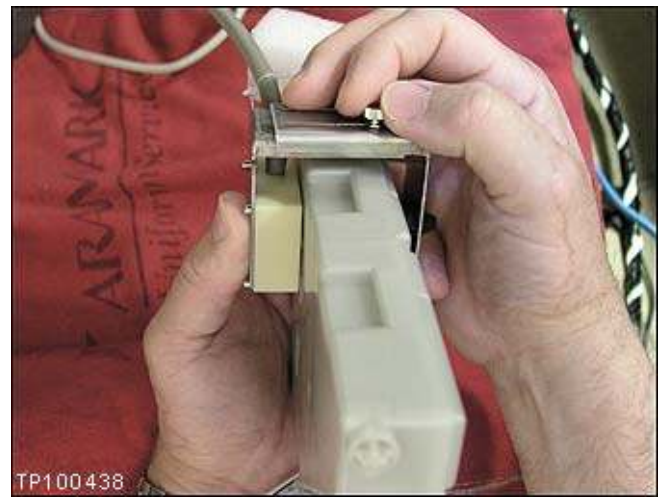
Figure 31

- Push and hold the Amp Probe in the amp probe slot, and then tighten the lock screw.

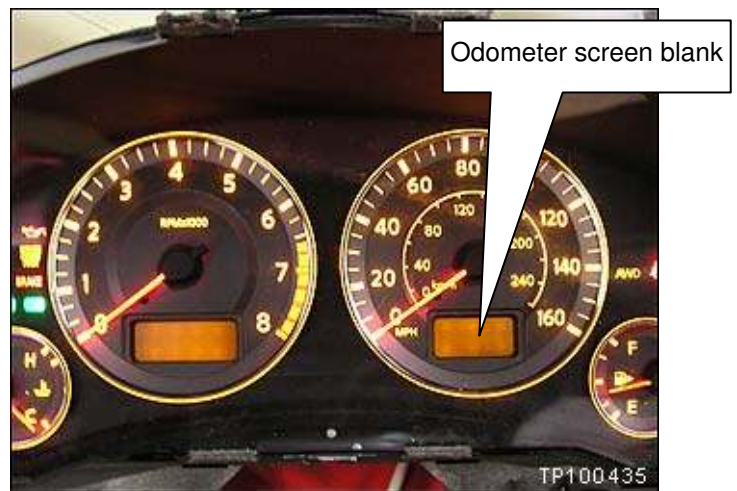
Figure 1a

1. Use the USB cable to connect the plus Vehicle Interface (plus VI) to the CONSULT PC, and then connect the plus VI to the vehicle.
2. Connect the AC Adapter to the CONSULT PC.
3. Make sure the CONSULT PC is connected to the PC Converter Box (J-50419-1) with the USB cable.
4. Turn the Ignition ON.

With the ignition ON, the odometer screen should be blank.

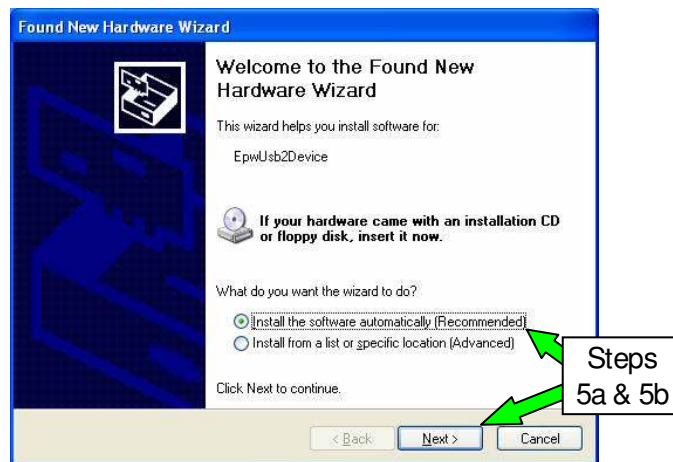
Figure 1b

a. Select Install the software automatically (Recommended).

b. Select Next.

5. Turn ON the CONSULT PC (do not launch / start C-III plus at this time).
  - The first time the reprogramming kit (PC converter box) is attached to either of the C-III plus USB ports, the following screens (Figures 1b – 1d) will display.
  - If this is not the first time, these screens will not display – go to step 6.

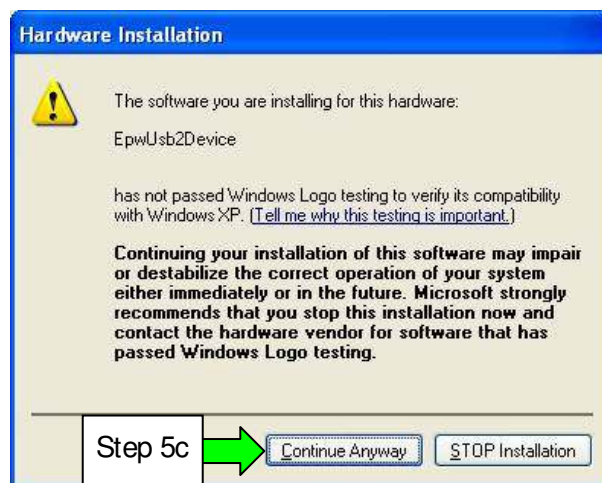
Figure 1c

c. Select Continue Anyway.

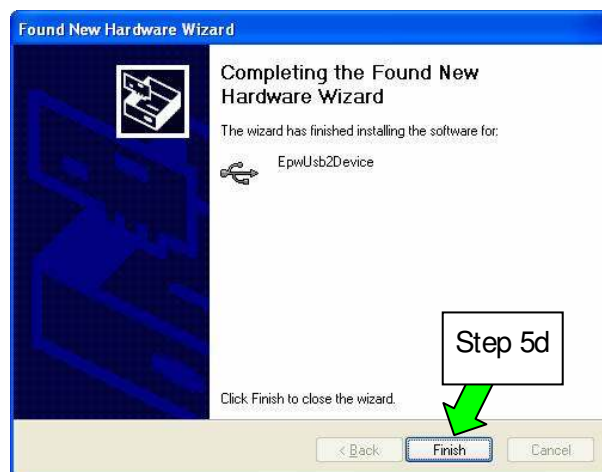
Figure 1d

d. Select Finish.

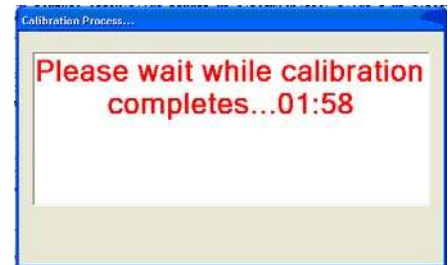
22. With the ignition OFF, wait for 2 minutes.

- The screen in Figure 1L will display with a 2 minute countdown.
