## SERVICE BULLETIN

EC15-011

### 2013-2015 TITAN AND ARMADA; MIL ON WITH DTC P0139 AND/OR P0159

**APPLIED VEHICLES:** 2013-2015 Titan (A60)  
2013-2015 Armada (TA60)

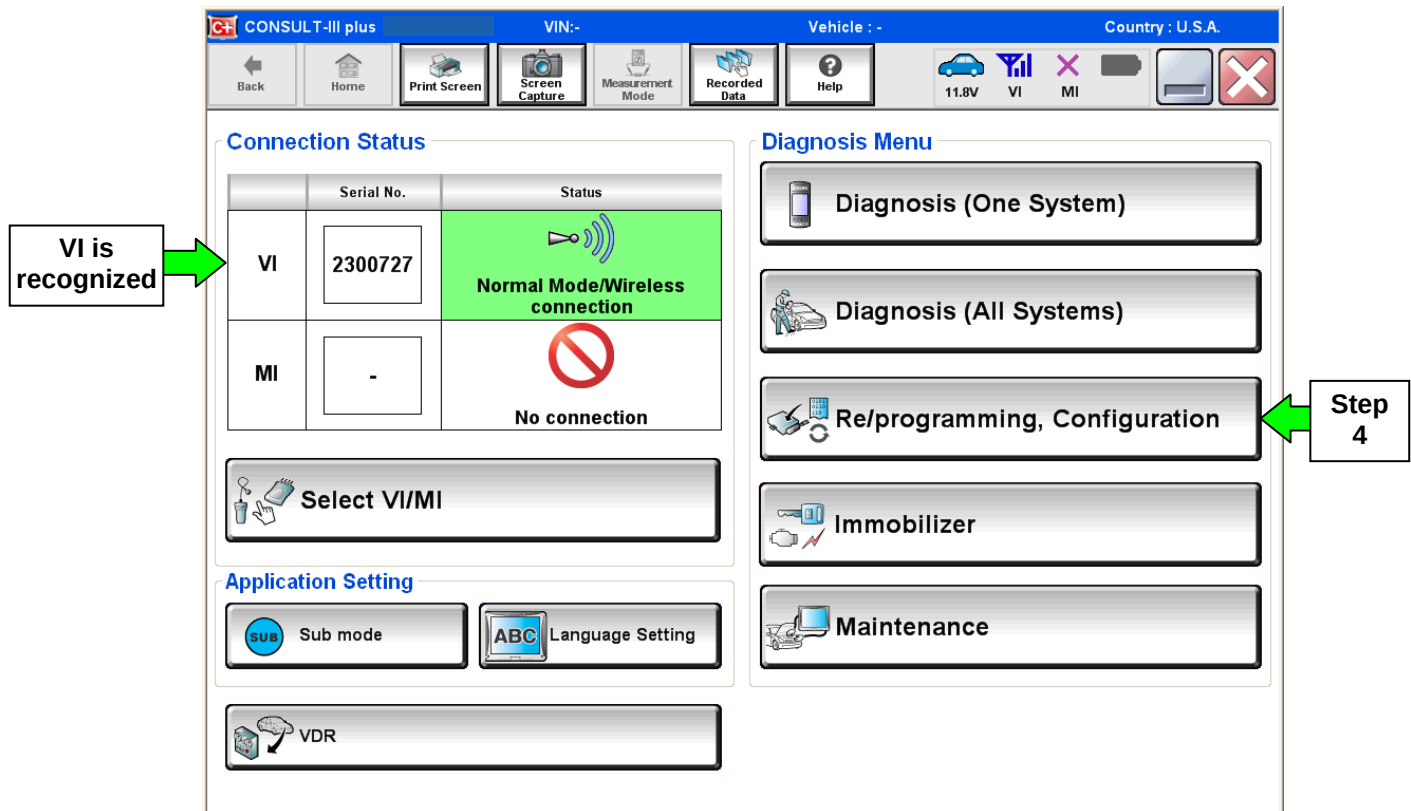
Figure 1

1. Connect the CONSULT PC to the vehicle to begin the reprogramming procedure.
2. Start C-III plus.
3. Wait for the plus VI to be recognized / connected.
  - The serial number will display when the plus VI is recognized / connected.
4. Select **Re/programming, Configuration**.

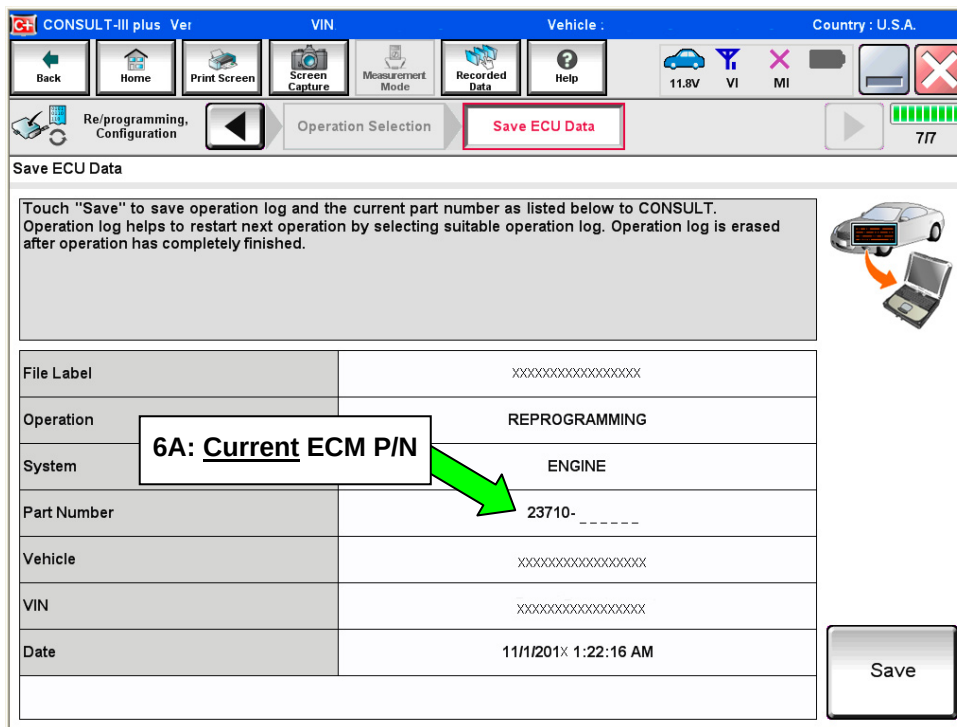
6. When you get to the screen shown in Figure 2, confirm this bulletin applies as follows.

A. Find the ECM **Part Number** and write it on the repair order.

**NOTE:** This is the current ECM Part Number (P/N).

5. Follow the on-screen instructions and navigate the C-III plus to the screen shown in Figure 2 on the next page.

B. Compare the P/N you wrote down to the numbers in the **Current ECM Part Number** column in **Table A** on page 5.

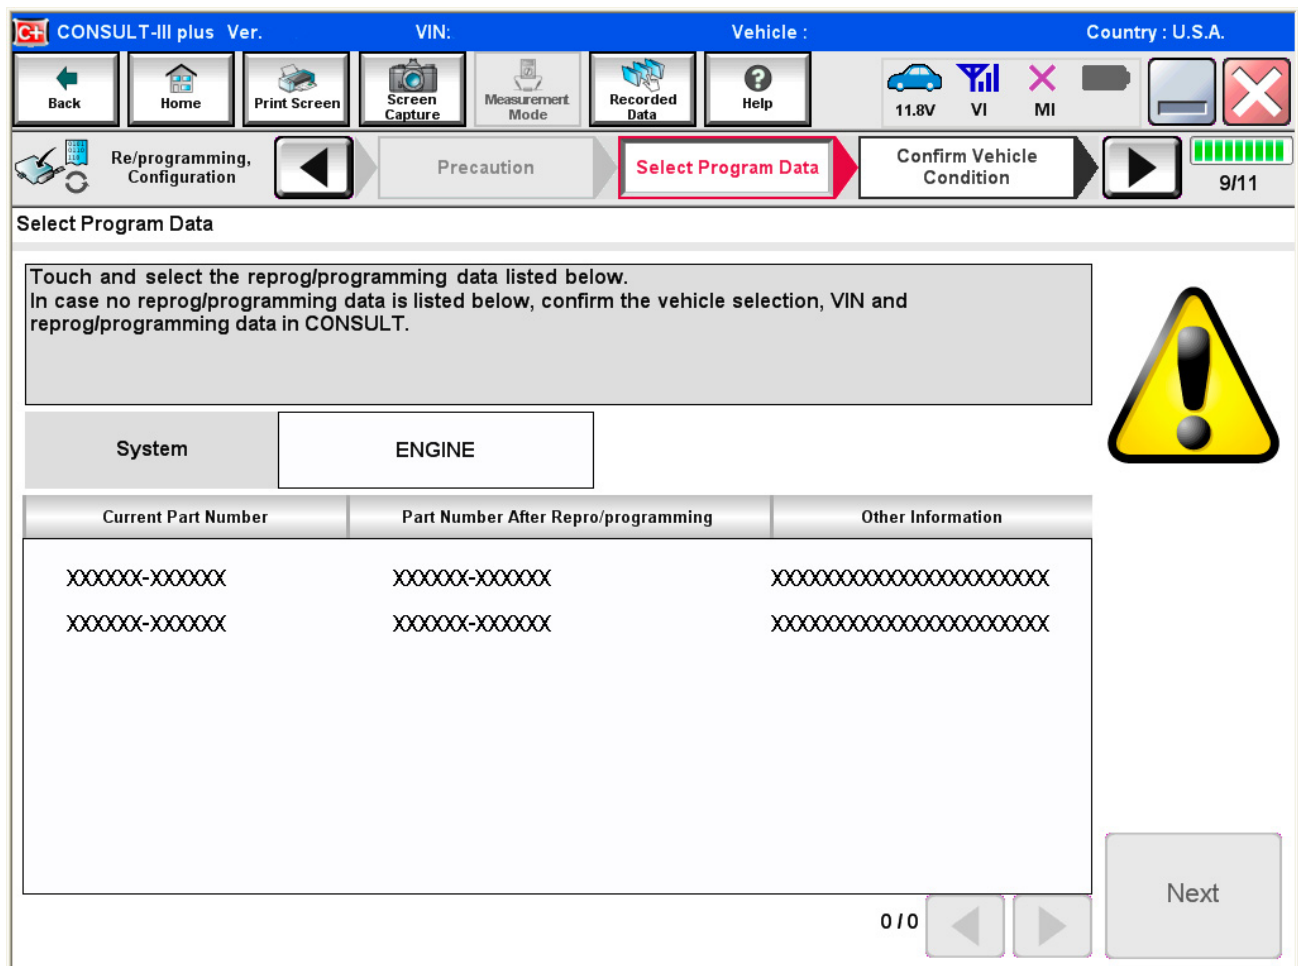
- In some cases, more than one new P/N for reprogramming is available.
  - In this case, the screen in Figure 3 displays.
  - Select and use the reprogramming option that **does not** have the message “Caution! Use ONLY with NTBXX-XXX”.
- If you get this screen and it is blank (no reprogramming listed), it means there is no reprogramming available for this vehicle. Close C-III plus and refer back to ASIST for further diagnosis.

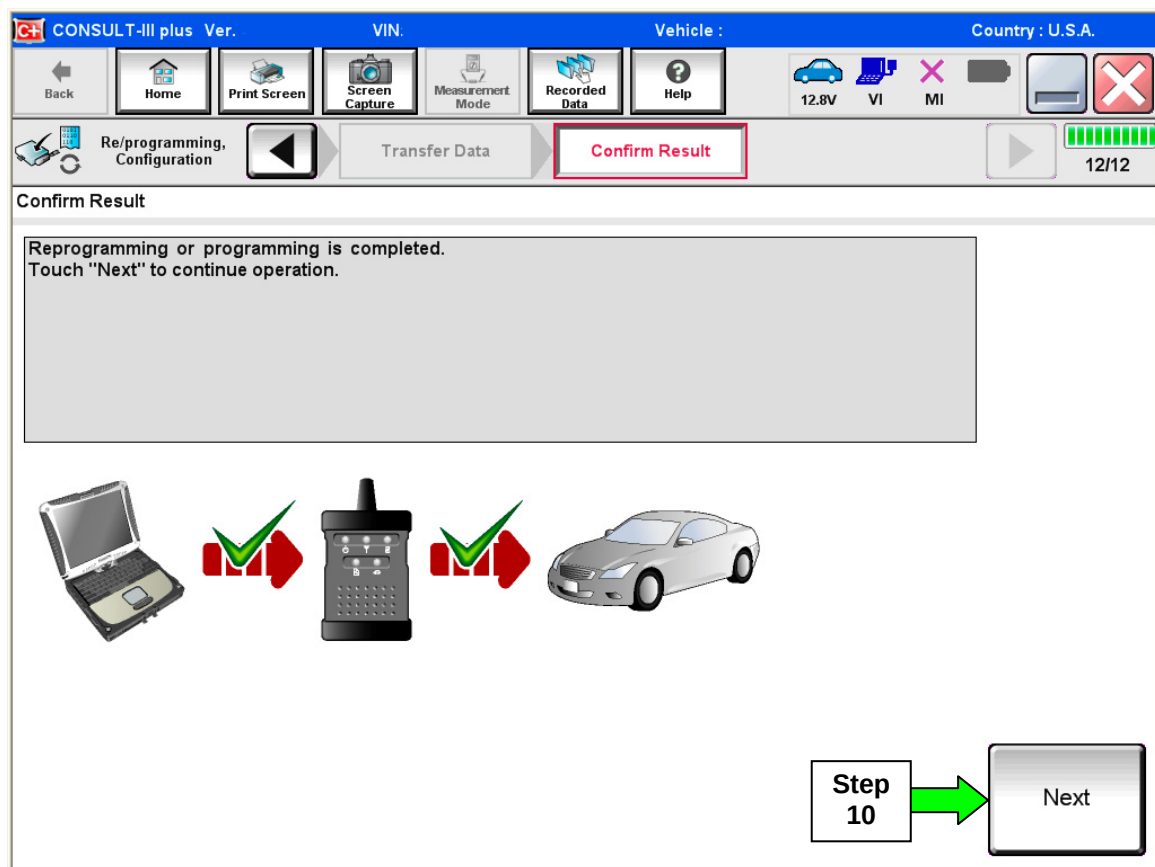
8. When the screen in Figure 4 displays, reprogramming is complete.

**NOTE:** If the screen in Figure 4 does not display (reprogramming does not complete), refer to the information on page 8.

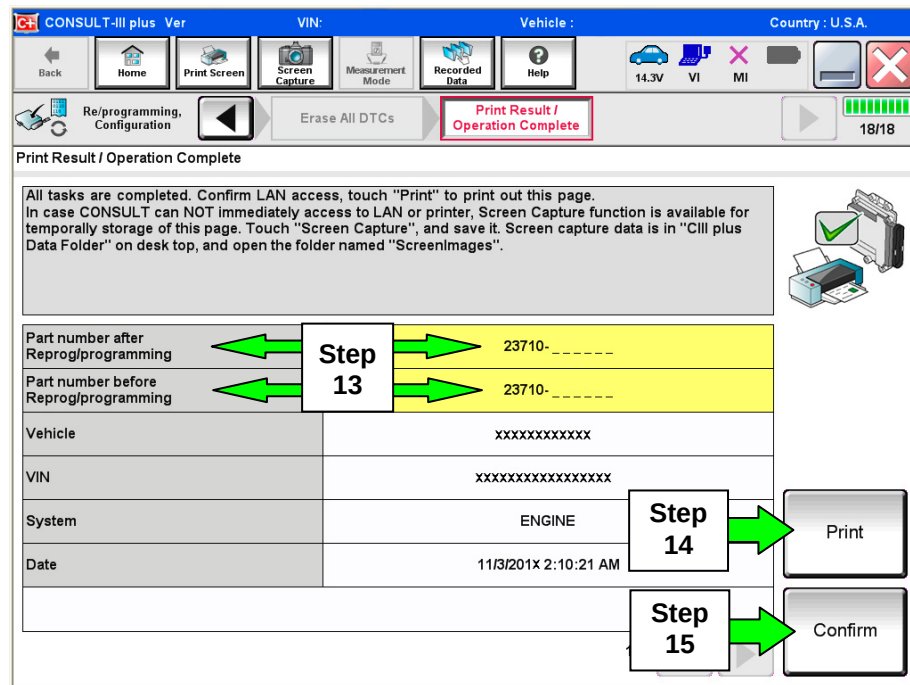
12. When the entire reprogramming process is complete, the screen in Figure 7 will display.
13. Verify the before and after part numbers are different.
14. Print a copy of this screen (Figure 7) and attach it to the repair order for warranty documentation.
15. Select **Confirm**.
