# Service Bulletin

Bulletin No.: 21-NA-092

Subject: Intermittent Malfunction Indicator Lamp (MIL) Illuminated DTC P146F Set

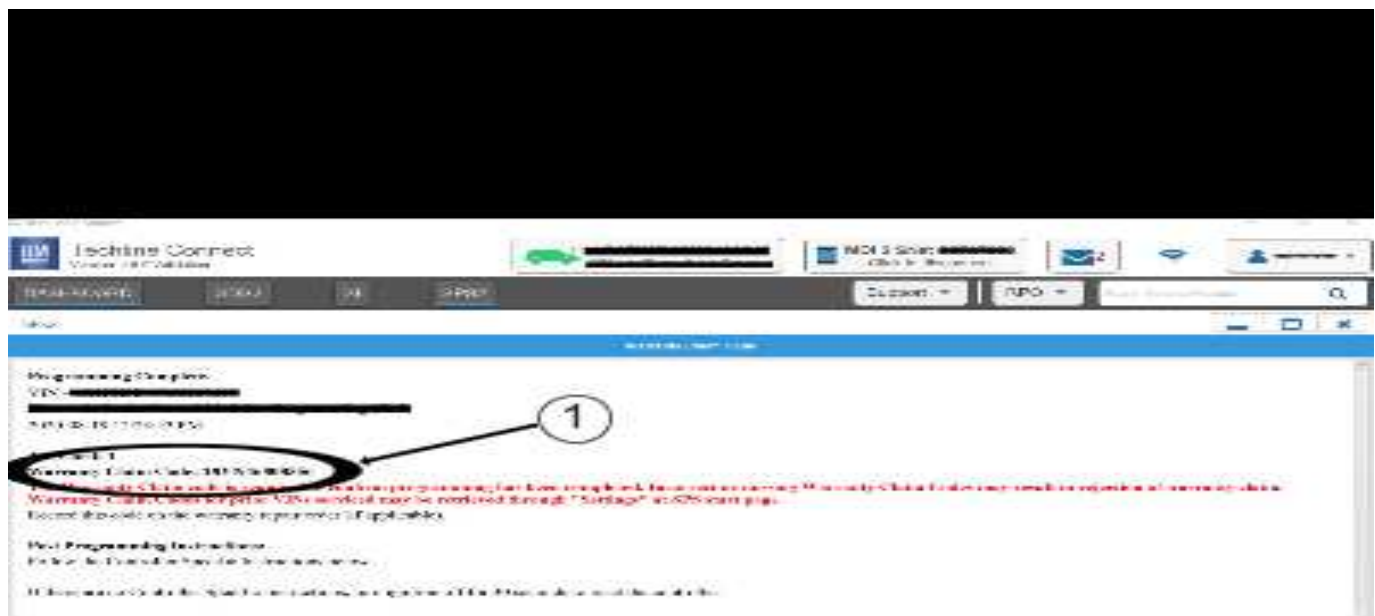
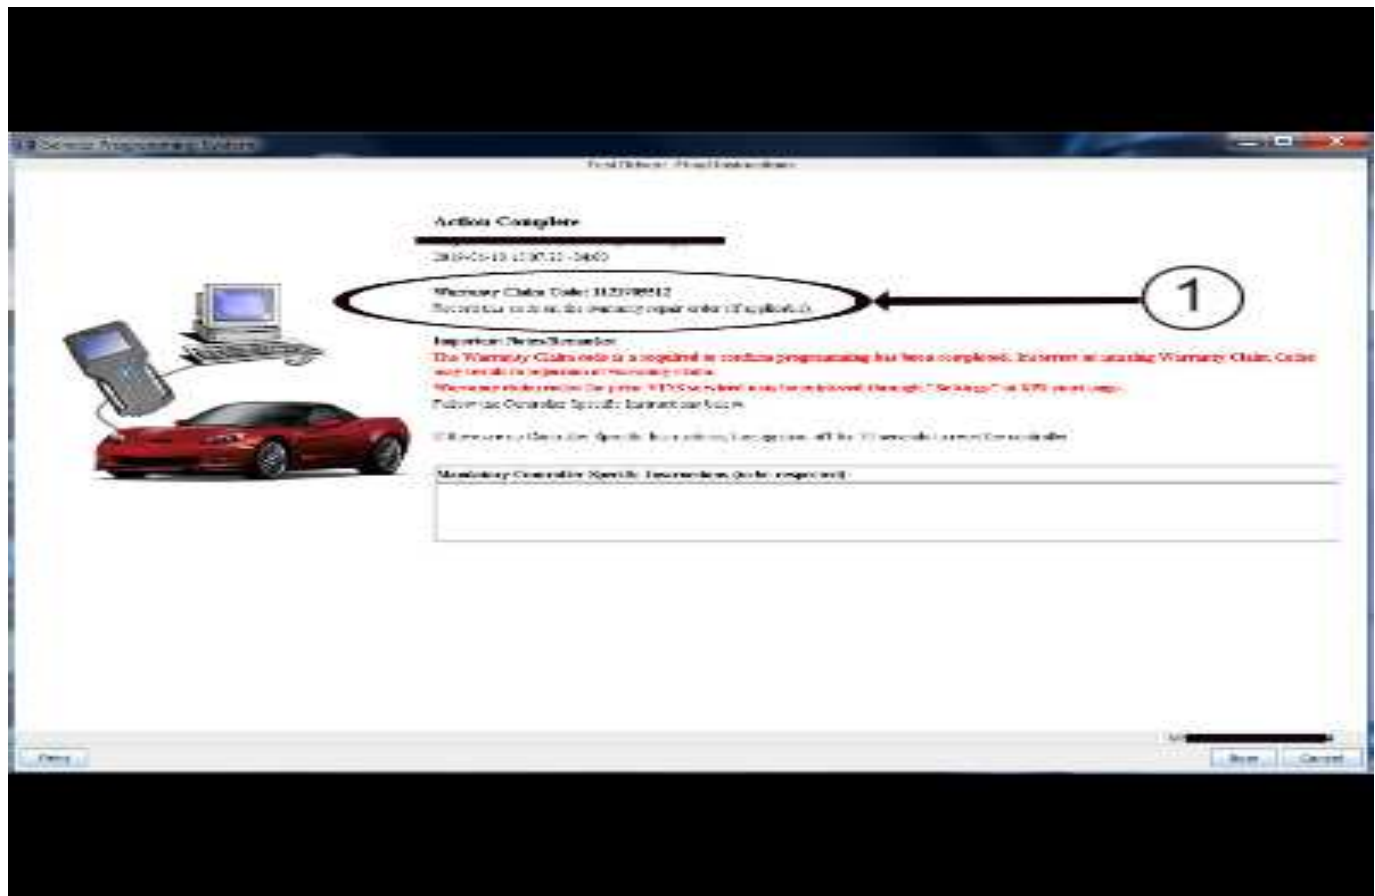
Note: The screenshots above are an example of module programming and may not be indicative of the specific module that is being programmed. Module selection and VIN information have been blacked out.
