# HYUNDAI

## Technical Service Bulletin

| GROUP<br><b>CAMPAIGN</b> | NUMBER<br><b>21-01-023H-1</b> |

**SUBJECT: ENGINE MONITORING LOGIC (SERVICE CAMPAIGN 966)**

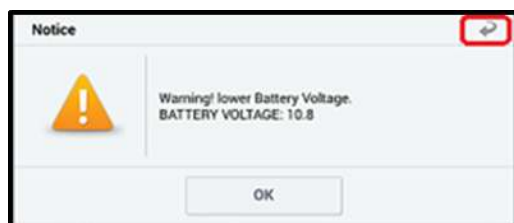
### ⚠ WARNING

### GDS Vehicle Battery Voltage Warning:

If voltage is below 12 volts as per the GDS warning, then select **Back** and run the engine at least 15 minutes to reach an adequate battery state of charge to prevent ECU Update failure. Cycle the ignition **OFF/ON** before retrying ECU update again.
