GLOBAL SAFETY FIELD INVESTIGATIONS  
DCS5788  
URGENT - DISTRIBUTE IMMEDIATELY

Subject: N202324050 - Service Update  
Differential Pressure Reading at DPF High Results in Reduced Power

Models: 2020 – 2021 Cadillac XT4  
Equipped with 2.0L Diesel Engine (RPO LSQ)

# N202324050 Differential Pressure Reading at DPF High Results in Reduced Power

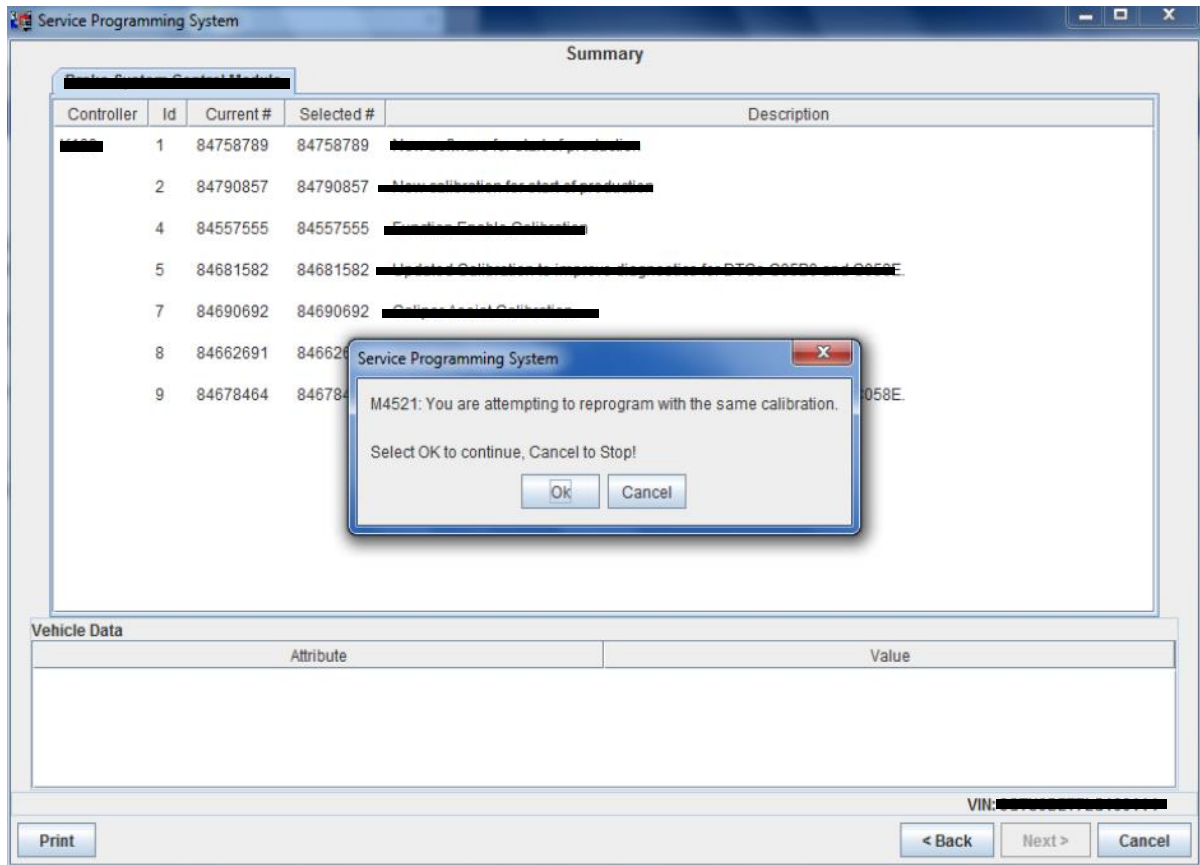
5431207

**Important:** Techline Connect and TIS2WEB screens shown above.

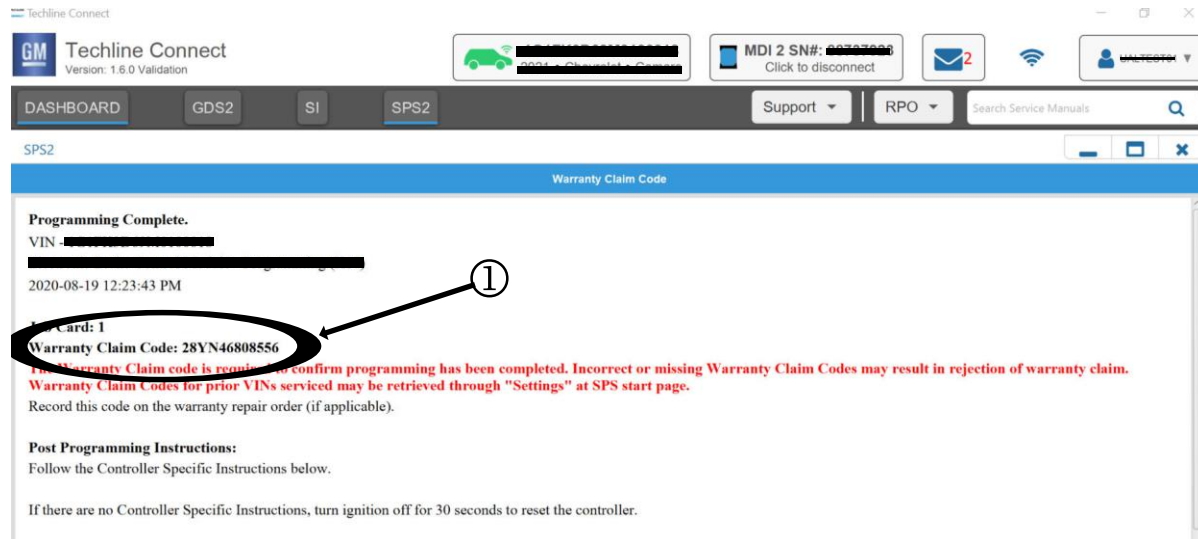
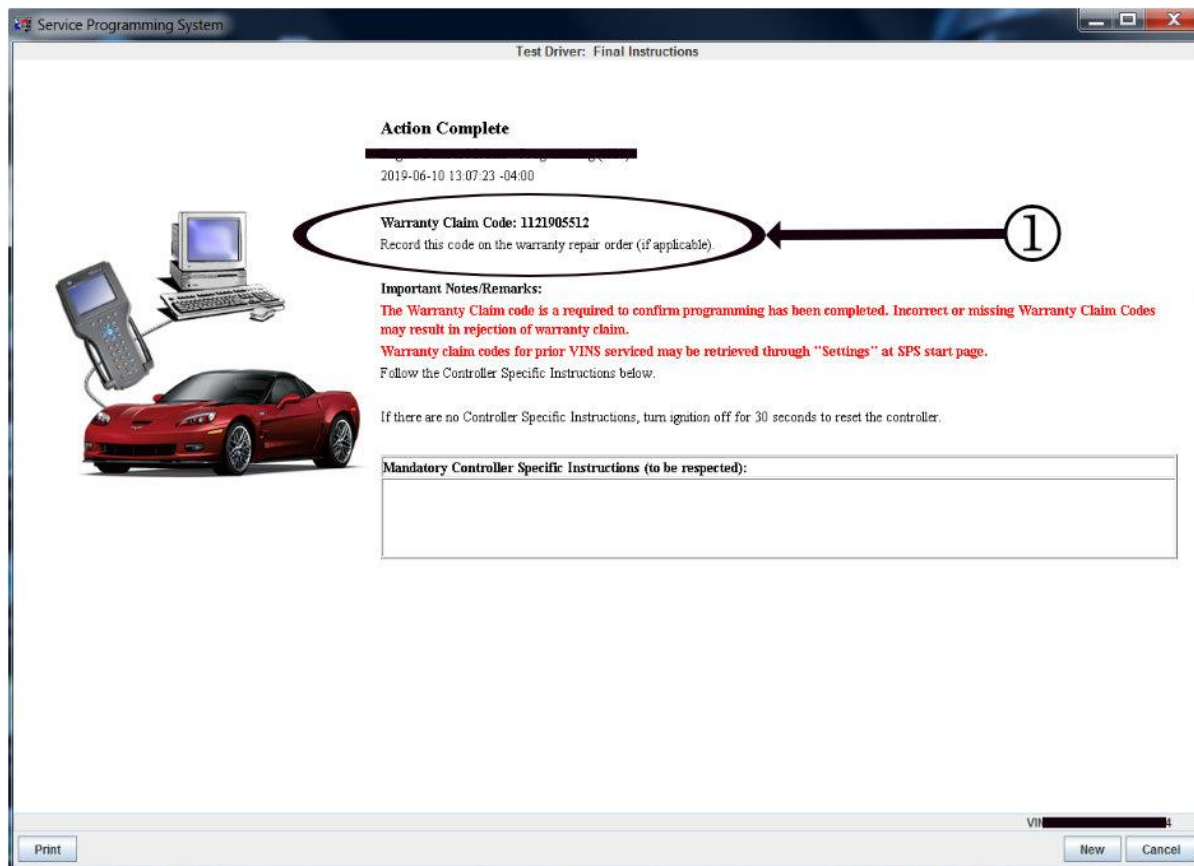
**Note:** The screenshots above are an example of module programming and may not be indicative of the specific module that is being programmed. Module selection and VIN information have been blacked out.
