# Audio Head Unit Software Update (Pioneer)

Some 2020 – 2021 model year vehicles equipped with Audio, Audio Plus, or Premium Audio (versions 1784) or earlier may exhibit one or more of the following conditions:

Follow the Multimedia Software Update Procedure in this bulletin to install the latest software version.

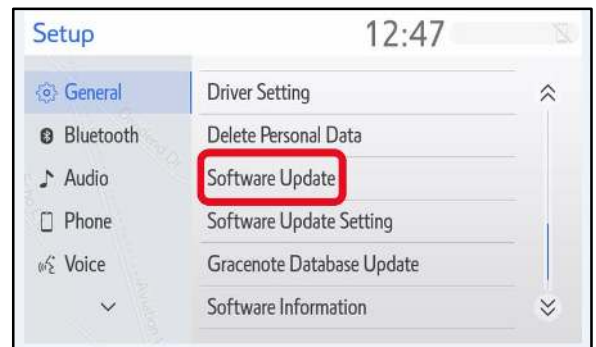
**Figure 3.**

4. Scroll down and select Software Update.

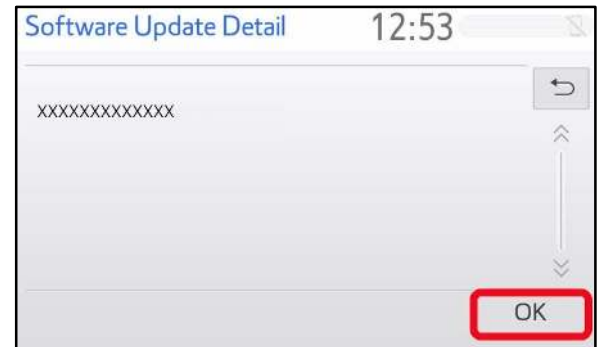
**Figure 8.**

12. Select OK on the Software Update Detail screen.

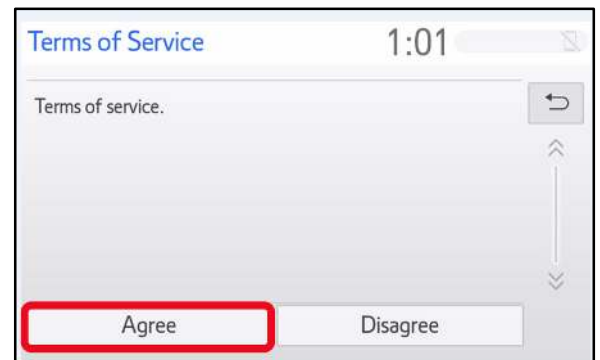
**Figure 9.**

13. Select Agree on the Terms of Service screen.

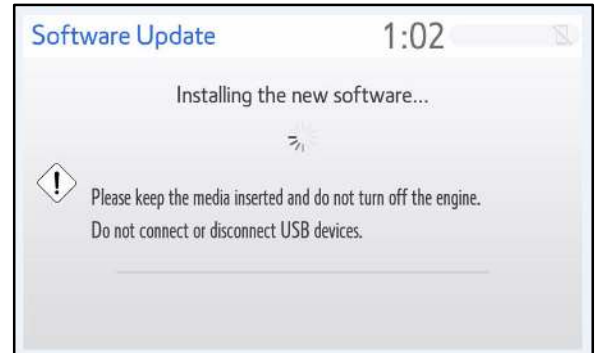
**Figure 11.**

15. Once the head unit begins installation, the update will take approximately 10 minutes.

- Do NOT turn OFF the vehicle or ACC BEFORE the software is ready for updating.
- Do NOT remove the USB flash drive until instructed in step 18.

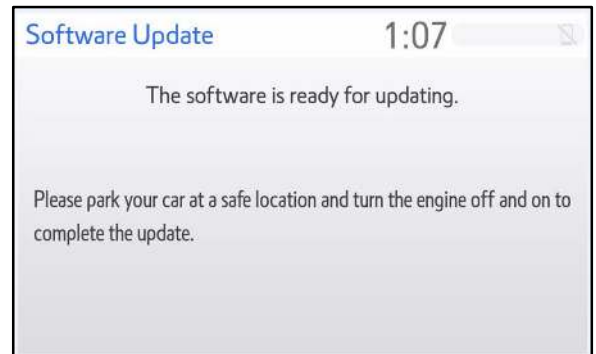
**Figure 12.**

16. When the “The software is ready for updating.” screen appears, turn OFF the vehicle.
