# HYUNDAI

## Technical Service Bulletin

| ENGINE<br>MECHANICAL | 26-EM-014H |

**SUBJECT:** CONTINUED DTC P132600 AFTER KSDS ENGINE MONITORING ECM LOGIC UPDATE

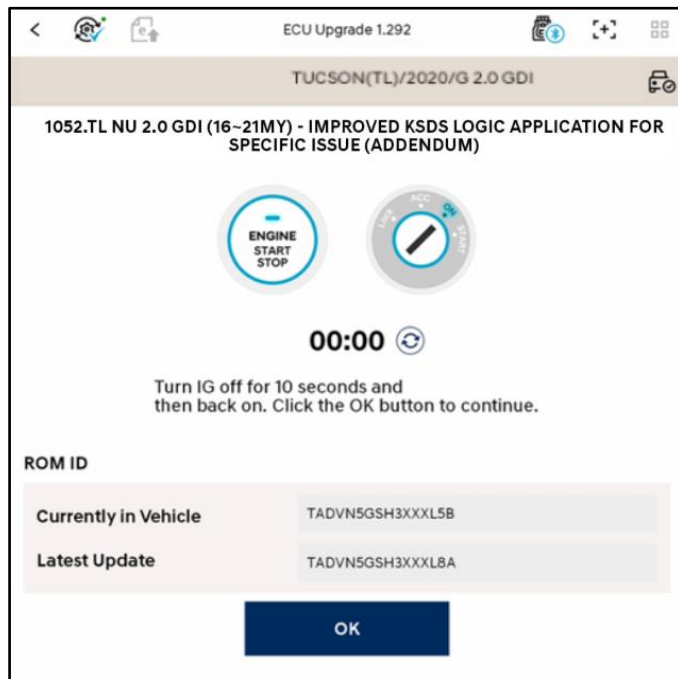
Use the **Refresh** button to reset the timer.
