# Entune Audio Head Unit Software Update (Fujitsu Ten)

**Service Category** Audio/Visual/Telematics

## **Entune Audio Head Unit Software Update (Fujitsu Ten)**

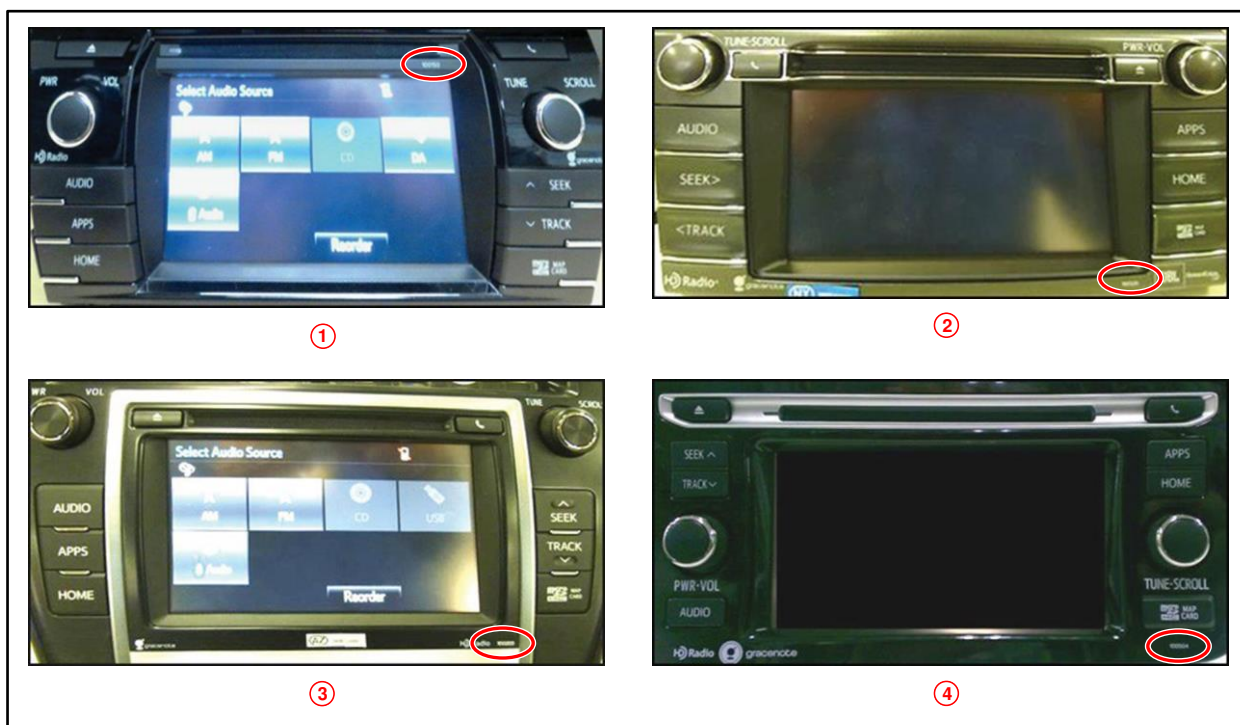
**Figure 1.**

1. Confirm the audio system type by checking the panel ID printed above the top right or bottom right of the display.

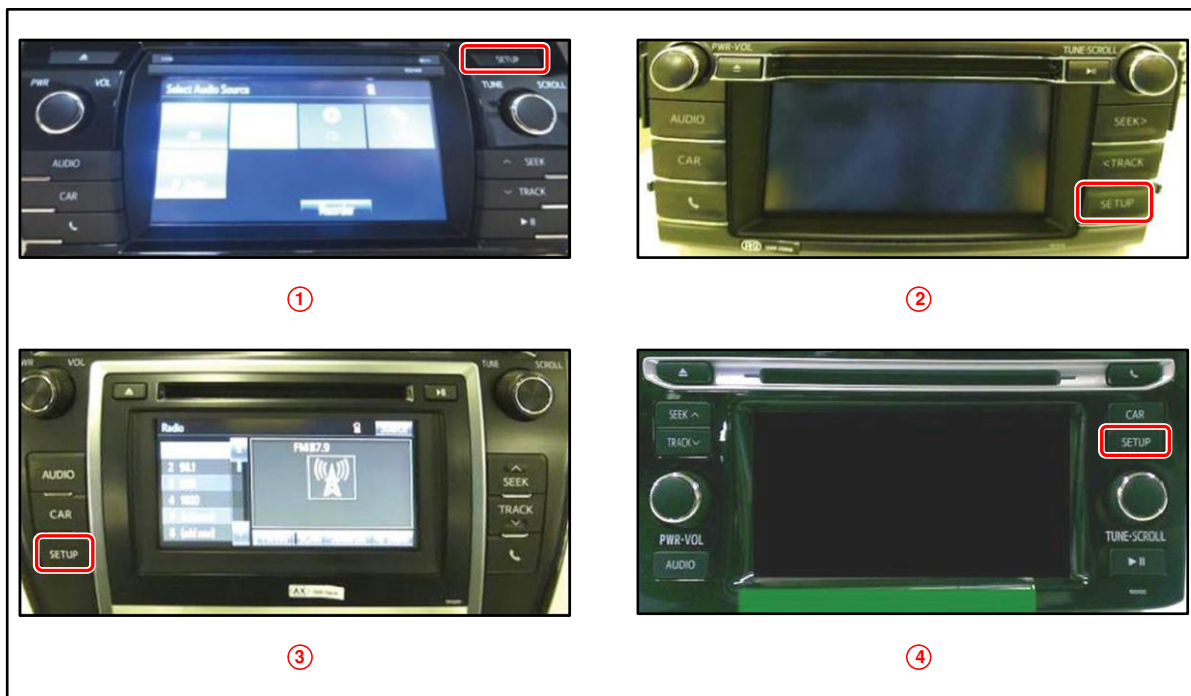
**Figure 4.**

7. Go to the Setup screen.
  - A. For Entune™ Audio:  
Press the Setup button on the panel.

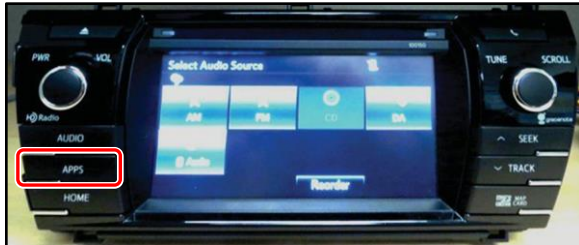
(1) Press the Apps button on the left or right of the panel.

**Figure 5. Camry, Camry HV, Corolla, RAV4, RAV4 HV**

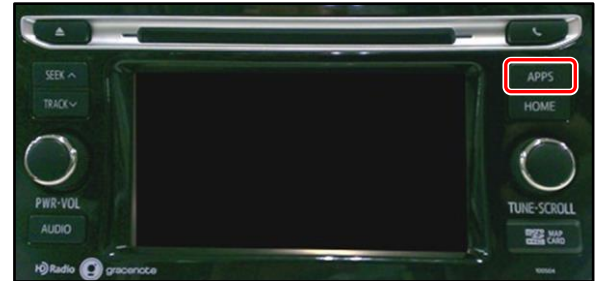
**Figure 6. Prius C**

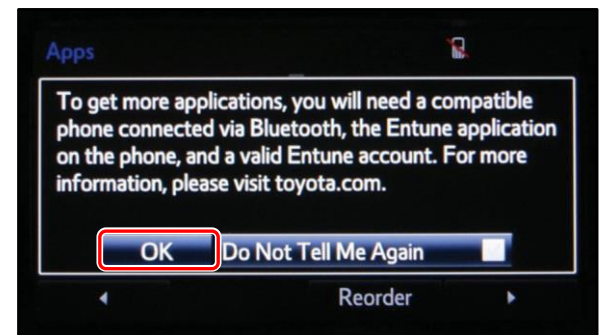
**Figure 7.**

If the Entune™ pop-up displays, select Ok.

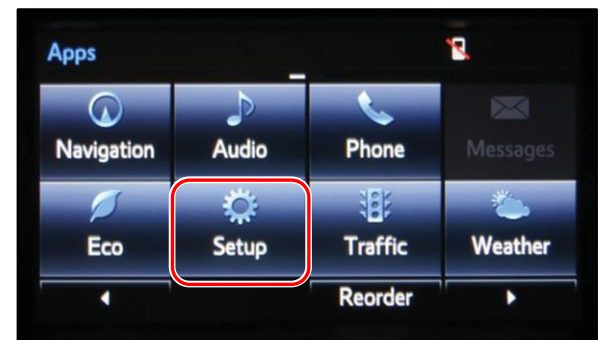
**Figure 8.**

(2) Select Setup on the Apps screen.

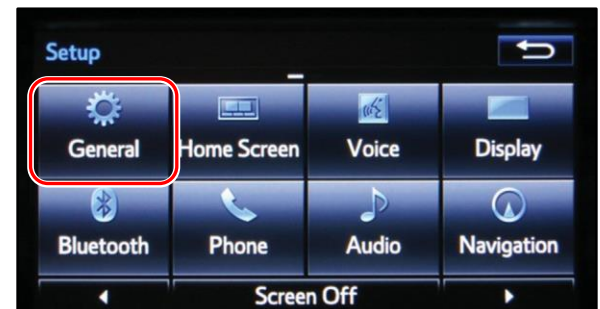
**Figure 9.**

8. Select General on the Setup screen.

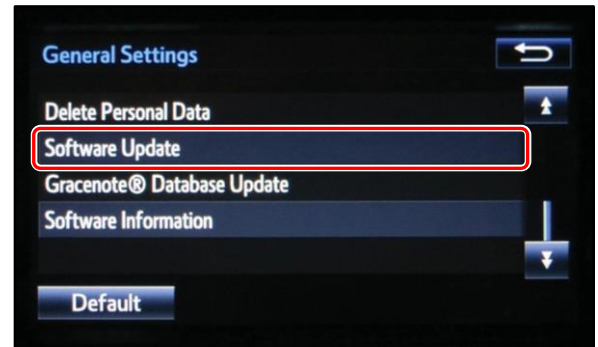
Figure 10.

9. Select Software Update from the list on the General Settings screen.

Scroll down the list until Software Update displays.

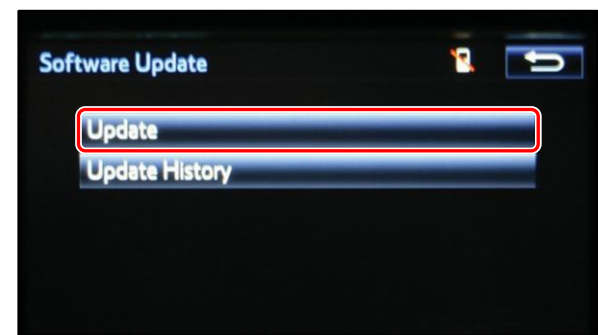
Figure 11.

10. Select Update on the Software Update screen.

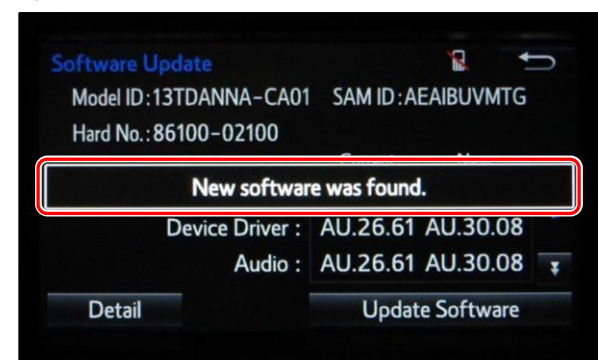
Figure 12.

If software is detected properly, a "New Software was found." pop-up will display.

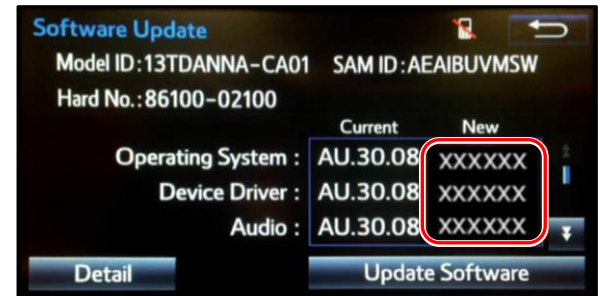
Figure 13.

11. Verify that the NEW software is up to date on the Software Update screen.

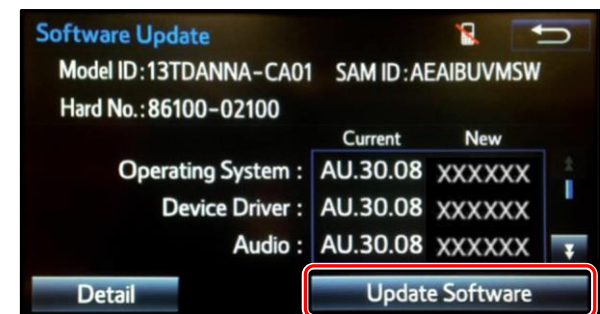
Figure 14.

12. Select Update Software on the Software Update screen.

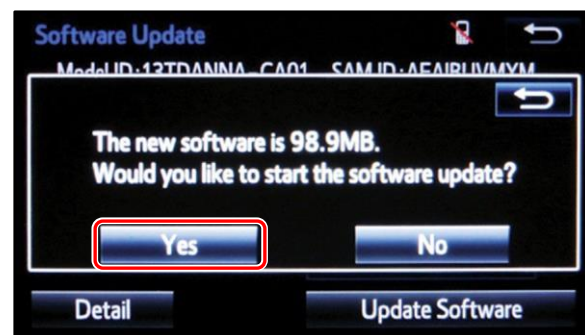
Figure 15.

13. Select Yes on the "Would you like to start the software update?" pop-up.

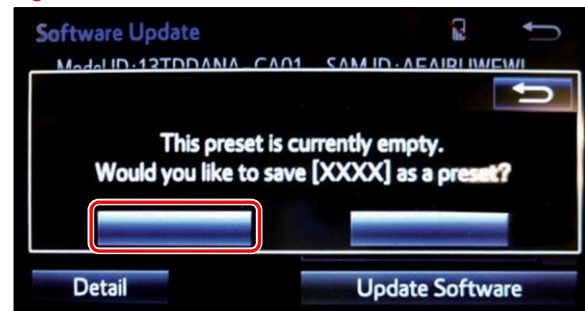
Figure 16.

Entune™ Audio Plus ONLY: Select the left box on the "This preset is currently empty. Would you like to save [XXXX] as a preset?" pop-up.

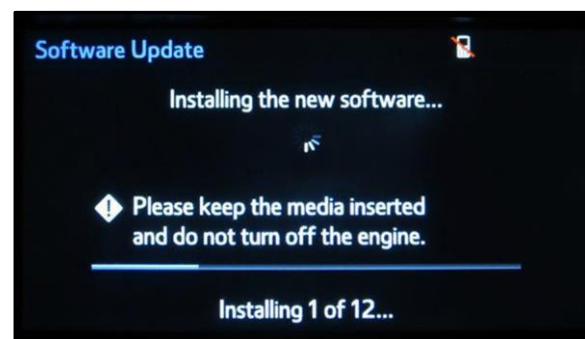
Figure 17.

14. This unit will begin installation.

Do NOT turn off ACC before the software is ready for updating.

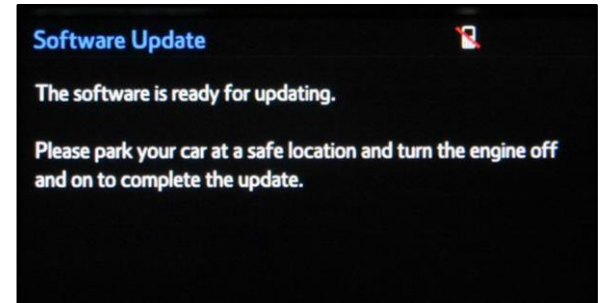
**Figure 18.**

15. When “The software is ready for updating” displays, cycle the ignition OFF, wait 30 seconds, then cycle the ignition ON again.

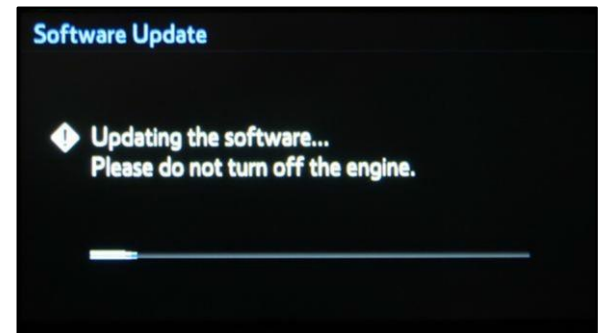
**Figure 19.**

16. Wait for the audio system to complete the software update.

Do NOT turn off ACC before the next Toyota logo screen displays.

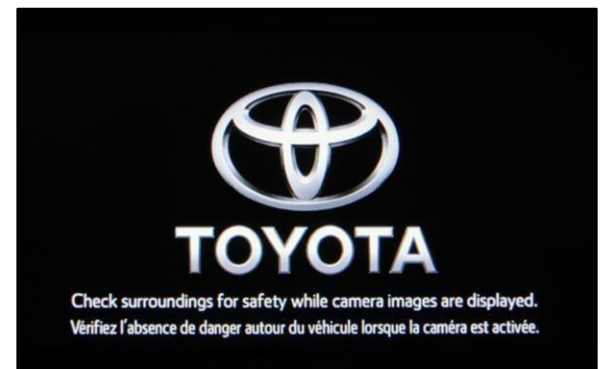
**Figure 20.**

When the Toyota logo screen displays, the update is complete.

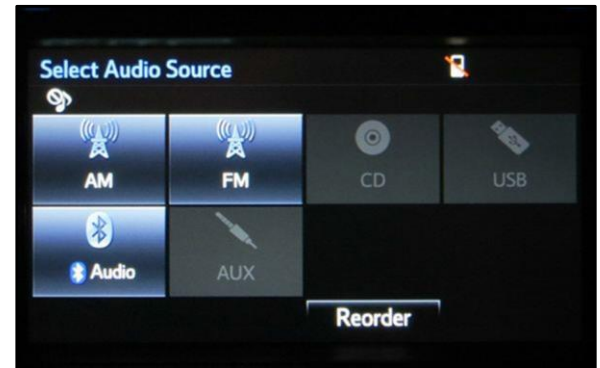
**Figure 21.**

18. When the the Select Audio Source screen displays, continue to the next step.
