# Technical Service Bulletin

**FRONT CAMERA SENSOR SYSTEM MALFUNCTION WARNING  
MESSAGE IN INSTRUMENT CLUSTER AND DTC U0155:00 STORED**

**Bulletin No.:** 15-001/19

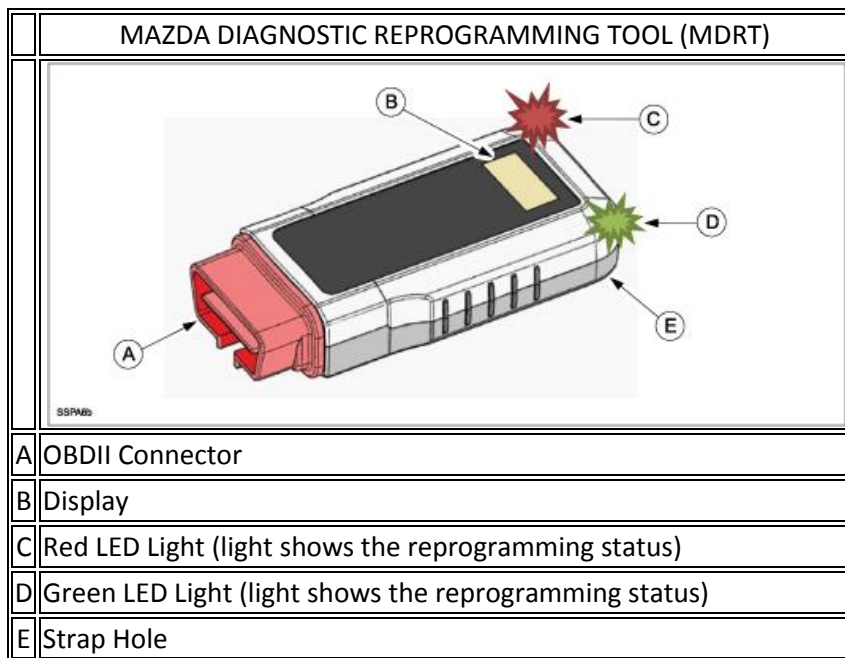
1. Verify customer concern.
2. Order loaner MAZDA DIAGNOSTIC REPROGRAMMING TOOL (MDRT) via Mazda eStore.
3. Prepare MDRT to reprogram the Instrument Cluster (IC) software.

**NOTE:** Before performing IC unit reprogramming with MDRT:

- Turn off all electric loads (i.e. air-conditioning, audio system etc.), then connect a battery charger to the vehicle battery.
- **DO NOT** touch the reprogramming tool while the green light is blinking (with a frequent beeping sound).
- During the reprogramming, the center display and instrument cluster may blink. This is normal.
- Place the advanced key on the center console.
