# HYUNDAI

## Technical Service Bulletin

| GROUP<br><b>CAMPAIGN</b> | NUMBER<br><b>19-01-006H-2</b> |

**SUBJECT:** THETA GDI ENGINE DTC P1326 - WIRING INSPECTION /  
INSTALLATION AND ENGINE INSPECTION / REPLACEMENT  
(SERVICE CAMPAIGN T3G)

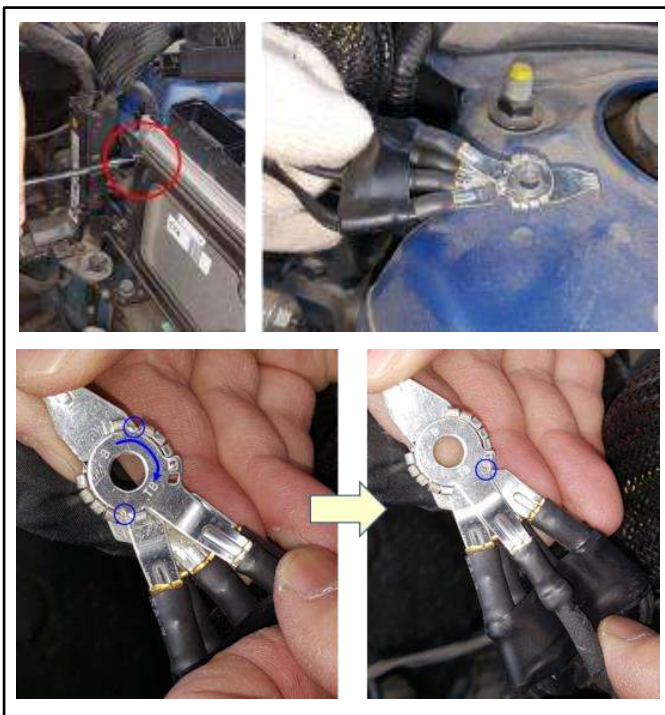
**11. For 18MY Sonata 2.0T only:**

- Loosen the ground bolt on the chassis.
- Connect the new extension wiring's ground terminal to the existing ground terminal. Rotate the new ground terminal clockwise as shown.
- Tighten the ground terminal to the chassis.

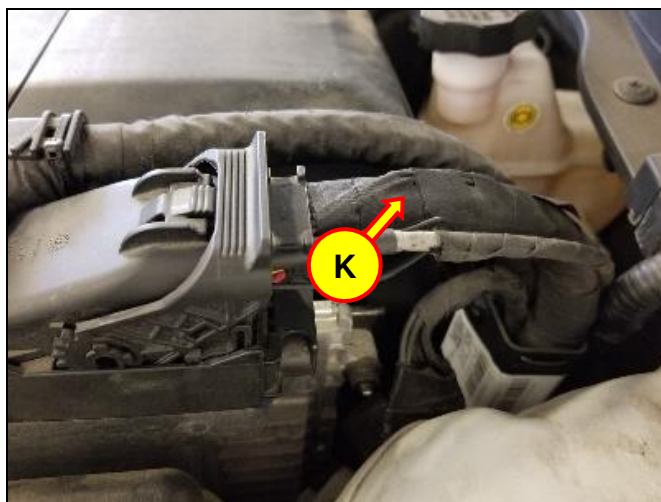
12. Cut off and discard the original terminals from the ECM connector and fold the original wires (K) back onto the original engine control wire harness and secure with tape. Secure any excess wire from the new wire harness extension onto the original engine control wire harness with tape.

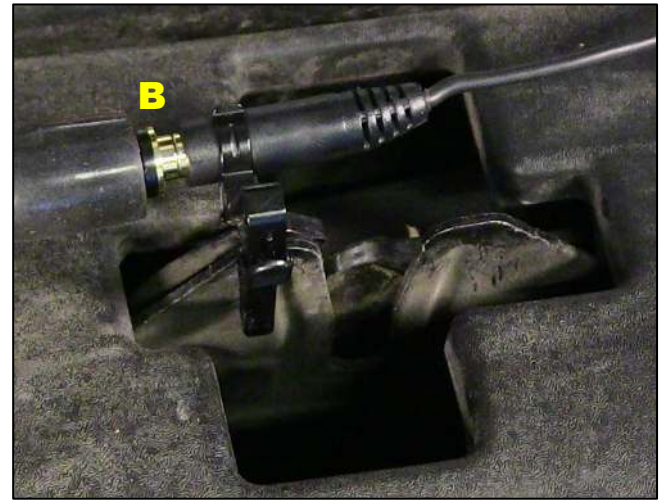
- Attach the clip (B) to the hood latch.
- Connect the stereo jack (C) to the GDS Mobile headphone jack.
- Feed the inspection tool through the open driver's front window.

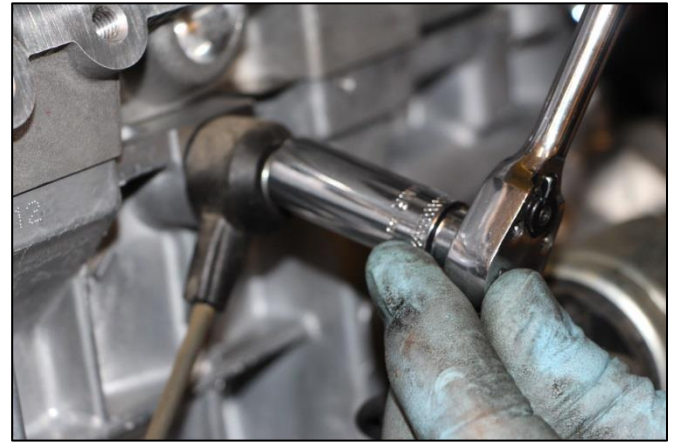
5. Remove and reinstall the engine knock sensor from the old engine to the new engine.

Ensure the knock sensor is torqued to specification using a torque wrench. Improper installation can result in DTC codes.

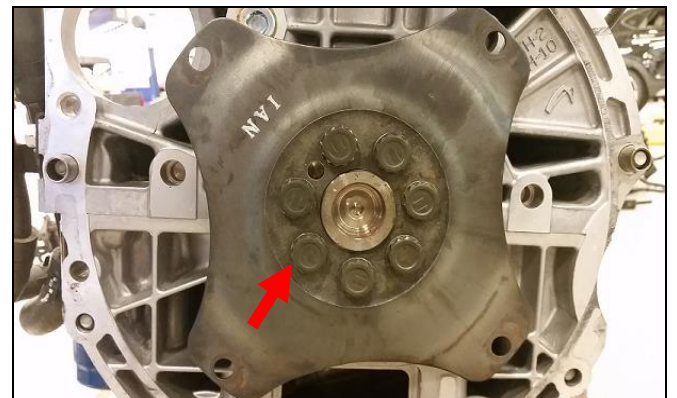
6. **If 21101-2GK70QQA engine is used:**

- Install the oil filler cap from the old engine to the new one.
- Install the drive plate/flywheel on the new engine using new bolts (QTY 7).

**Drive Plate Tightening torque :**

111.7 ~ 127.5 Nm (86.8 ~ 94.1 lb-ft)
