MODEL  
2019MY  
Forte (BDm)

NUMBER  
204 (Rev 1, 05/24/2019)

## TECHNICAL SERVICE BULLETIN

SUBJECT: SERVICE ACTION: ECU LOGIC IMPROVEMENT  
FOR P0300, P0301, P0302, P0303, P0304 AND/OR P219C00,  
P219D00, P219E00, P219F00 (SA378)

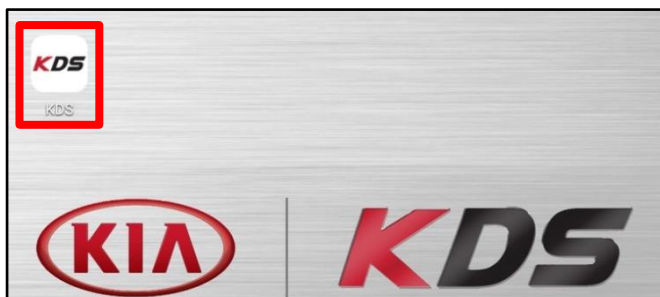
2. With the ignition ON, turn ON the KDS tablet. Select **KDS** from the home screen.

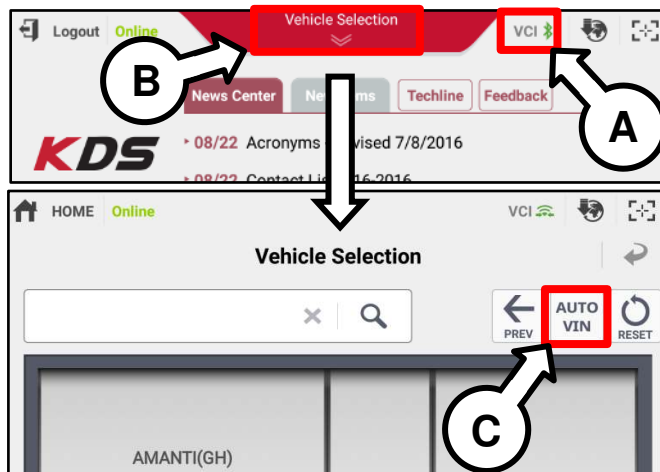
3. Confirm communication with VCI (A) and then configure the vehicle (B) using the **AUTO VIN** (C) feature.

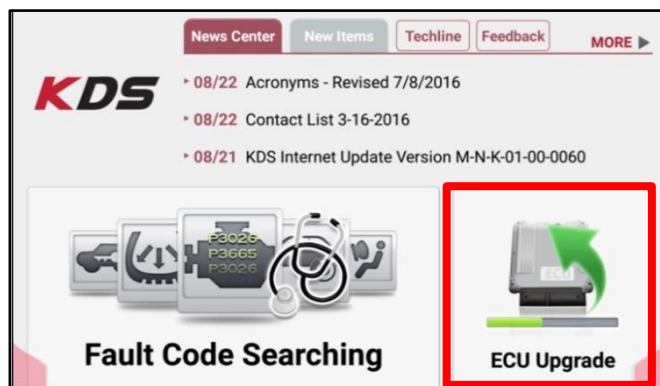
4. Select **ECU Upgrade**.

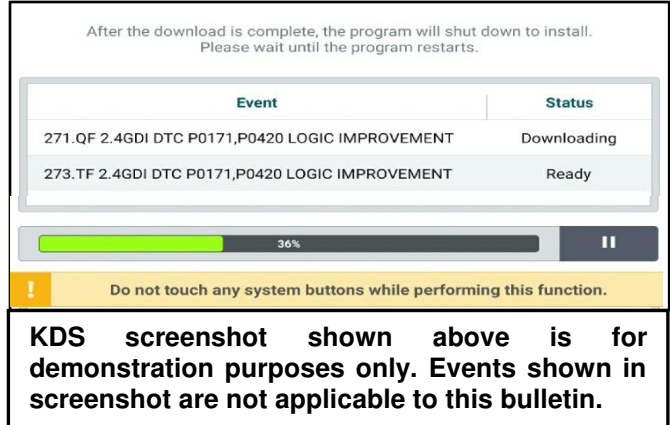
5. The KDS will check the server for recently uploaded Events and then automatically download **Upgrade Event #406**.

The vehicle must be identified in Vehicle Selection to download an Event for that vehicle.

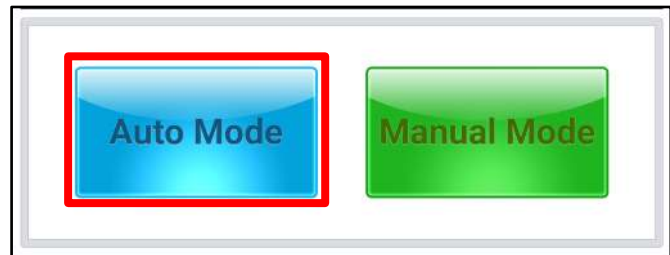
6. Select **Auto Mode**.

Do NOT attempt to perform a Manual Mode upgrade UNLESS Auto Mode fails. Always follow the instructions given on the KDS in either Auto or Manual mode.

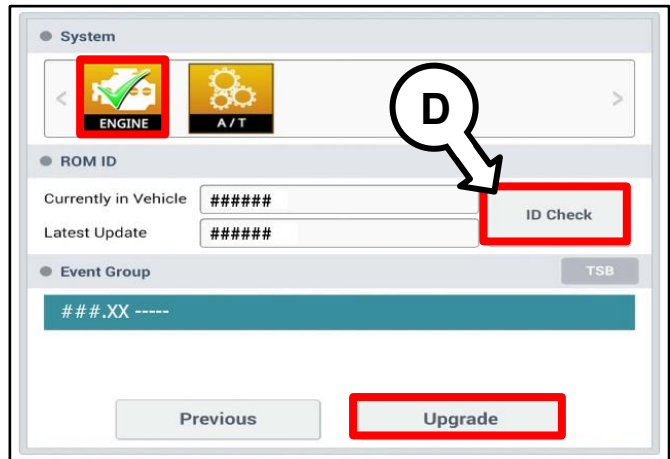
7. Select the **Engine** system under the System selection menu.

Touch **ID Check** (D) and confirm that the latest update is available.

Select **Upgrade Event #406** and select **Upgrade** to continue.

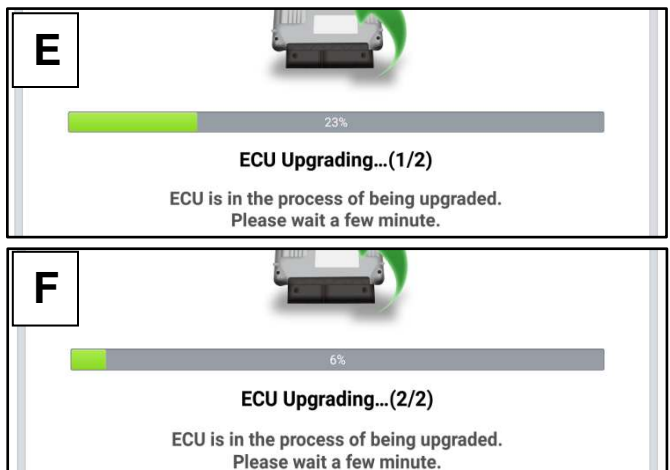
8. The ECU upgrade will begin and the progress of the upgrade will appear on the bar graph. Upgrade part (1/2) (E) will download the upgrade event to the VCI-II. Upgrade part (2/2) (F) will upgrade the ECU.

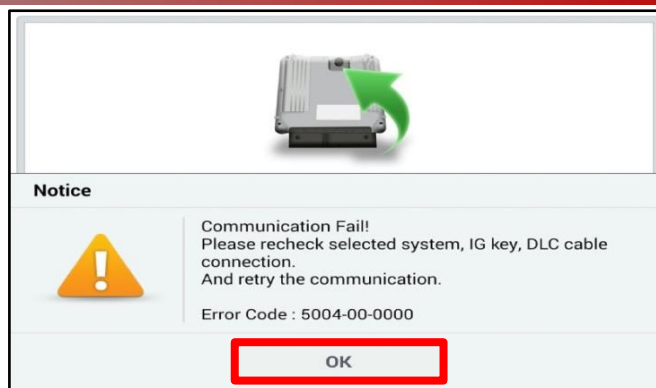
9. If a "Communication Fail" screen appears, verify that the VCI-II and KDS are communicating properly. Touch **OK** and restart the procedure from step 4.

**If an error notice continues to appear or if the upgrade cannot be performed, DO NOT disconnect the KDS/VCI-II. Contact GIT America Help Desk at (888) 542-4371 or Techline.**

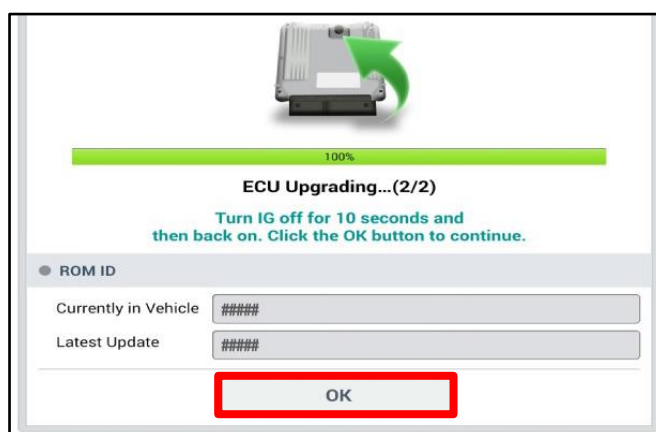
10. When instructed on the KDS, turn the ignition **OFF** for ten (10) seconds then back on. Touch **OK** to continue.

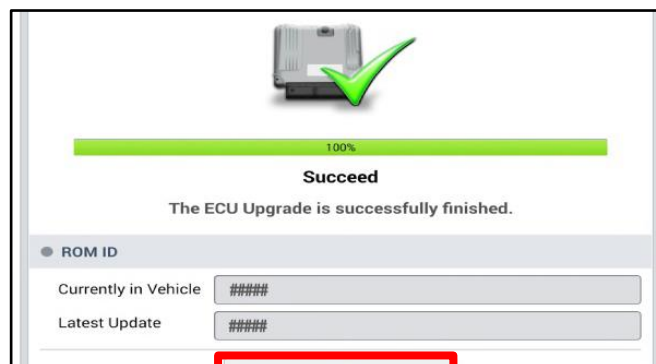
11. Once the upgrade is complete, touch **OK** to finalize the procedure.

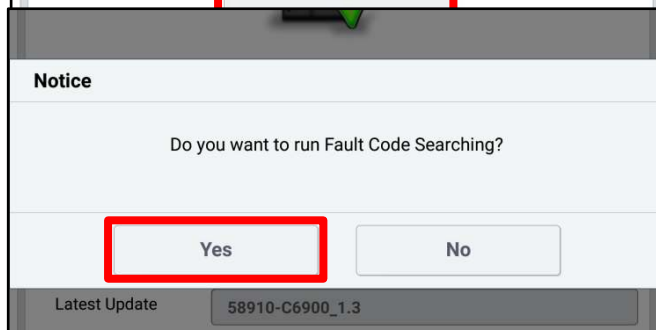
12. When prompted, select **YES** to check for Diagnostic Trouble Codes (DTC) and erase any DTCs stored such as EPS, ESC, and TPMS that may have been set during the upgrade.
