| | GROUP<br><b>TRA</b> | MODEL<br><b>2019MY<br/>Sorento (UMa) 3.3L<br/>Sedona (YP) 3.3L</b> |
| | NUMBER<br><b>082 (Rev 1, 07/03/2019)</b> | DATE<br><b>May 2019</b> |
| <b>TECHNICAL SERVICE BULLETIN</b> | | |
| <b>SUBJECT:</b> SERVICE ACTION: 3.3L GDI 8AT TCU<br>LOGIC IMPROVEMENT FOR DTC P0741 (SA387) | | |

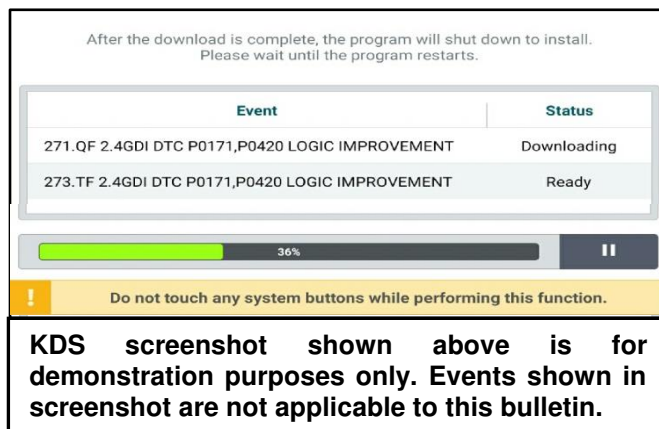
5. The KDS will check the server for recently uploaded Events and then automatically download **Upgrade Event #420 (UMa) or #421 (YP PE)**.

The vehicle must be identified in Vehicle Selection to download an Event for that vehicle.

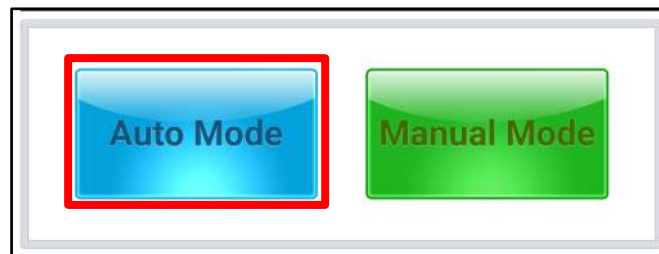
6. Select **Auto Mode**.

Do NOT attempt to perform a Manual Mode upgrade UNLESS Auto Mode fails. Always follow the instructions given on the KDS in either Auto or Manual mode.

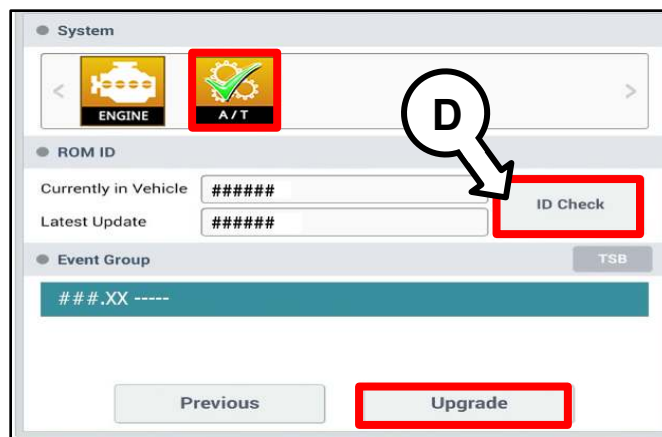
7. Select the **A/T** system under the System selection menu.

Touch **ID Check** (D) and confirm that the latest update is available.

Select **Upgrade Event #420 or #421** and select **Upgrade** to continue.

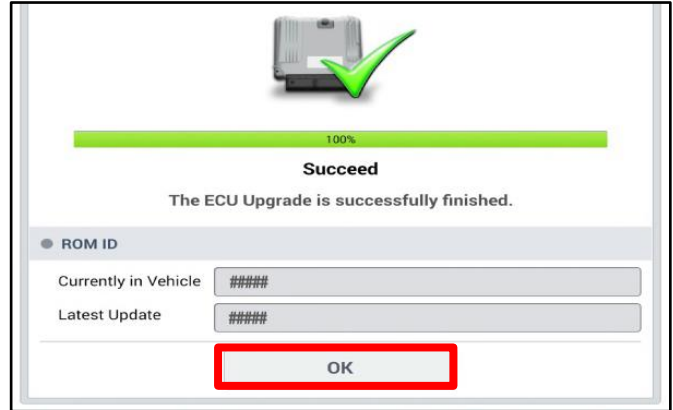
11. Once the upgrade is complete, touch **OK** to finalize the procedure.

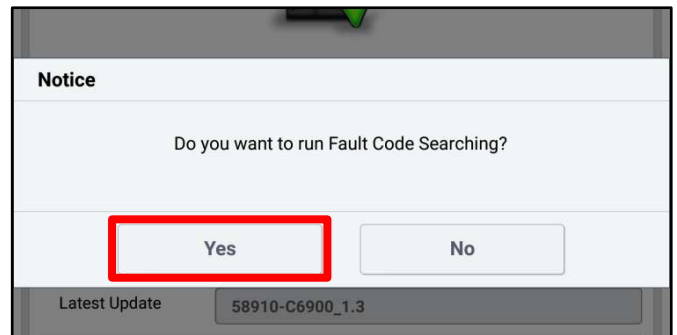
12. When prompted, select **YES** to check for Diagnostic Trouble Codes (DTC) and erase any DTCs stored such as EPS, ESC, and TPMS that may have been set during the upgrade.
