| <b>PRODUCT IMPROVEMENT CAMPAIGN</b> | | |
| <b>SUBJECT:</b> KNOCK SENSOR DETECTION SYSTEM - ECU<br>LOGIC IMPROVEMENT (PI1802) | | |

This bulletin provides information related to a software update to the Engine Control Unit (ECU) to install the Knock Sensor Detection System (KSDS) in order to protect the engine from excessive connecting rod bearing damage. This update is for:

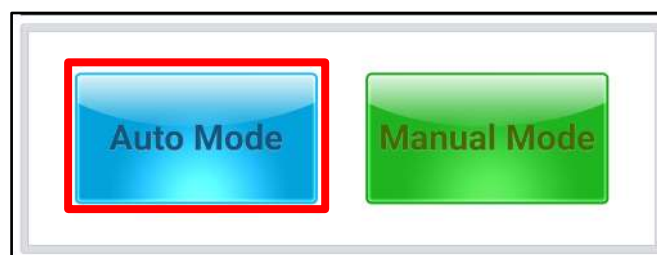
6. Select **Auto Mode**.
