| | GROUP<br><b>FUE</b> | MODEL<br><b>2019-2020MY<br/>Sedona (YP)</b> |
| | NUMBER<br><b>042</b> | DATE<br><b>September 2019</b> |
| <b>TECHNICAL SERVICE BULLETIN</b> | | |
| <b>SUBJECT: SERVICE ACTION: 3.3 GDI ULEV ECU MIL WITH<br/>DTC P0456 LOGIC IMPROVEMENT (SA397)</b> | | |

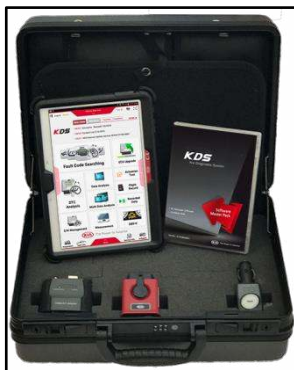
Kia Diagnostic System (KDS)

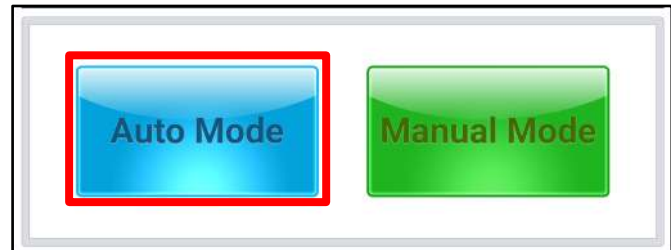
6. Select **Auto Mode**.

Do NOT attempt to perform a Manual Mode upgrade UNLESS Auto Mode fails. Always follow the instructions given on the KDS in either Auto or Manual mode.
