# Technical product information

| <b>Topic</b> | DTC C1260F0 - Compressor electronics for suspension levelling - Warning light within (DIP) |

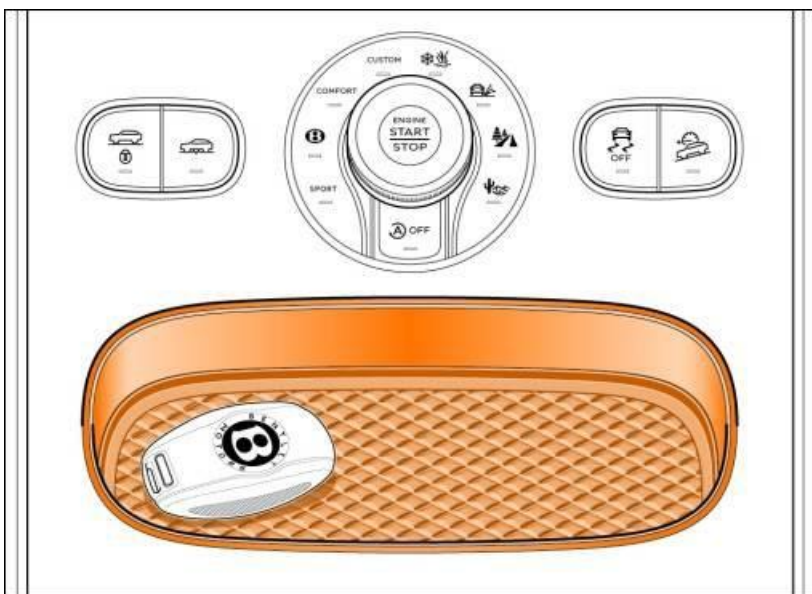
Figure 1

1. Ensure a suitable battery charger is correctly connected to the vehicle electrical system for the duration of this procedure
2. Ensure the ignition key is located in the remote control key reader and switch on the ignition (Figure 1)

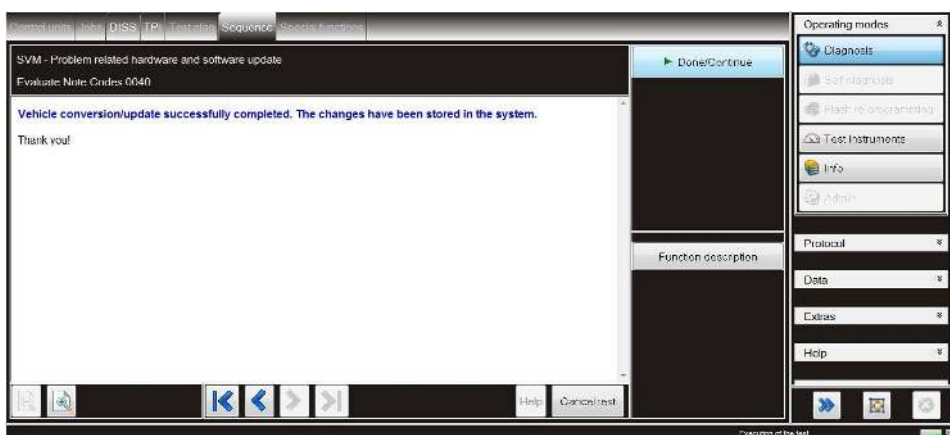
12. Follow all remaining on-screen prompts until at Figure 9
