# HYUNDAI

## Technical Service Bulletin

| GROUP<br><b>CAMPAIGN</b> | NUMBER<br><b>19-01-006H-4</b> |

**SUBJECT:** THETA GDI ENGINE DTC P1326 - WIRING INSPECTION /  
INSTALLATION AND ENGINE INSPECTION / REPLACEMENT  
(SERVICE CAMPAIGN T3G)

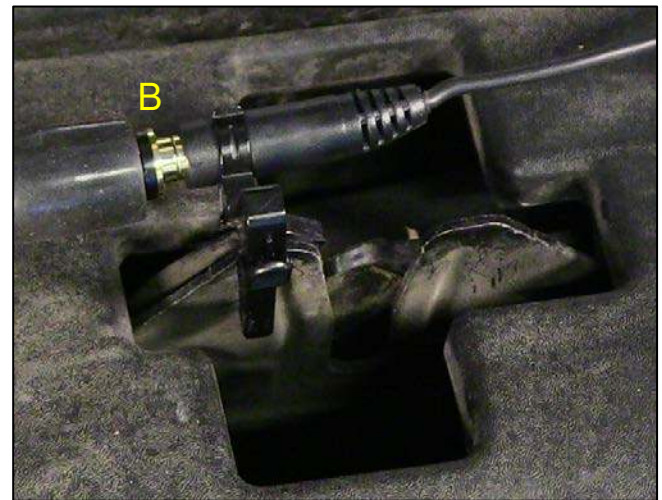
Adjust the dipstick tube to create clearance between the tube and manifold if necessary.

- Attach the clip (B) to the hood latch.
- Connect the stereo jack (C) to the GDS Mobile headphone jack.
- Feed the inspection tool through the open driver's front window.

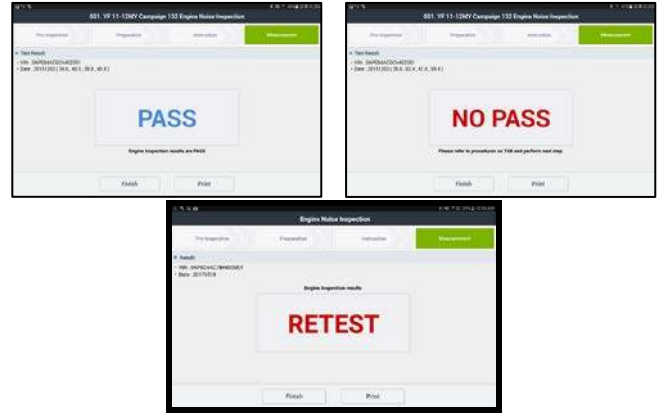
6. After the Engine Noise Inspection is complete, the application will display **PASS**, **NO PASS**, or **RETEST**.

- This information will be sent to HMA when the GDS is connected to Wi-Fi.

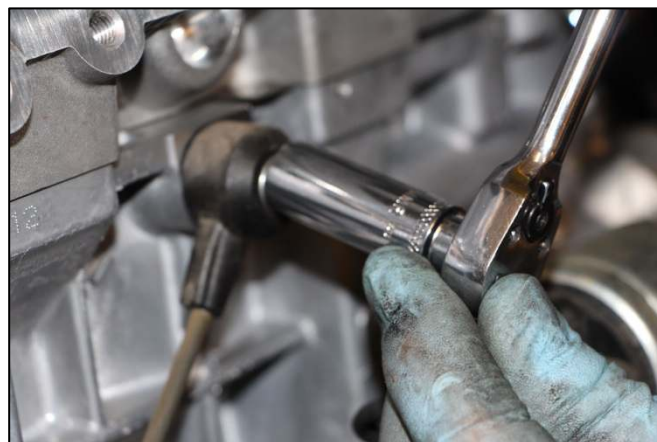
5. Remove and reinstall the engine knock sensor from the old engine to the new engine.

**Knock Sensor Fastener**

Ensure the knock sensor is torqued to specification using a torque wrench. Improper installation can result in DTC codes.

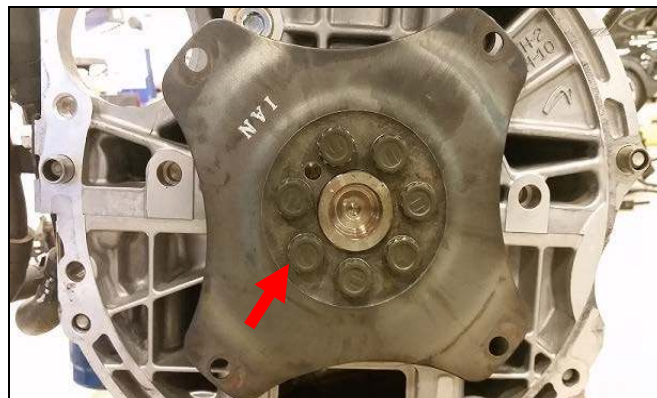
6. **If 21101-2GK70QQA engine is used:**

- Install the oil filler cap from the old engine to the new one.
- Install the drive plate/flywheel on the new engine using new bolts (QTY 7).

**Drive Plate Tightening torque :**

111.7 ~ 127.5 Nm (86.8 ~ 94.1 lb-ft)

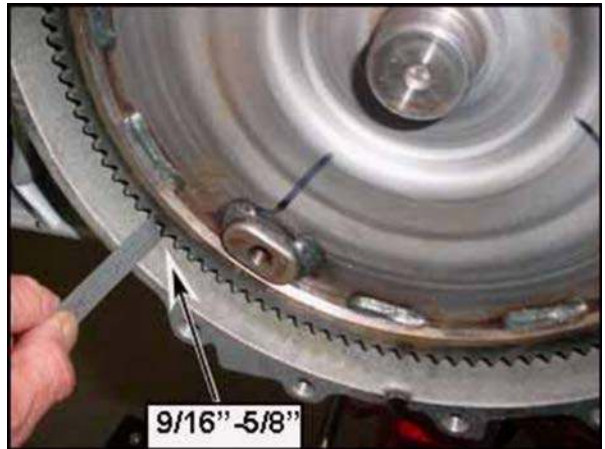
If the torque converter has moved from the fully inserted position, carefully push inward and rotate the torque converter until the converter is recessed approximately 9/16 - 5/8" (14 -16 mm) into the transaxle case when reinstalling the automatic transaxle.

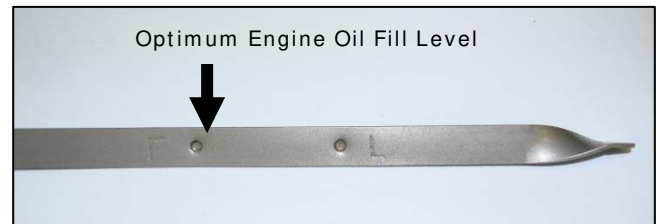
13. Start the engine to warm it up and begin the cooling system air bleeding process.
  - Check for any leaks during this time.
  - After the engine has warmed up to normal operating temperature, turn the engine off, wait a few minutes, and then **adjust the engine oil level to near the “F” mark as shown.**

14. Install the wire harness extension according to the following procedure.
15. Perform the Wiring Signal Interference Inspection.

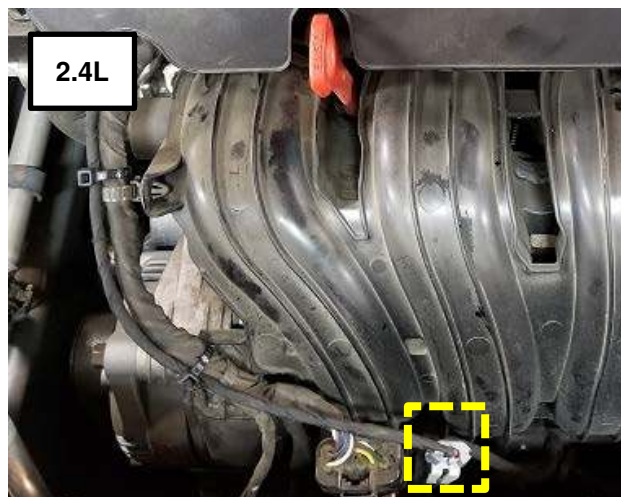
2. Disconnect the knock sensor connector and connect the connector from the new wire harness extension.

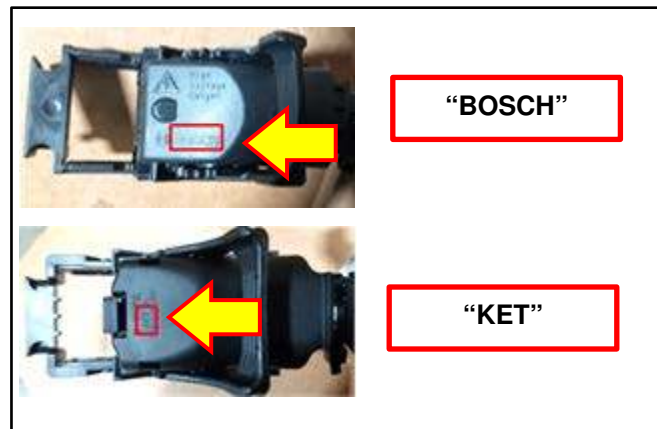
First remove ECM connector (D) to release ECM connector (E). Then remove ECM connector (E) and top cover by gently prying at (F1) or pressing on (F2) based on connector type using a flat head screwdriver.

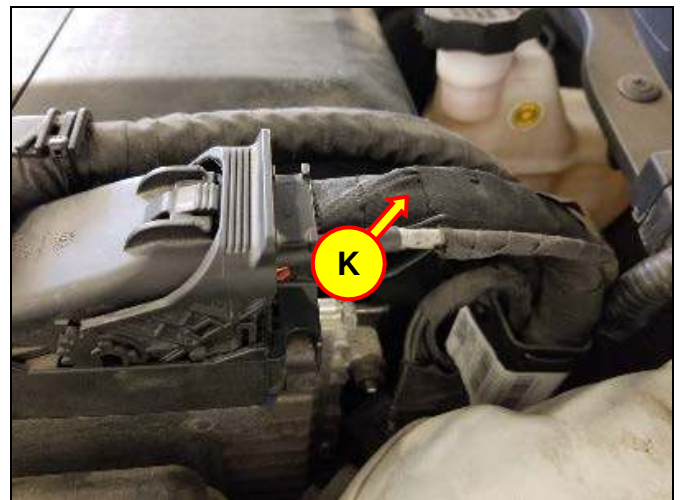
12. Cut off and discard the original terminals from the ECM connector and fold the original wires (K) back onto the original engine control wire harness and secure with tape. Secure any excess wire from the new wire harness extension onto the original engine control wire harness with tape.

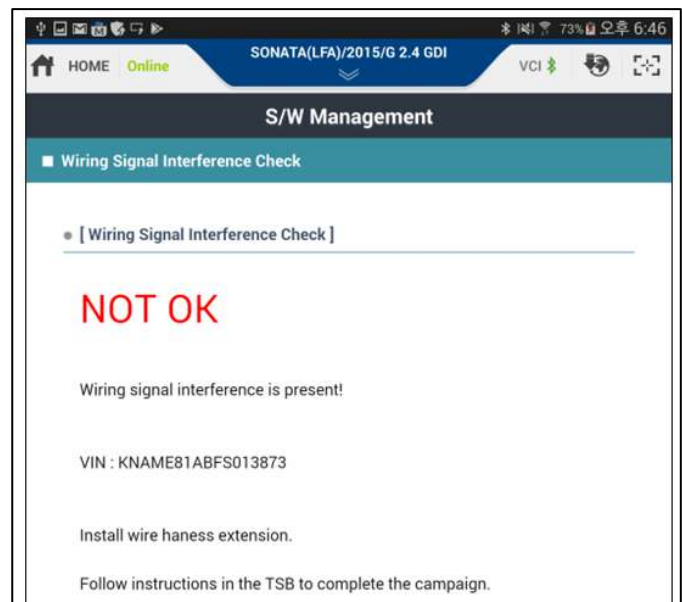
4. Follow the prompts on the GDS to complete the inspection. At the end of the inspection, take a screenshot of the results screen.

**If the inspection result is NOT OK:**

- If the test result is still NOT OK after installing the extension harness, follow the Service Procedure flowchart on Page 9 until an OK test result is achieved.
