## SERVICE BULLETIN

EC18-028b

### 2018 ARMADA AND TITAN; MIL ON WITH DTC P0138 AND/OR P0158

**APPLIED VEHICLES:** 2018 Armada (Y62)  
2018 Titan (A61)  
2018 Titan XD (A61)  
**APPLIED ENGINE:** VK56VD (gasoline V8)

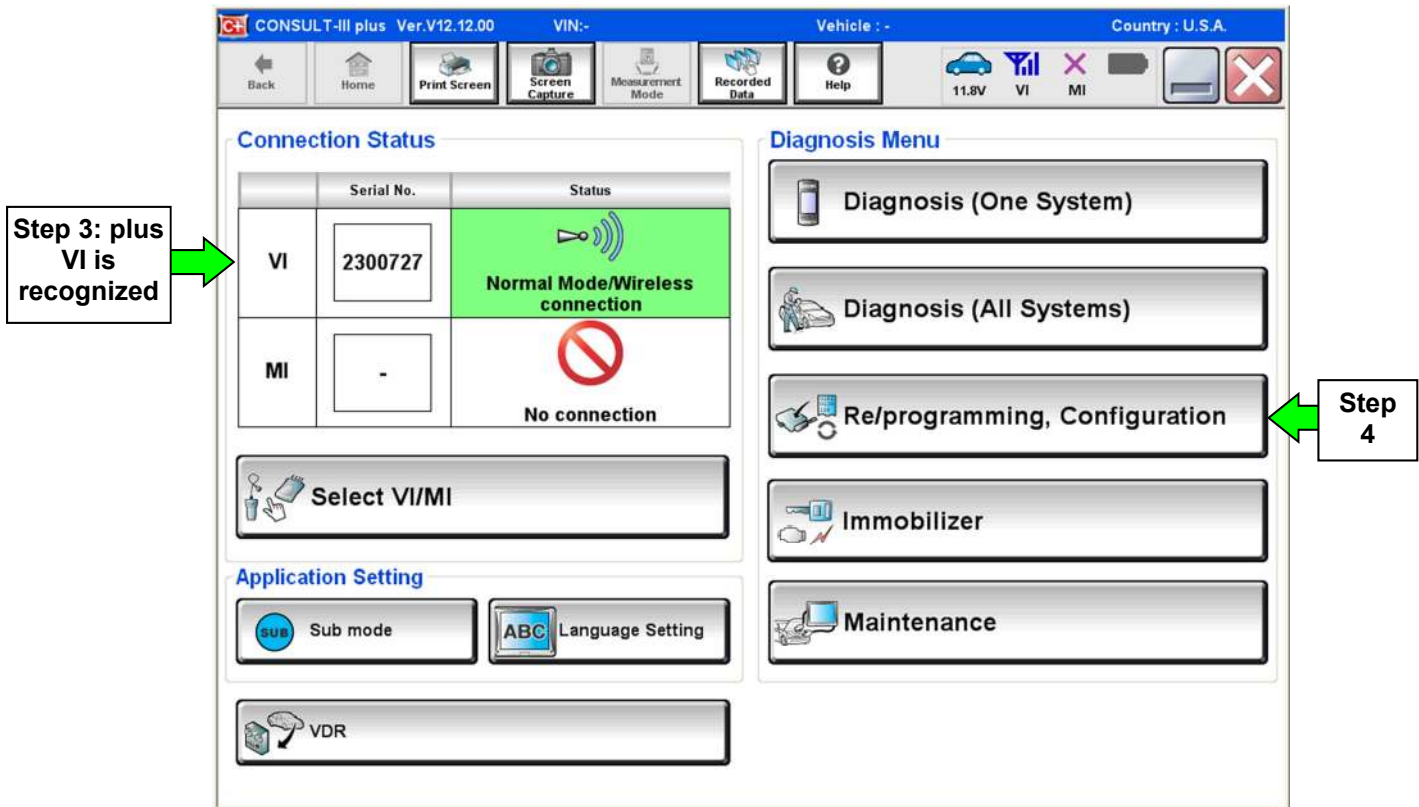
Figure 1

1. Connect the CONSULT PC to the vehicle to begin the reprogramming procedure.
2. Start C-III plus.
3. Wait for the plus VI to be recognized / connected.
  - The serial number will display when the plus VI is recognized / connected.
4. Select **Re/programming, Configuration**.

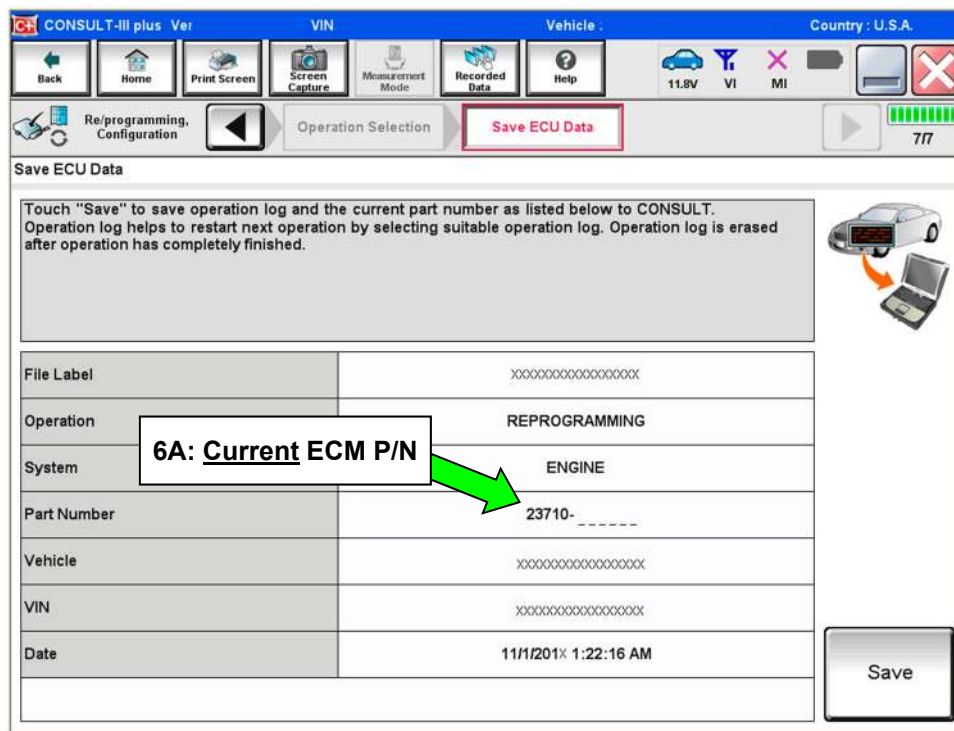
6. When the screen in Figure 2 displays, confirm this bulletin applies as follows.

A. Find the ECM **Part Number** and write it on the repair order.

**NOTE:** This is the current ECM Part Number (P/N).

5. Follow the on-screen instructions and navigate the C-III plus to the screen shown in Figure 2 on the next page.

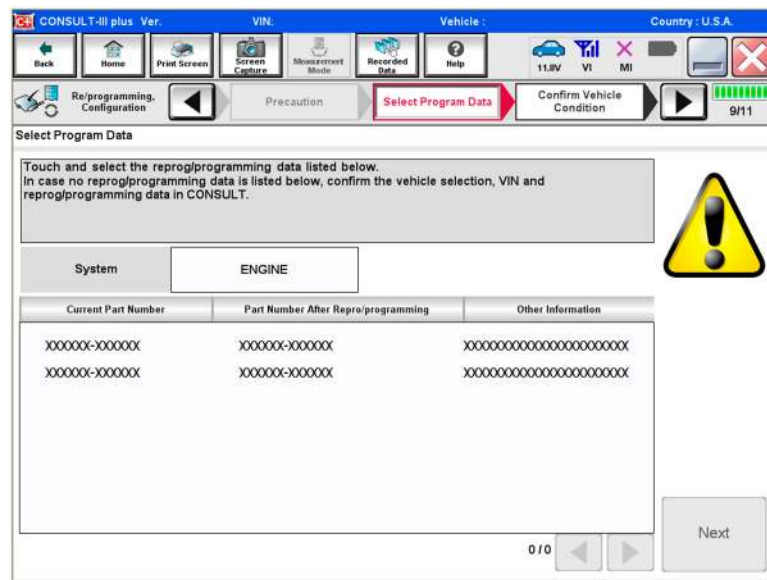
- In some cases, more than one new P/N for reprogramming is available.
  - In this case, the screen in Figure 3 displays.
  - Select and use the reprogramming option that **does not** have the message “Caution! Use ONLY with NTBXX-XXX”.
- If you get this screen and it is blank (no reprogramming listed), it means there is no reprogramming available for this vehicle. Close C-III plus and refer back to ASIST for further diagnosis.

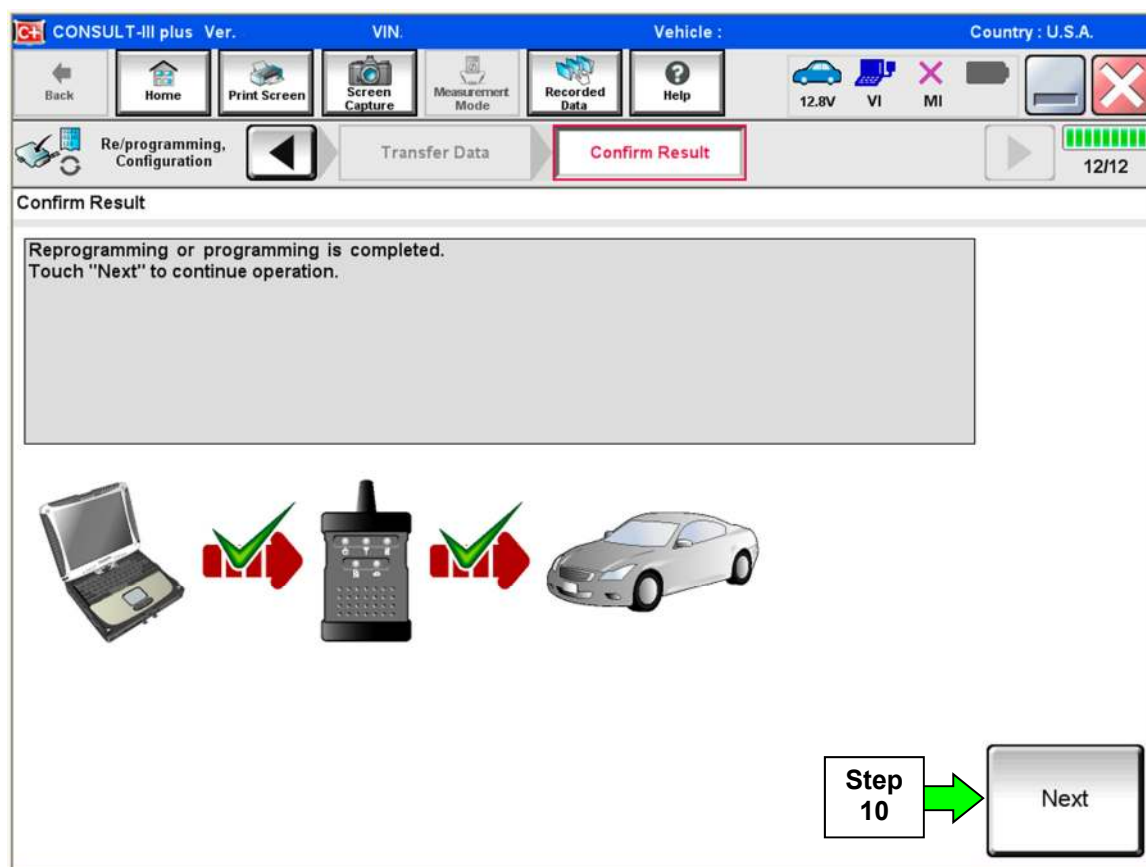
8. When the screen in Figure 5 displays, reprogramming is complete.

**NOTE:** If the screen in Figure 5 does not display (reprogramming does not complete), refer to the information on page 7.

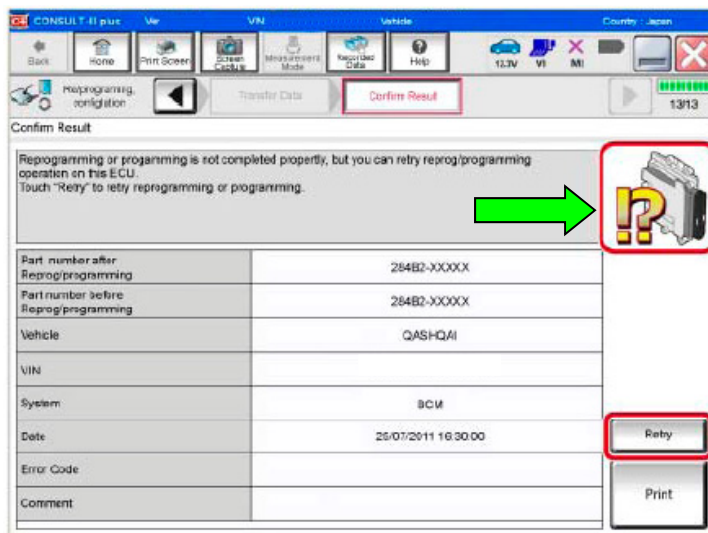
Figure 6

If reprogramming does not complete and the “!?” icon displays as shown in Figure 6:

- Check battery voltage (12.0 - 15.5 V).
- Ignition is ON, engine OFF.
- External Bluetooth® devices are OFF.
- All electrical loads are OFF.
- **Select retry and follow the on screen instructions.**
- **“Retry” may not go through on first attempt and can be selected more than once.**

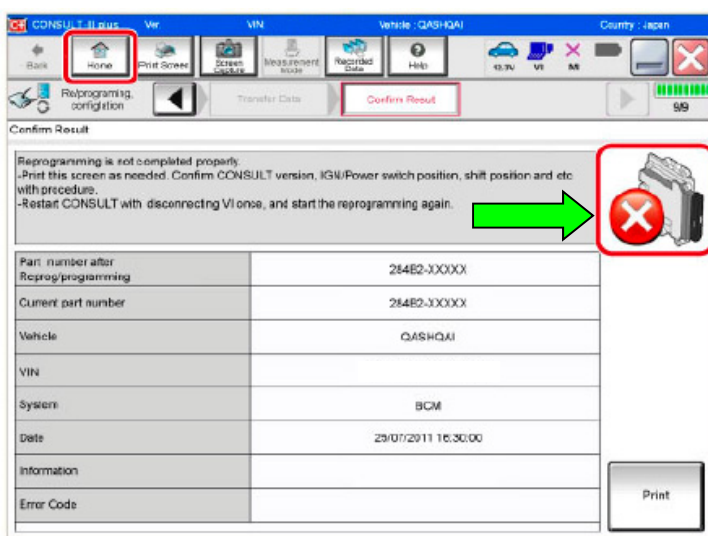
Figure 7

If reprogramming does not complete and the “X” icon displays as shown in Figure 7:

- Check battery voltage (12.0 - 15.5 V).
- CONSULT A/C adapter is plugged in.
- Ignition is ON, engine OFF.
- Transmission is in Park.
- All C-III plus / VI cables are securely connected.
- All C-III plus updates are installed.
- **Select Home, and restart the reprogram procedure from the beginning.**

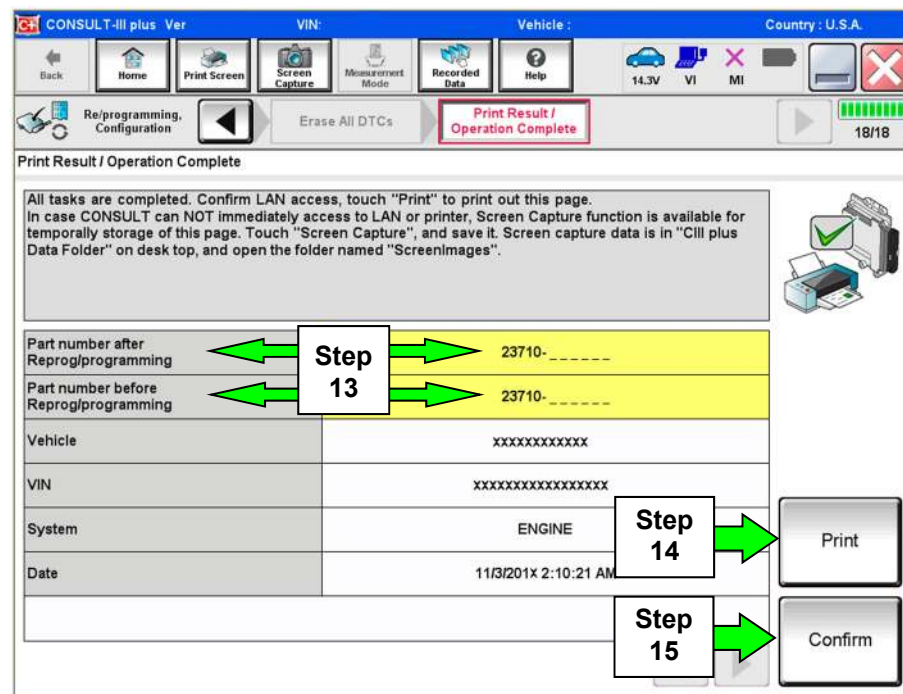
12. When the entire reprogramming process is complete, the screen in Figure 8 will display.
13. Verify the before and after part numbers are different.
14. Print a copy of this screen (Figure 8) and attach it to the repair order for warranty documentation.
15. Select **Confirm**.
