# Service Update

## N192266190 Engine Control Software Issue

**Release Date:** October 2019

**Revision:** 02

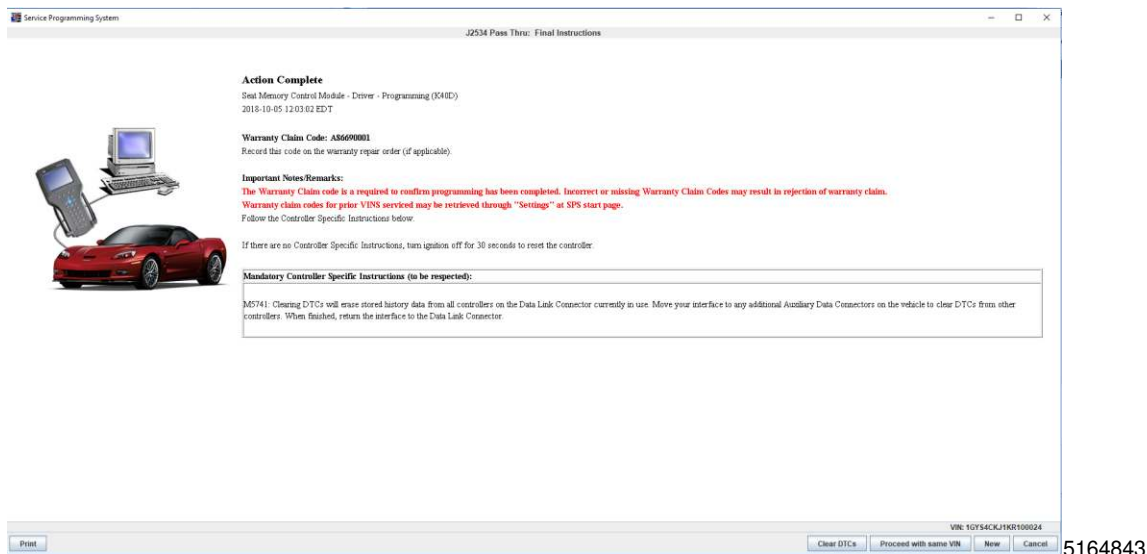
1. Reprogram the Engine Control Module. Refer to *K20 Engine Control Module: Programming and Setup* in SI.

- **Please note, ECM and TCM programming are sequenced on the XT5, however no new TCM calibration has been released for that vehicle since launch, so programming will skip the TCM.**
