February 9, 2018

Version 1

## The ACC, LKAS, Road Departure Mitigation, Collision Mitigation Brake System, BRAKE Indicators and/or "Auto High Beam Problem" Message Comes On

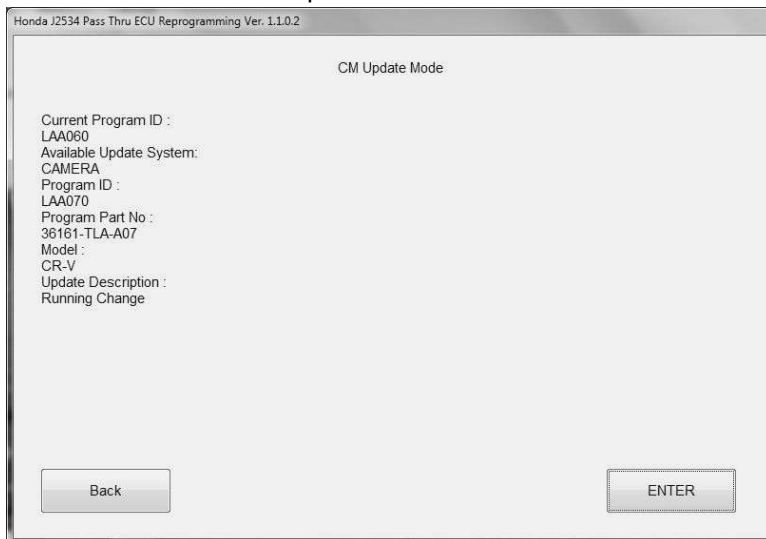
8. Confirm that the program ID is the correct one listed in the SOFTWARE INFORMATION. Select **Enter** and the camera software will be updated.
