LTB01101NAS1

# TECHNICAL BULLETIN

303-01: Engine - GTDI 2.0L Petrol

Poor Engine Performance

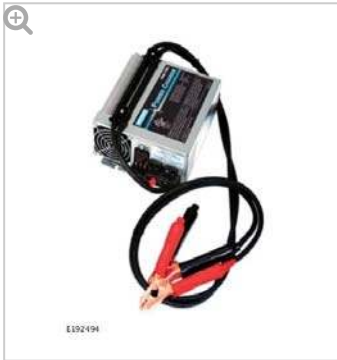
Jaguar Land  
Rover-approved  
Midtronics battery  
power supply

- A Jaguar Land Rover-approved Midtronics battery power supply must be connected to the vehicle battery during diagnosis / module programming.
- All ignition ON/OFF requests must be carried out. Failure to perform these steps may cause damage to control modules in the vehicle.

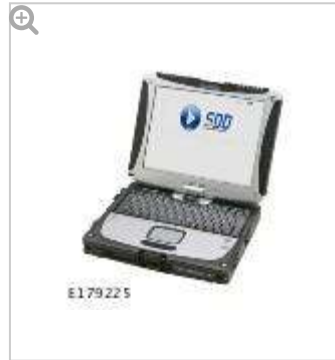
Jaguar Land  
Rover-approved  
diagnostic tool  
with latest SDD  
Software  
Management Pack

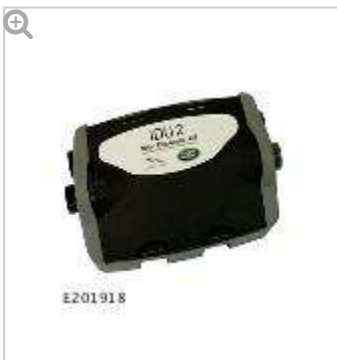
Inline Diagnostic  
Unit 2 (IDU2)
