09021 Version 3

## MID Displays ACC, CMBS, LKAS, RDM, Brake Warnings and Other Listed Symptoms

Supersedes 17-064, dated September 23, 2017, to revise the information highlighted in yellow

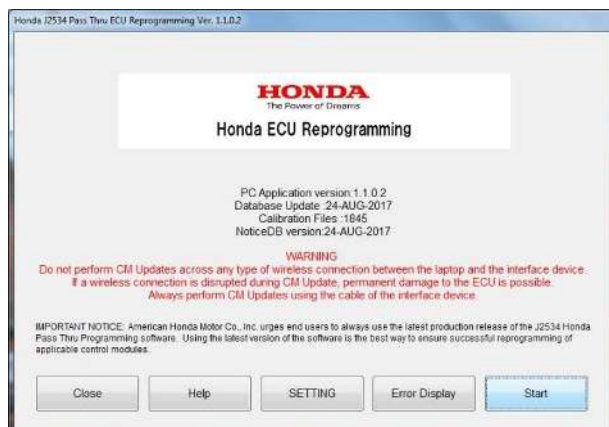
5. Confirm the software is the same or later as listed in SOFTWARE INFORMATION.
