# Technical Service Bulletin

| SUBJECT:<br><b>MIL ILLUMINATION WITH DTC P0068</b> | | | No: <b>TSB-18-13-001</b> |
| | | | MODEL: <b>2018 Eclipse Cross</b> |

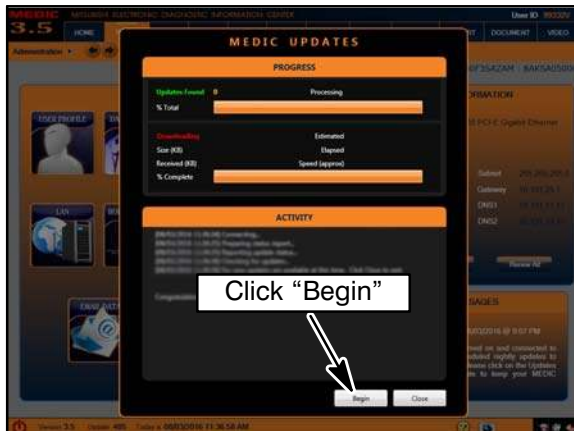
3. Select the MEDIC 3.5/4 Admin tab and click on "Updates."

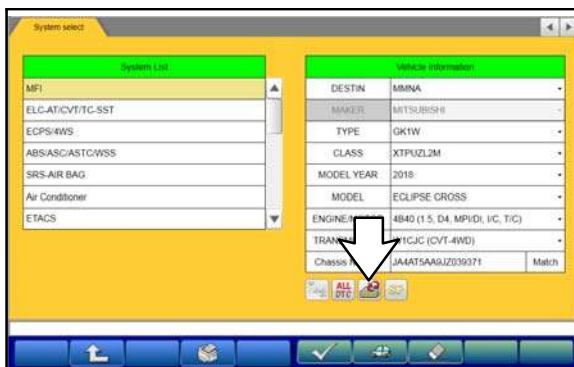
a. Click “STV.”

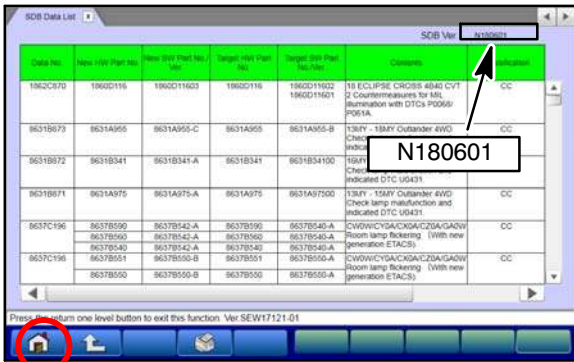
c. Click “SDB Data List.”

d. Confirm that the database number displayed in the upper right above the chart is **N180601** or **higher**

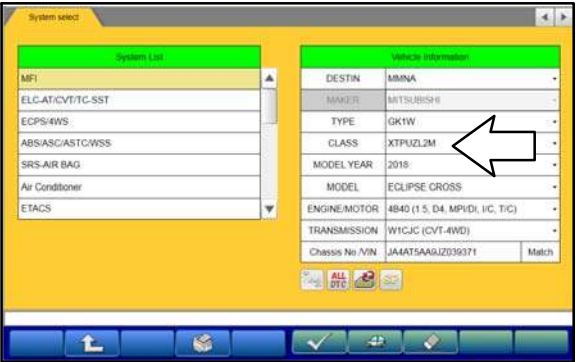
3. Using MEDIC, from the main page, click the “MUT3–SE” icon at the top center of the screen to open MUT–III SE.

Click the STV button.

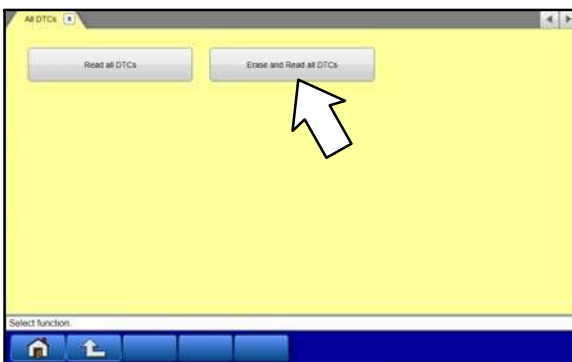
a. On the System Select screen click the “ALL DTC” button.

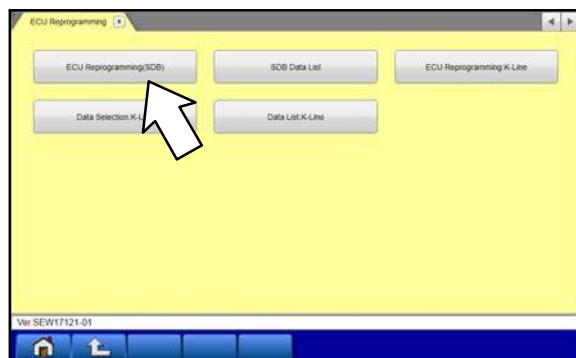
a. On the System Select page, click on the Reprogram button.

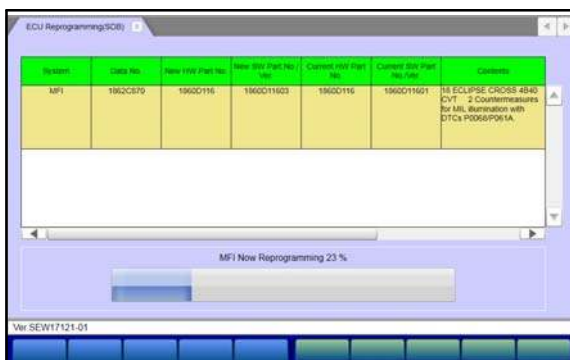
- f. Click the check mark in the “Check reprogramming data” dialog box.
