# Technical Service Bulletin

| SUBJECT:<br><b>MIL ILLUMINATION WITH DTC P061A</b> | | | No: <b>TSB-18-13-002</b> |
| | | | MODEL: <b>2018 Eclipse Cross</b> |

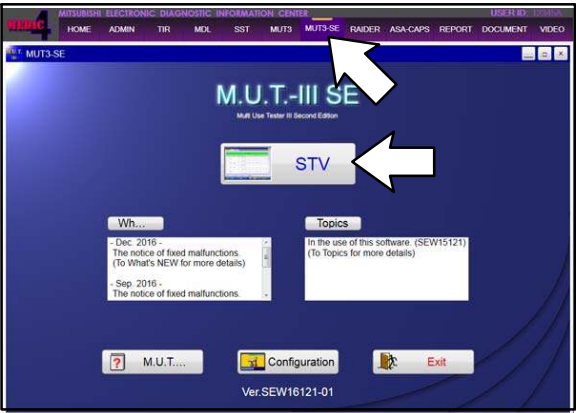
3. Using MEDIC, from the main page, click the “MUT3–SE” icon at the top center of the screen to open MUT–III SE.

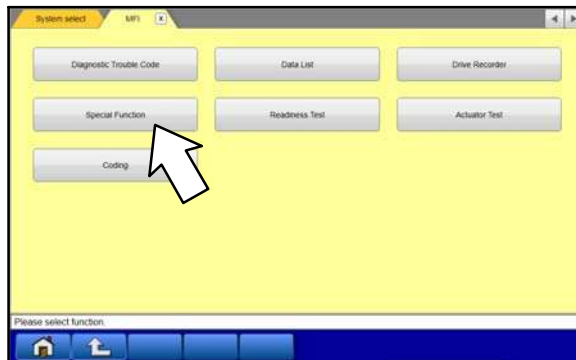
- b. Select “Special Function.”

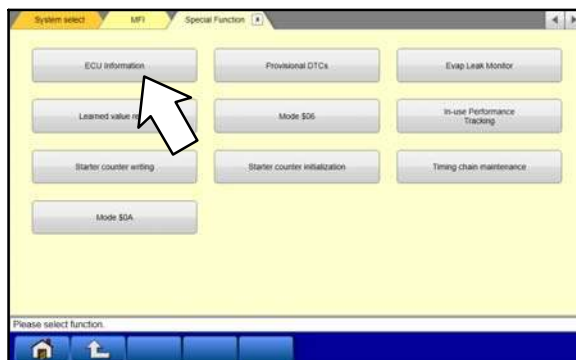
- c. Select “ECU Information.”

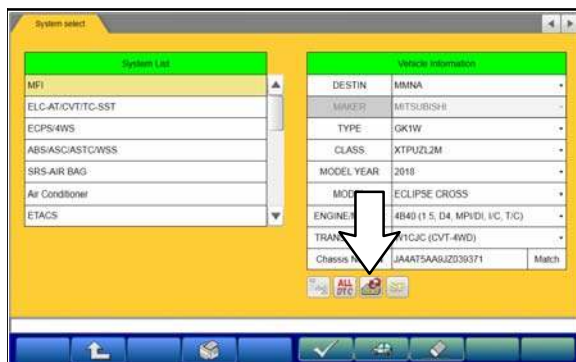
a. On the System Select page, click on the Reprogram button.
