# Technical Service Bulletin

| <b>SUBJECT:</b><br><br><b>4WD WARNING INDICATOR ILLUMINATES<br/>WITH DTC U0431</b> | | | No: <b>TSB-18-23-001</b> |
| | | | MODEL: <b>2014-18 Outlander</b> |

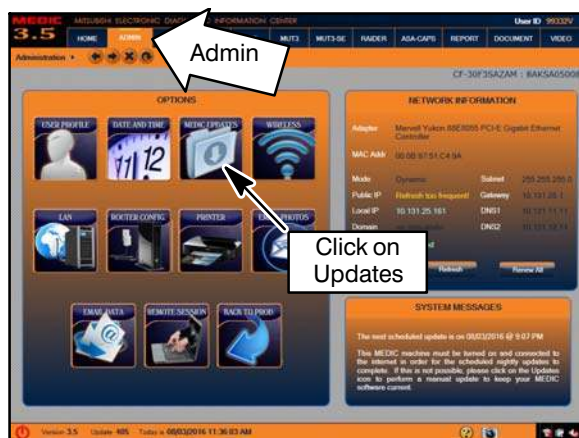
2. Verify the MEDIC 3.5/4 is at version 3.5 and at update **532** or higher.

If your **MEDIC 3.5/4 update is at least 532**, continue with the Reprogramming Procedure.

If your **MEDIC 3.5/4 update is below 532**, update your MEDIC as follows.

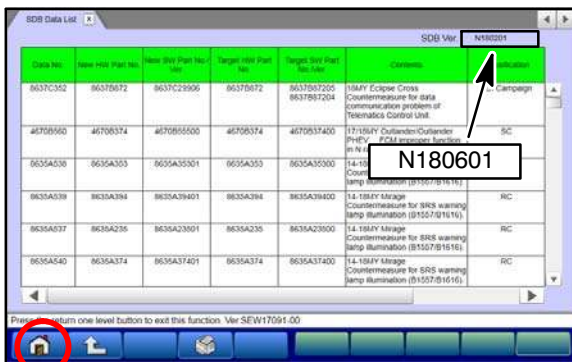
c. Click “SDB Data List.”

d. Confirm that the database number displayed in the upper right above the chart is **N180601 or higher**

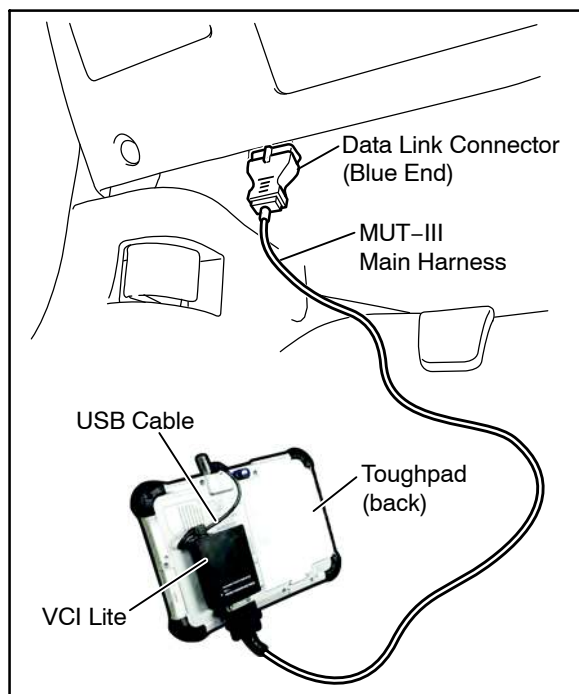
1. Connect the equipment as follows:

**NOTE:** VCI Lite and MEDIC 4.0 Toughpad shown for illustration purposes only.

- Turn the MEDIC PC/tablet on. If the battery indicator in the lower right hand corner of the screen does not show a full charge, it is recommended that either the battery be charged prior to beginning, or be used with the A/C power adaptor connected.
- Connect the USB cable to the VCI/VCI Lite.
- When the laptop/tablet displays the MUT-III main screen, connect the USB cable to the device.
- Connect the MUT-III main harness with the blue DLC connection to the VCI/VCI Lite.
- Connect the blue connection of the MUT-III main harness to the vehicle's data link connector.
- Turn the VCI power switch ON. Verify that the indicator lamp in the upper right corner of the screen is green.

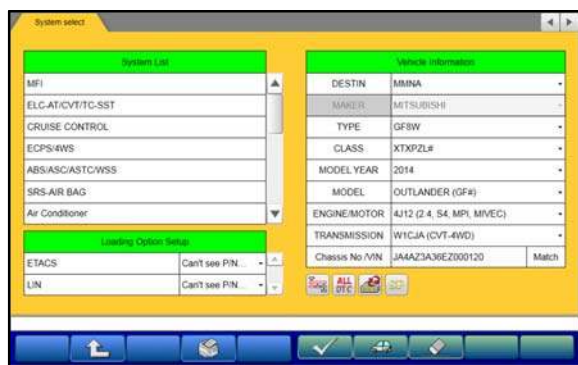
4. The System Select screen opens and populates with some basic information from the vehicle.

Look at the label on the passenger side B pillar to identify the appropriate class.

If necessary, select the correct class from the drop–down list.

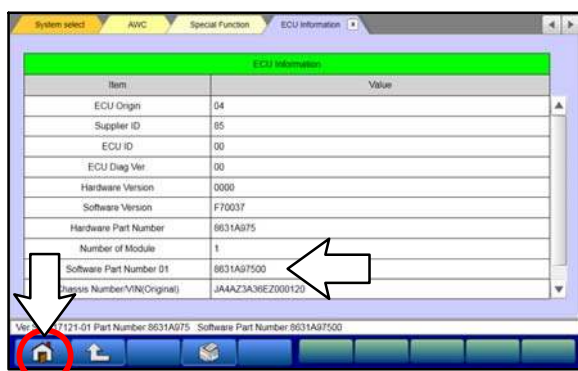
- c. Select “ECU Information.”

- d. If the Software Part Number listed is **not** at the latest level (shown in the **“AWC ECU Reprogramming Chart”** in this TSB), proceed with the next step. Click the Home button to return to the System Select screen.

10. Perform an “Erase and Read All DTCs” again to clear any DTCs that may have set.  
**For instructions, refer to steps 7 and 8 in this TSB.**
11. Confirm the software version has been updated.  
**For instructions, refer to step 6 in this TSB.**

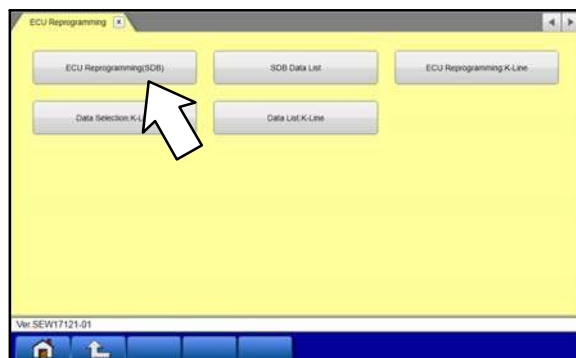
a. On the System Select page, click on the Reprogram button.

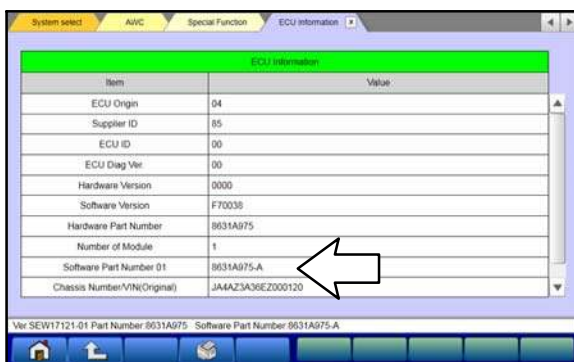
Confirm “Software Part Number” now matches the one shown for the applicable model in the **“AWC ECU Reprogramming Chart”** in this TSB.
