# Technical Service Bulletin

| SUBJECT:<br><b>MIL ILLUMINATION WITH DTC P0AA7/P0AA8</b> | | | No: <b>TSB-18-54-005</b> |
| | | | MODEL: <b>2018 Outlander PHEV</b> |

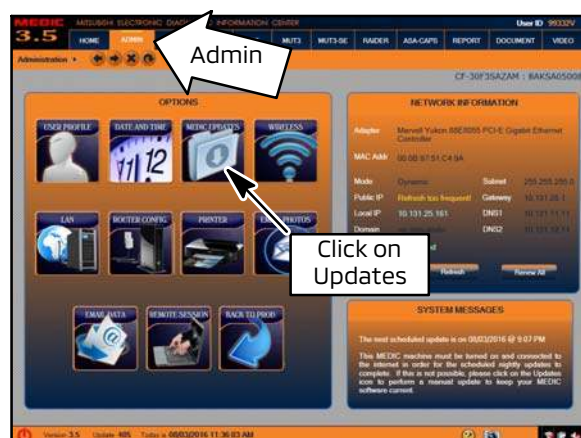
2. Verify the MEDIC 3.5/4 is at version 3.5 and at update **543** or higher.

If your **MEDIC 3.5/4 update is at least 543**, continue with the Reprogramming Procedure.

If your **MEDIC 3.5/4 update is below 543**, update your MEDIC as follows.

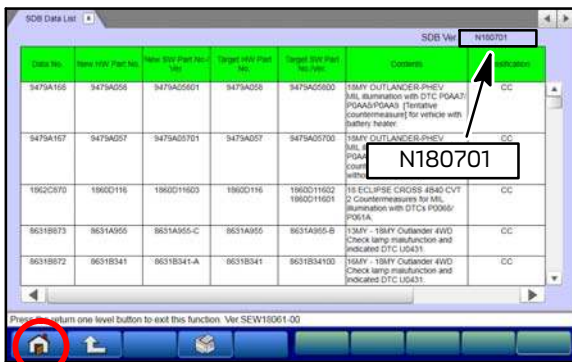
c. Click "SDB Data List."

d. Confirm that the database number displayed in the upper right above the chart is **N180701 or higher**

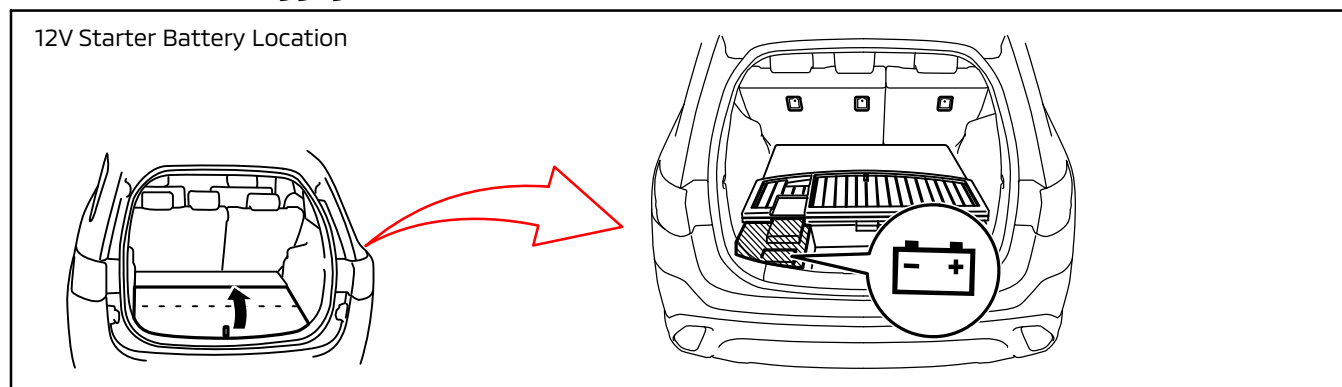
To ensure that the vehicle battery maintains 12V during the procedure, hook-up a battery charger to the 12V starter battery during the procedure. The 12V starter battery can be accessed from the rear of the vehicle under the luggage floorboard, in the location shown below.

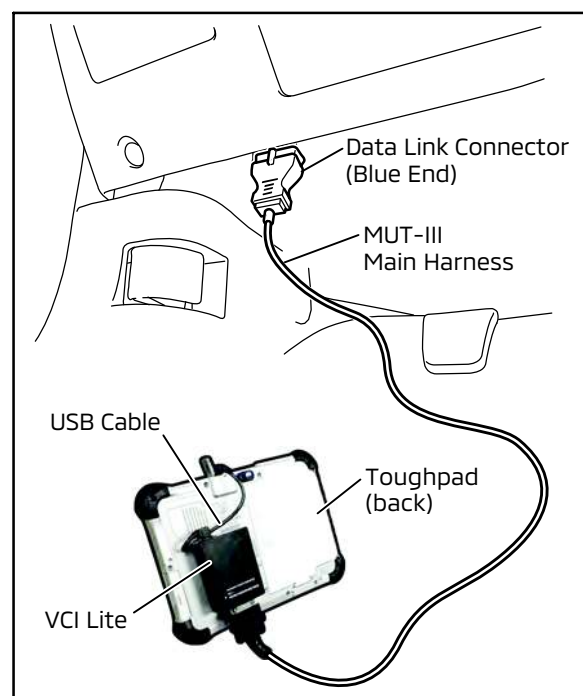
1. Connect the equipment as follows:

**NOTE: VCI Lite and MEDIC 4.0 Toughpad shown for illustration purposes only.**

- Turn the MEDIC PC/tablet on. If the battery indicator in the lower right hand corner of the screen does not show a full charge, it is recommended that either the battery be charged prior to beginning, or be used with the A/C power adaptor connected.
- Connect the USB cable to the VCI/VCI Lite.
- When the laptop/tablet displays the MUT-III main screen, connect the USB cable to the device.
- Connect the MUT-III main harness with the blue DLC connection to the VCI/VCI Lite.
- Connect the blue connection of the MUT-III main harness to the vehicle's data link connector.
- For VCI only (p/n MB991824): Turn the VCI power switch ON. Verify that the indicator lamp in the upper right corner of the screen is green.

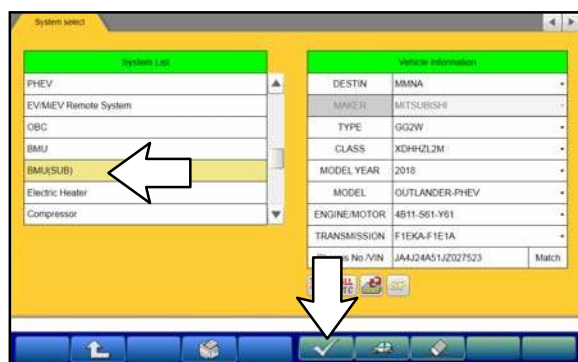
4. The System Select screen opens and populates with some basic information from the vehicle.

Look at the label on the passenger side B pillar to identify the appropriate class.

If necessary, select the correct class from the drop-down list.

5. Verify that the Sub-BMU has not already been updated to the latest S/W number shown in the **"Sub-BMU Reprogramming Chart"** in this TSB.  
If the Sub-BMU is at the latest level, reprogramming is not necessary.

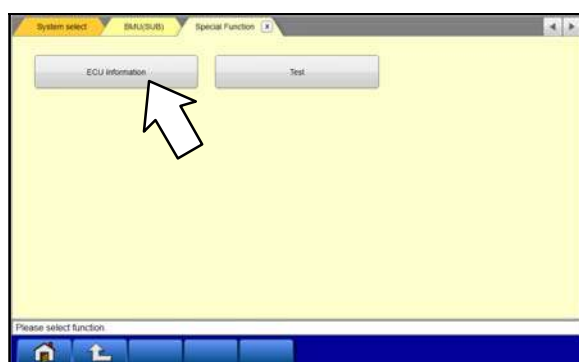
b. Select "Special Function."

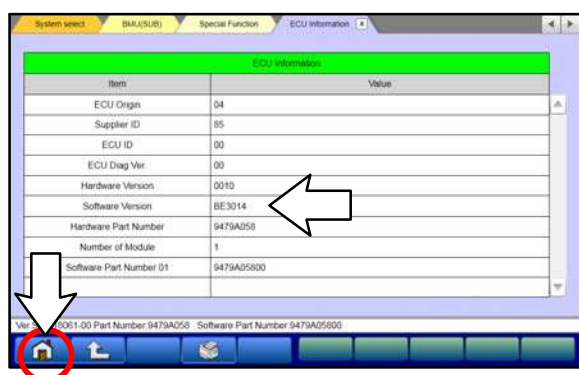
c. Select "ECU Information."

d. If the Software Version listed is **not** at the latest level (shown in the "**Sub-BMU Reprogramming Chart**" in this TSB), proceed with the next step. Click the Home button to return to the System Select screen.

9. Perform an "Erase and Read All DTCs" again to clear any DTCs that may have set.  
**For instructions, refer to steps 6 and 7 in this TSB.**
10. Confirm the software version has been updated.  
**For instructions, refer to step 5 in this TSB.**

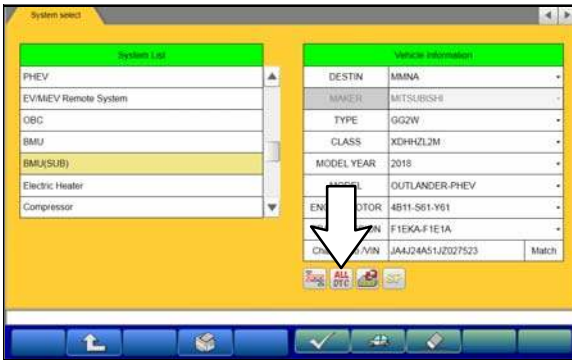
6. Before reprogramming, perform an **"Erase and Read All DTCs"** to clear any DTCs that may have set.

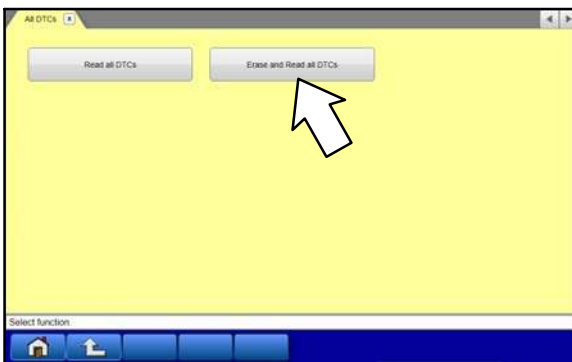
- a. On the System Select screen click the "ALL DTC" button.

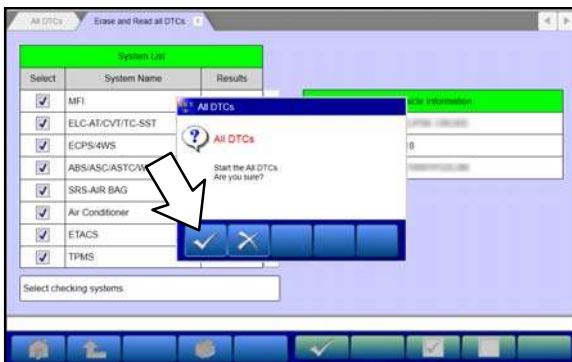
- b. Select "Erase and Read All DTCs."

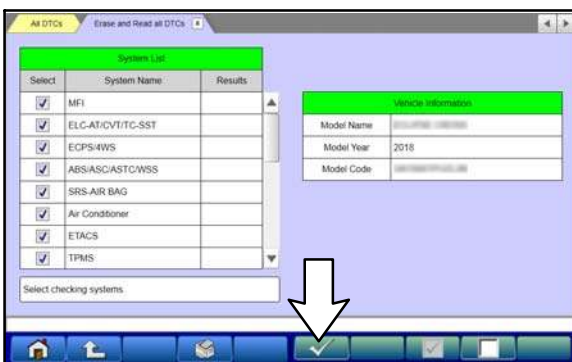
- c. A window will pop up asking you to confirm DTC erasing. Click the check mark in the dialog box for DTC erasing and reading to begin.

- d. The "System List" on the left side of the screen will have all selections checked. Do not change these selections.

- e. Click the check mark to continue.

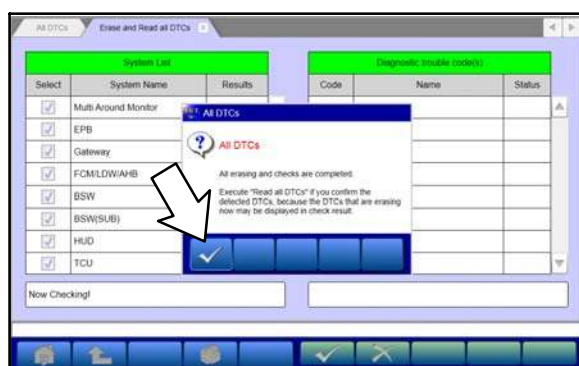
7. When DTC erasing is completed, click the check mark in the pop-up message that reads "All erasing and checks are completed."

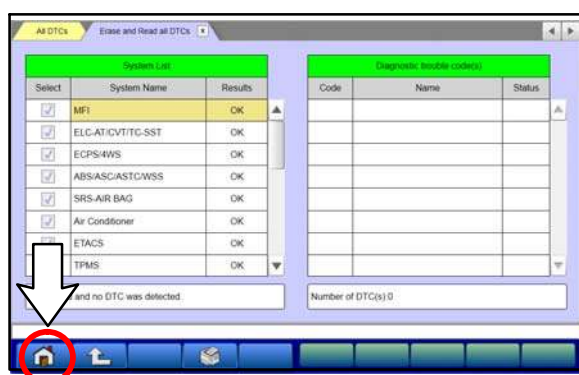
a. If any DTCs return after erasing is completed, click the check mark to clear the window. Diagnose and repair per the Service Manual.

b. If DTCs do not return, click the check mark to clear the window, then click the Home icon in the lower left to return to the System Select menu.

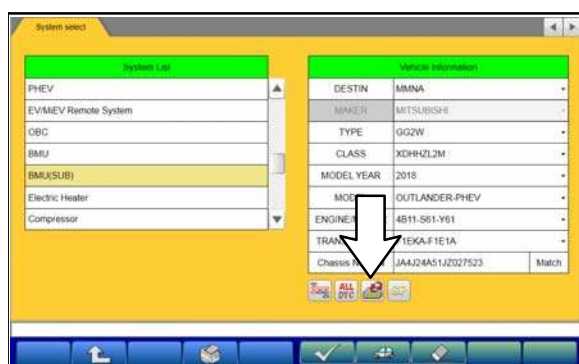
8. **Reprogram the Sub-BMU** following the steps below.

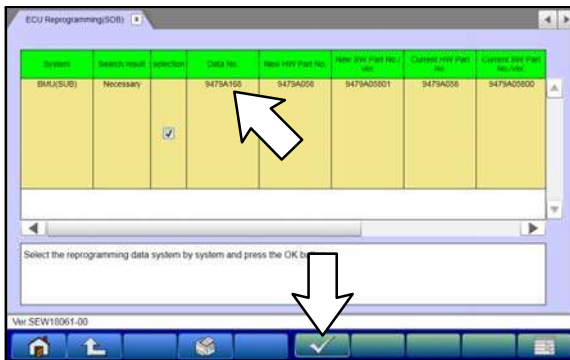
- c. Select "**BMU(SUB)**" in the System List, then click the check mark.

d. Verify that the correct data file listed in the table matches the one in the **"Sub-BMU Reprogramming Chart."**

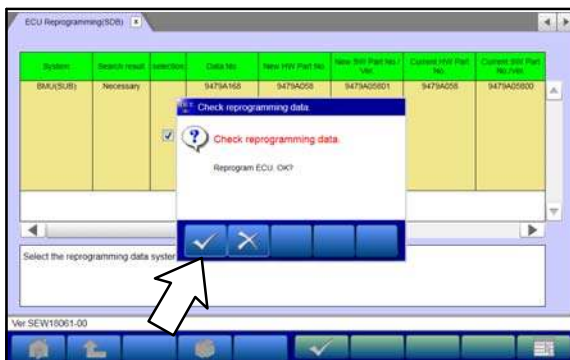
- e. Click the check mark at the bottom of the page to initiate reprogramming.

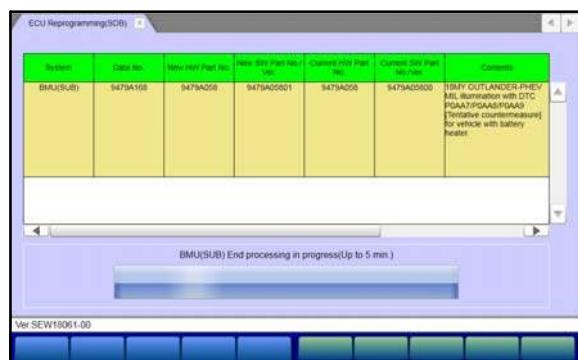
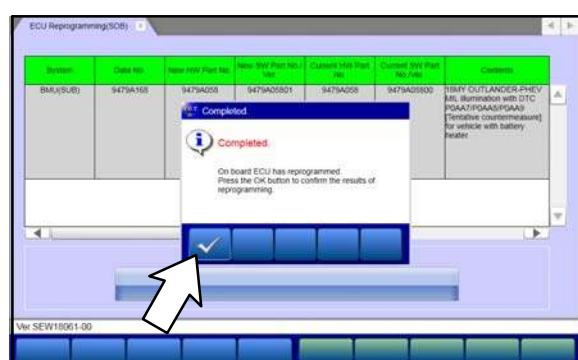
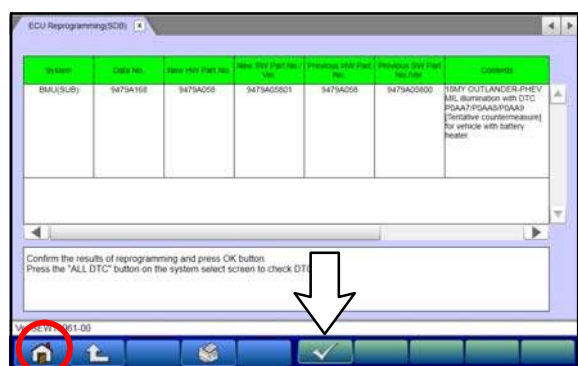
g. Once the reprogramming is initiated, the screen shown will indicate the reprogramming progress.

**NOTE: Do NOT disturb the cables or turn off the ignition during reprogramming.**

h. Once reprogramming is completed, click the check mark in the "Completed" dialog box.

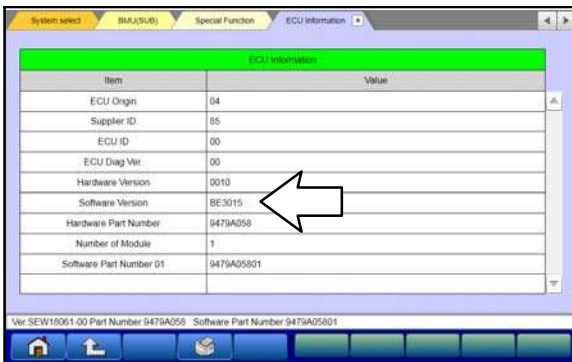
Confirm "Software Version" now matches the NEW one shown in the **"Sub-BMU Reprogramming Chart"** in this TSB.
