# Technical Service Bulletin

| SUBJECT: | | | No: <b>TSB-18-54-007</b> |
| <b>QUICK CHARGING OR READY MODE NOT POSSIBLE: DTC P101B &amp; P101C</b> | | | DATE: <b>August 2018</b> |
| | | | MODEL: <b>2016 i-MiEV</b> |

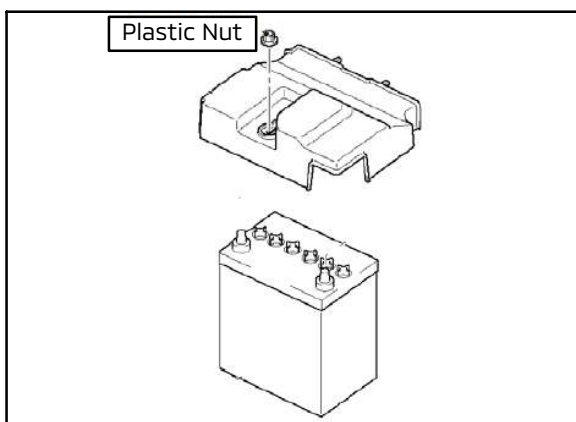
1. With the vehicle parked, set the parking brake and open the hood.
2. Remove the 12V auxiliary battery cover. Unscrew the plastic nut (pull up while turning).

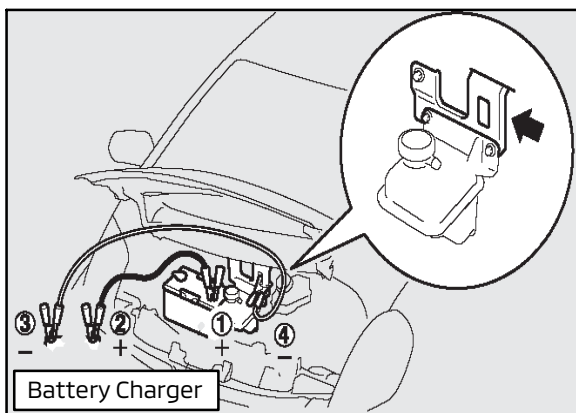
3. Attach the battery charge (with a charging rate not to exceed 10 amps) to the 12V auxiliary battery.

**NOTE: Ensure battery charger does not time out during this procedure.**

**NOTE: Connect the positive (+) terminal of the 12V auxiliary battery (1) to the positive (+) battery charger cable (2). Connect the negative (-) battery charger cable (3) to the designated ground location (4).**

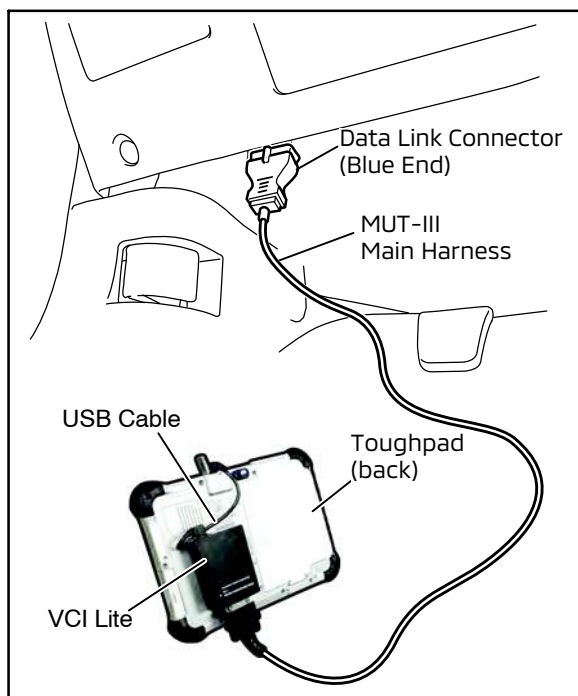
1. Connect the equipment as follows:

**NOTE: VCI Lite and MEDIC 4.0 Toughpad shown for illustration purposes only.**

- Turn the MEDIC PC/tablet on. If the battery indicator in the lower right hand corner of the screen does not show a full charge, it is recommended that either the battery be charged prior to beginning, or be used with the A/C power adaptor connected.
- Connect the USB cable to the VCI/VCI Lite.
- When the laptop/tablet displays the MEDIC main screen, connect the USB cable to the device.
- Connect the MUT-III main harness with the blue DLC connection to the VCI/VCI Lite.
- Connect the blue connection of the MUT-III main harness to the vehicle's data link connector.
- For VCI only (P/N MP991824): Turn the VCI power switch ON. Verify that the indicator lamp in the upper right corner of the screen is green.

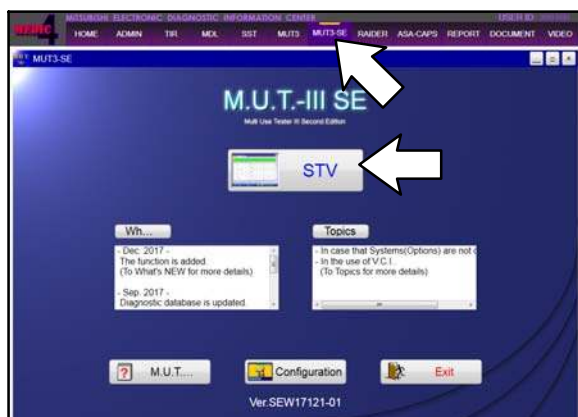
3. Using MEDIC, from the main page, click the "MUT3-SE" icon at the top center of the screen to open MUT-III SE.

Click the "STV" button.

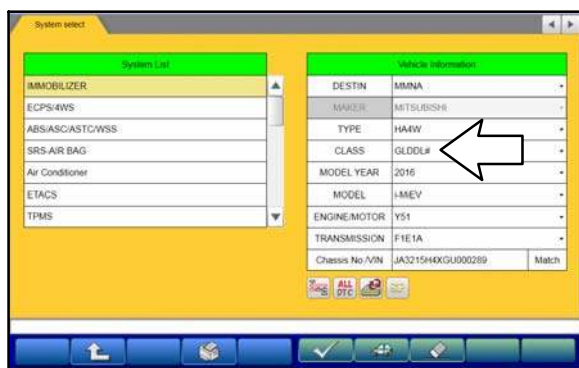
4. The System Select screen opens and populates with some basic information from the vehicle.

If the class has to be chosen from the drop down menu, then please look at the label on the passenger side B pillar to identify the appropriate class.

Then select the correct class from the drop-down list.

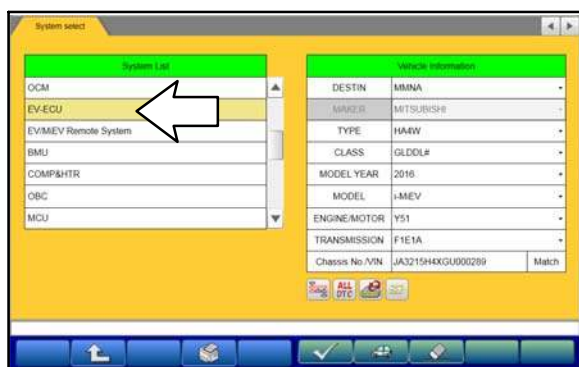
- a. Select "EV-ECU" from the System List, then click on the check mark at the bottom of the screen.

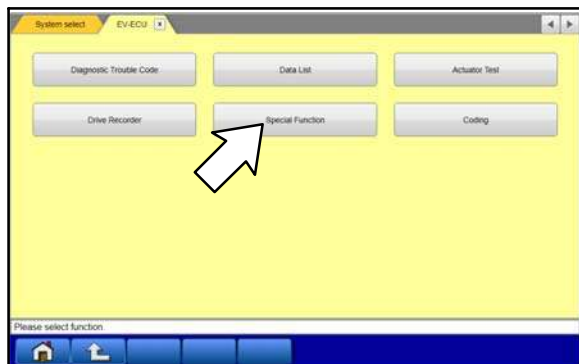
- b. Select "Special Function."

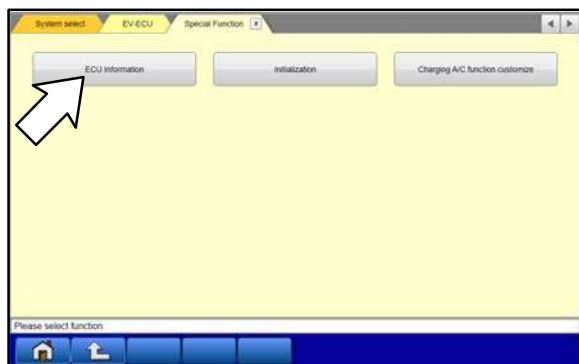
- c. Select "ECU Information."

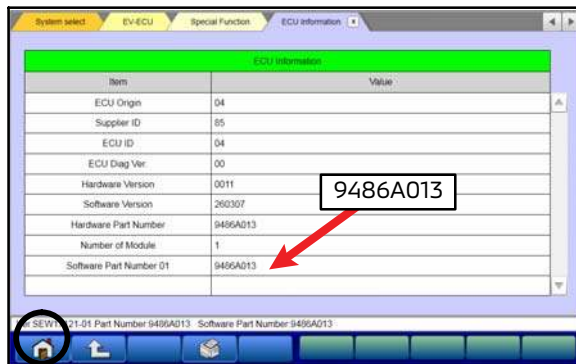
- b. If the Software Part Number listed is **not** at the latest level (shown in the "**EV-ECU Reprogramming Chart**"), proceed with the next steps.

If the Software Part Number is **9486A01303**, then reprogramming is not necessary.

12. Verify that the software Part Number is now at the latest number listed in the "**EV-ECU Reprogramming Chart**" in this TSB.  
**For instructions, refer to step 5 in this TSB.**

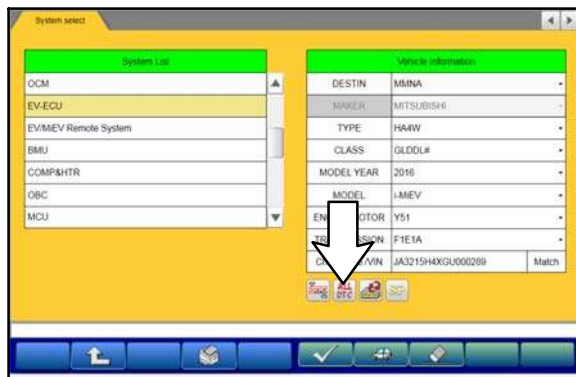
- a. Click on the home button to go back to the System Select screen.

Click the "ALL DTC" button.

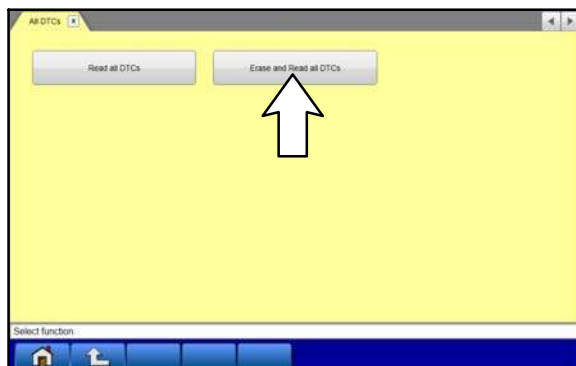
- b. Select "Erase and Read all DTCs."

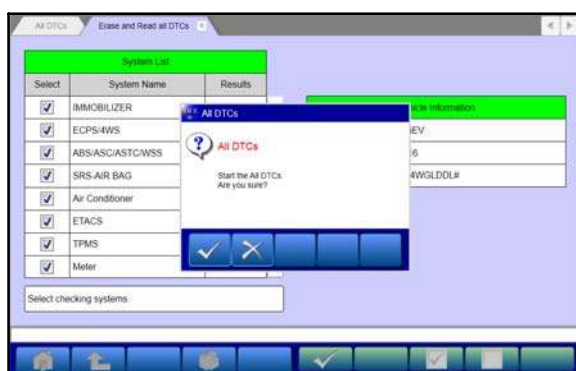
- c. A window will pop up asking you to confirm DTC erasing. Click the check mark in the dialog box for DTC erasing and reading to begin.

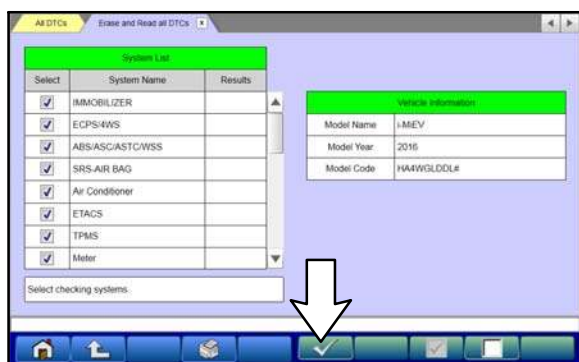
d. The "System List" on the left side of the screen will have all selections checked. **Do not** change these selections.

e. Click the check mark at the bottom of the page to continue.

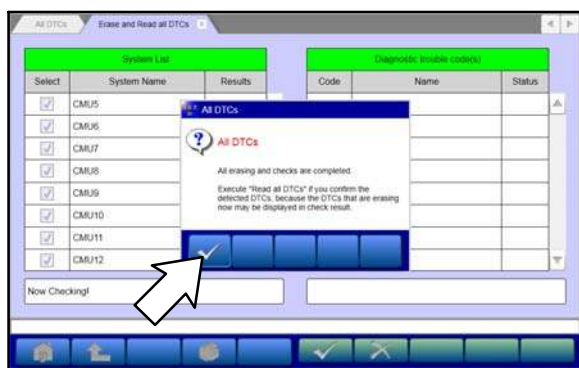
7. When DTC erasing is completed, click the check mark in the pop-up message that read "All erasing and checks are complete."

a. If DTCs return after erasing is completed, click the check mark to clear the window. Diagnose and repair per the Service Manual.

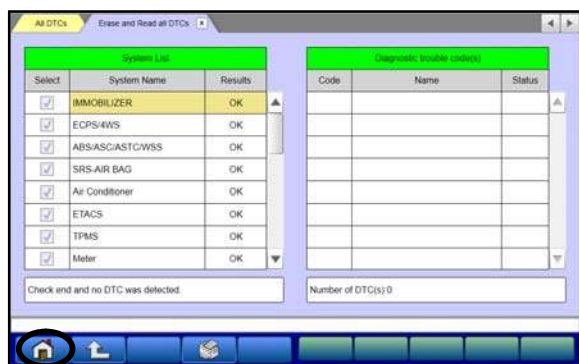
b. If DTCs do not return, click the check mark to clear the window, then click the Home icon in the lower left to return to the System Select menu.

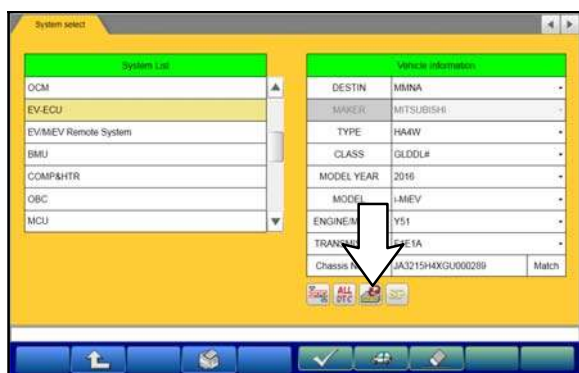
a. Click on the Reprogram button.

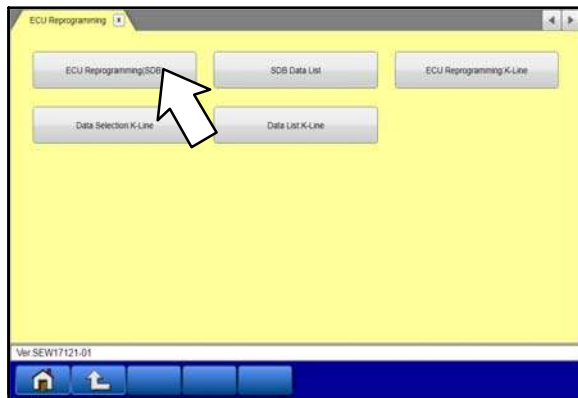
b. Select "ECU Reprogramming (SDB)."

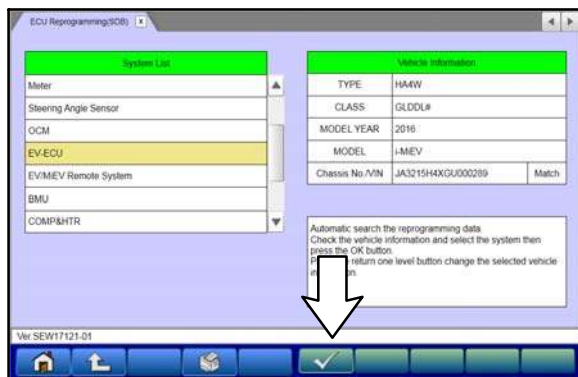
c. Verify the "EV-ECU" is selected in the System List, then click the check mark at the bottom of the page.

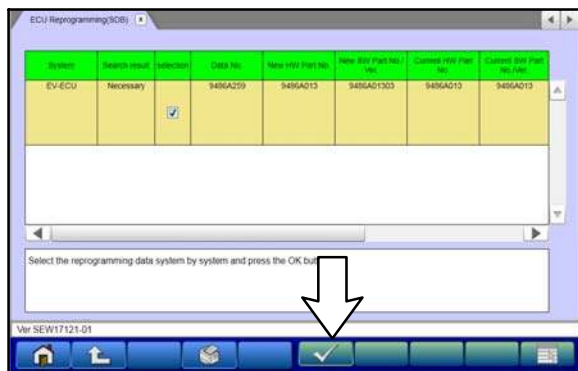
d. Verify the correct Data No. is listed in the **ECU Reprogramming Chart**.

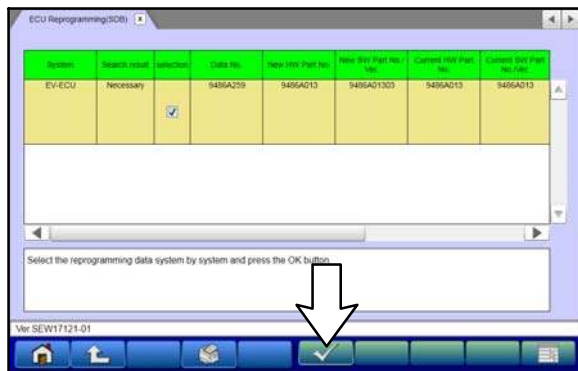
e. Click the check mark at the bottom of the page to initiate reprogramming.

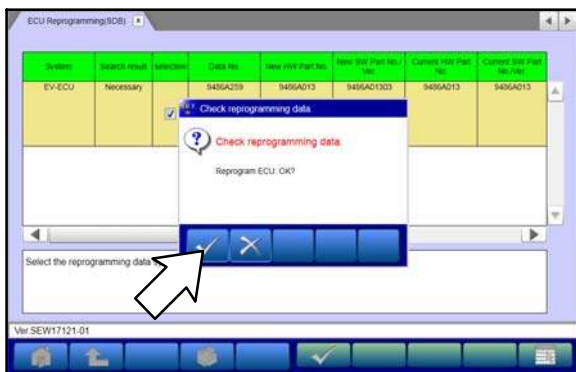
- f. Click the check mark in the "Check reprogramming data" dialog box.

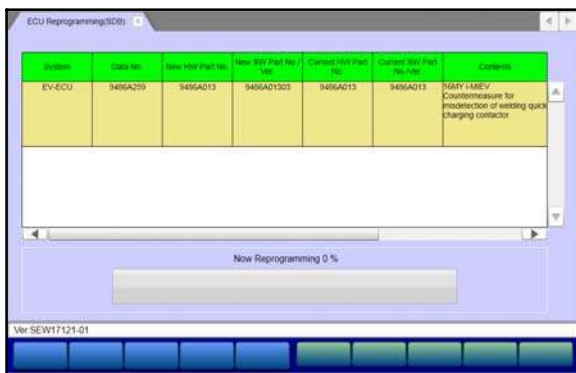
- g. Once the reprogramming is initiated, the screen shown will indicate the reprogramming progress.

**NOTE: Do NOT disturb the cables or turn off the ignition during reprogramming.**

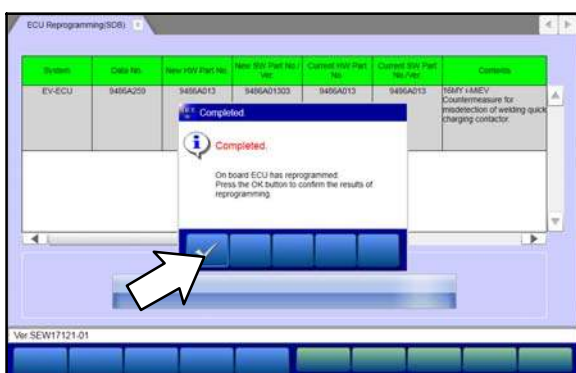
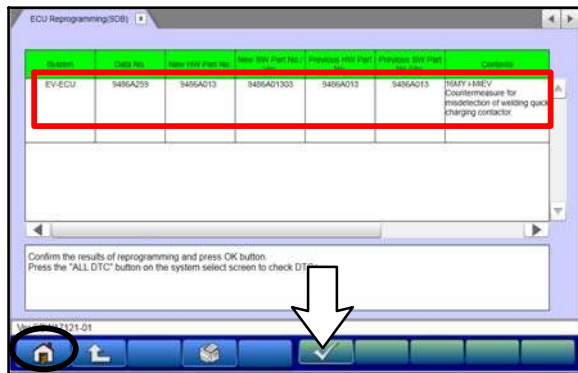
- i. Verify the correct information is listed in the table. Click the check mark at the bottom of the page, then click the Home button to return to the System Select screen.
- j. Click the home icon on the bottom of the page.
