# TECHNICAL BULLETIN

303-14B: Electronic Engine Controls - V6 S/C 3.0L Petrol

Engine MIL Illuminated With DTC P0089-64 Stored

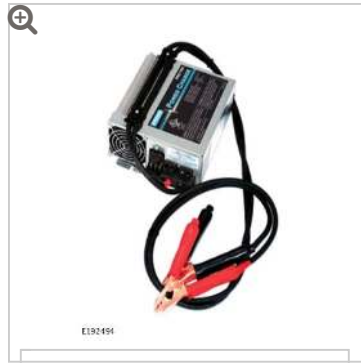
Jaguar Land Rover-  
approved  
Midtronics battery  
power supply

- **A Jaguar Land Rover-approved Midtronics battery power supply must be connected to the vehicle battery during diagnosis / module programming.**
- **Make sure all ignition ON/OFF requests are carried out; failure to perform these steps may cause damage to control modules in the vehicle.**

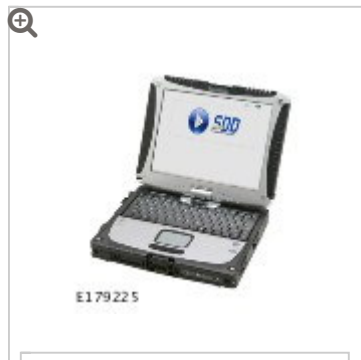
Jaguar Land Rover-  
approved  
diagnostic tool with  
latest PATHFINDER  
software
