## SERVICE BULLETIN

EC17-015

### 2016-2017 TITAN XD; MIL ON WITH DTC P218F WHEN OPERATED IN AMBIENT TEMPERATURE AT 32°F OR BELOW

**APPLIED VEHICLE:** 2016-2017 Titan XD (A61)

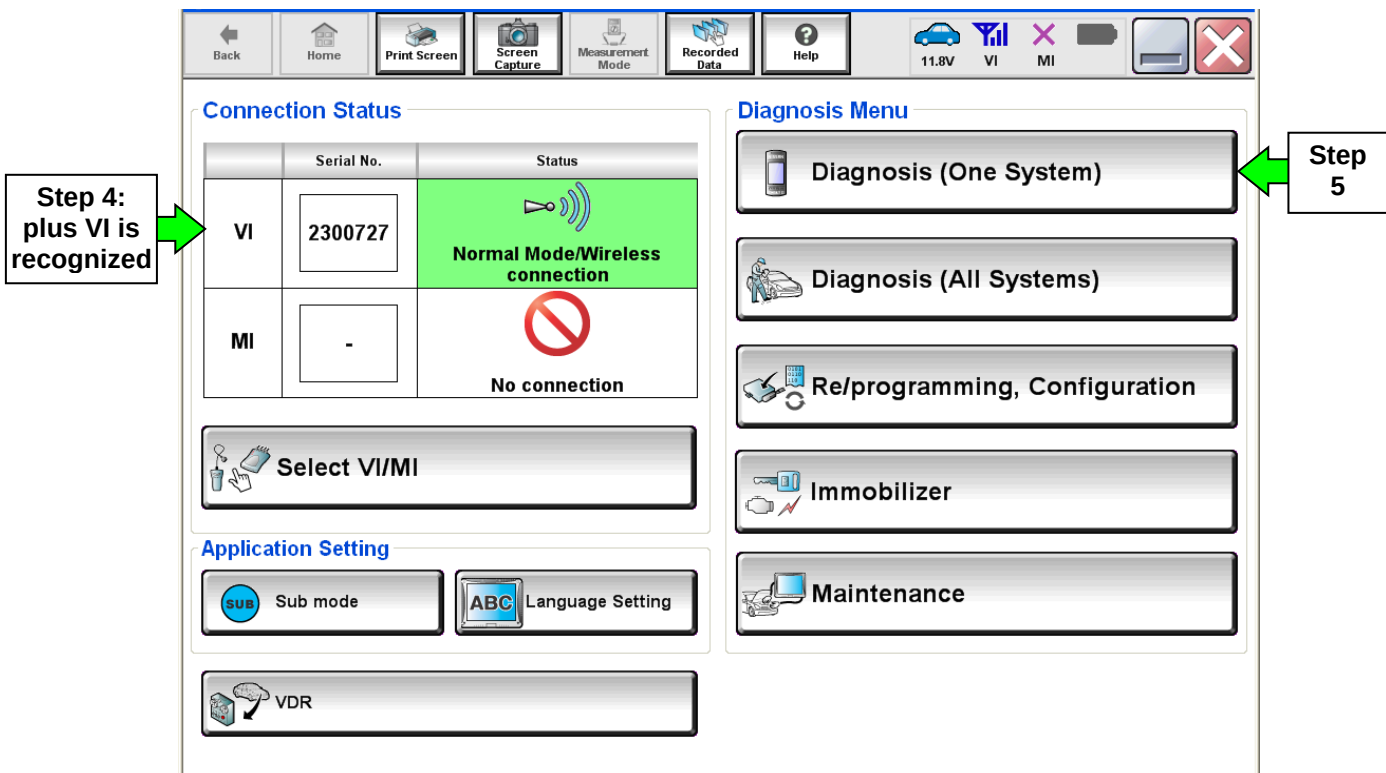
Figure A

1. Connect the CONSULT PC to the vehicle.
2. Open / start C-III plus.
3. Turn the ignition ON, with engine OFF (engine not running).
4. Wait for the plus VI to be recognized.
  - The **Serial No.** will display when the plus VI is recognized.
5. Select **Diagnosis (One System)**.

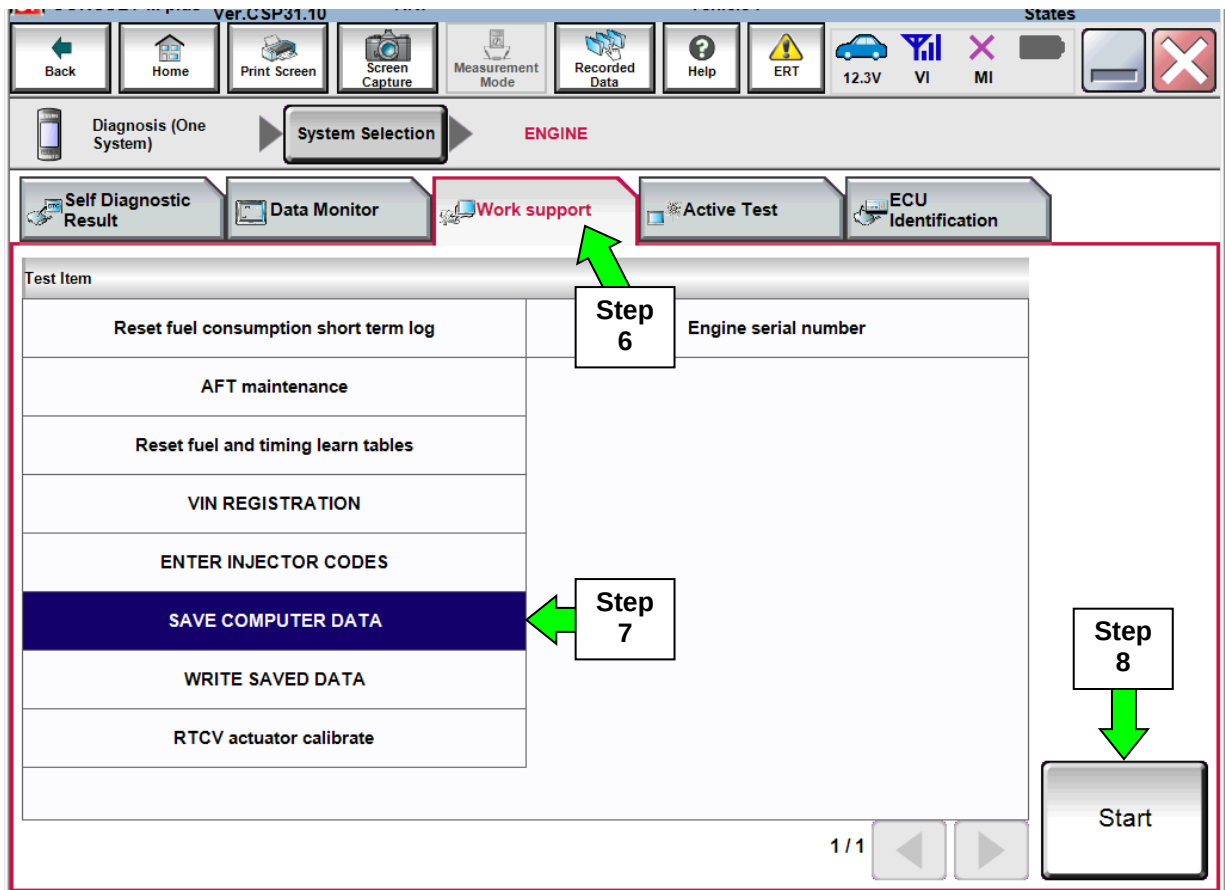
Figure B

6. Navigate C-III plus to Engine > Work Support (see Figure B).
7. Select **SAVE COMPUTER DATA**.
8. Select **Start**.

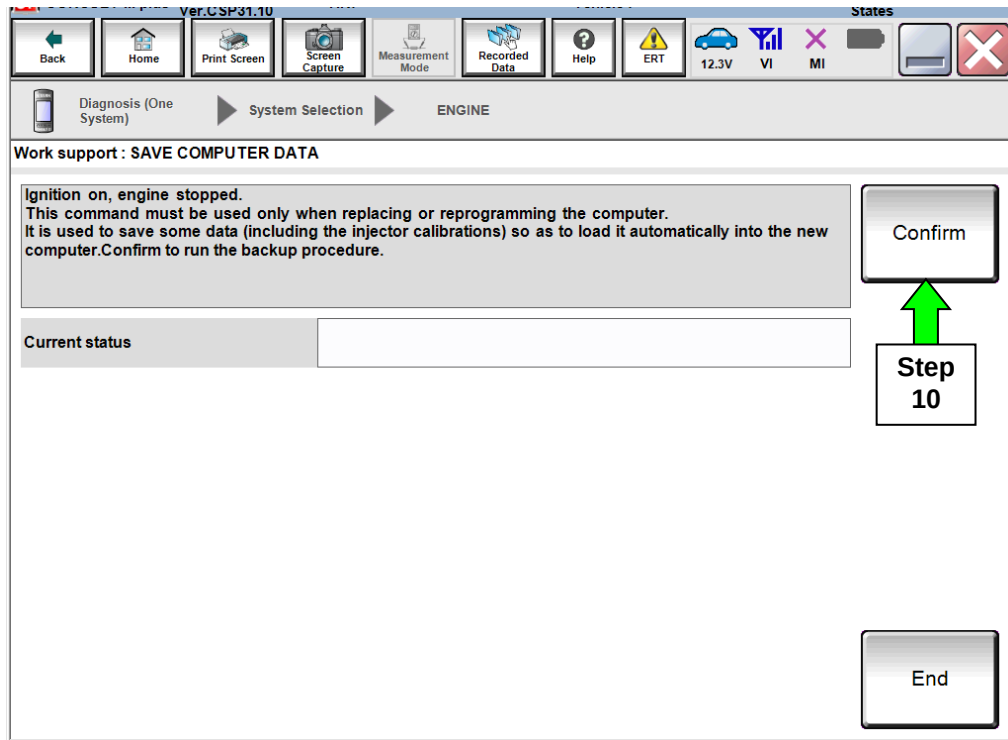
Figure C

9. Make sure the ignition is ON and the engine is OFF (engine not running).

10. Select **Confirm**.

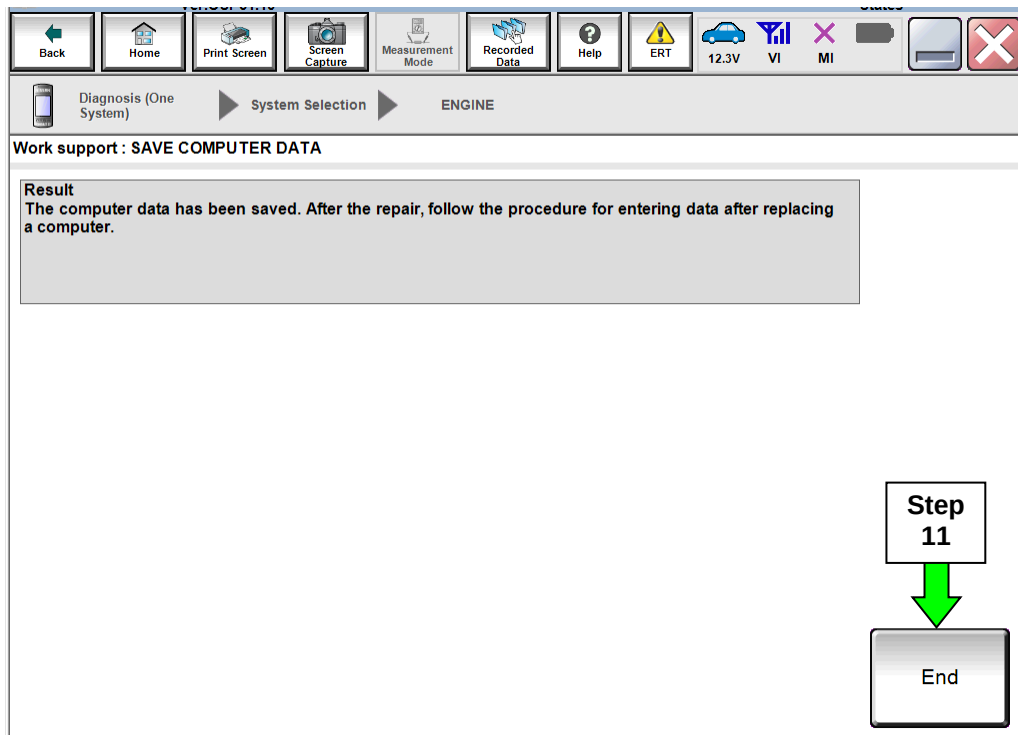
Figure D

11. Select **End**.

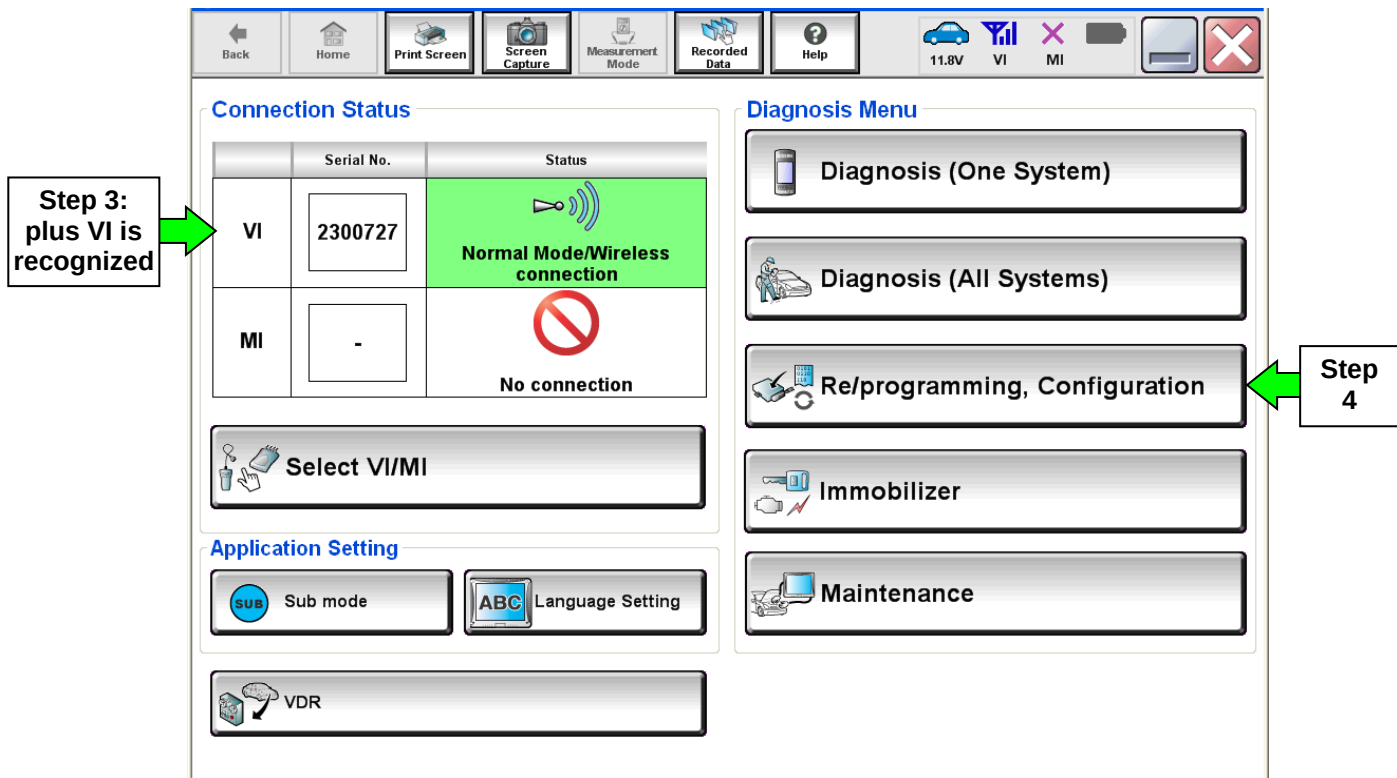
Figure 1

1. Return to the C-III plus Home screen (see Figure 1).
2. Confirm the ignition is ON, with engine OFF.
3. Confirm the plus VI is recognized.
  - The **Serial No.** will display when the plus VI is recognized.
4. Select **Re/programming, Configuration**.

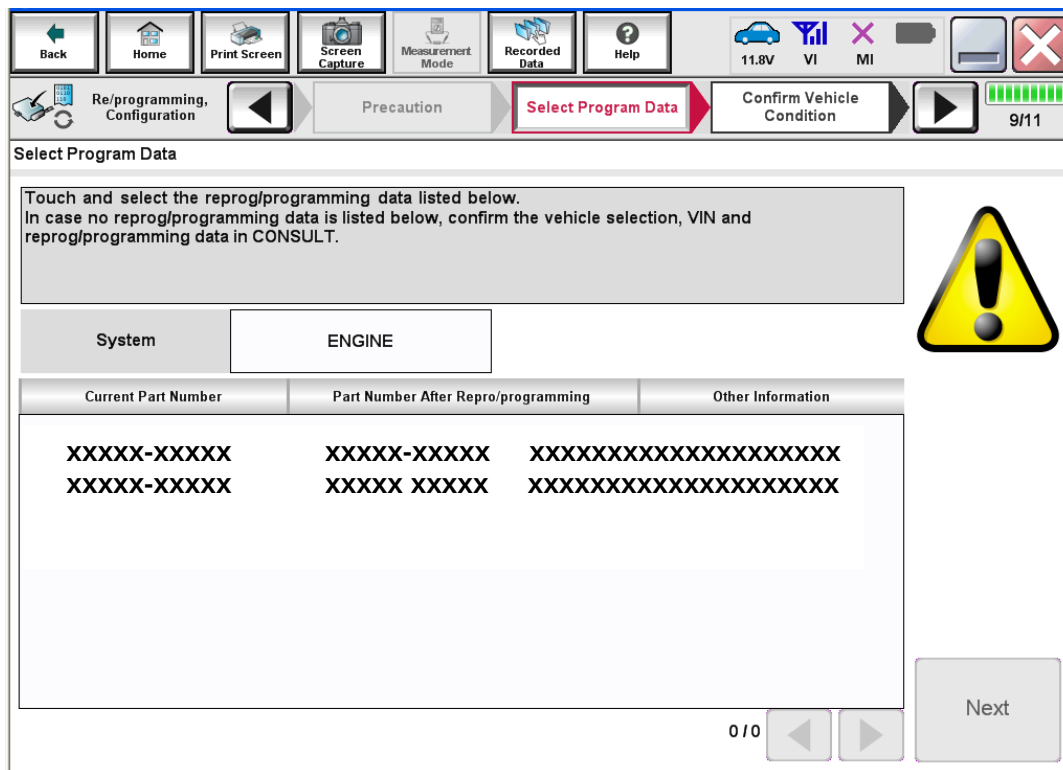
- In some cases, more than one new P/N for reprogramming is available.
  - If more than one new P/N is available, the screen in Figure 3 displays.
  - Select and use the reprogramming option that **does not** have the message “Caution! Use ONLY with NTBXX-XXX”.
- If you get this screen and it is blank (no reprogramming listed), it means there is no reprogramming available for this vehicle. Close C-III plus and refer back to ASIST for further diagnosis.

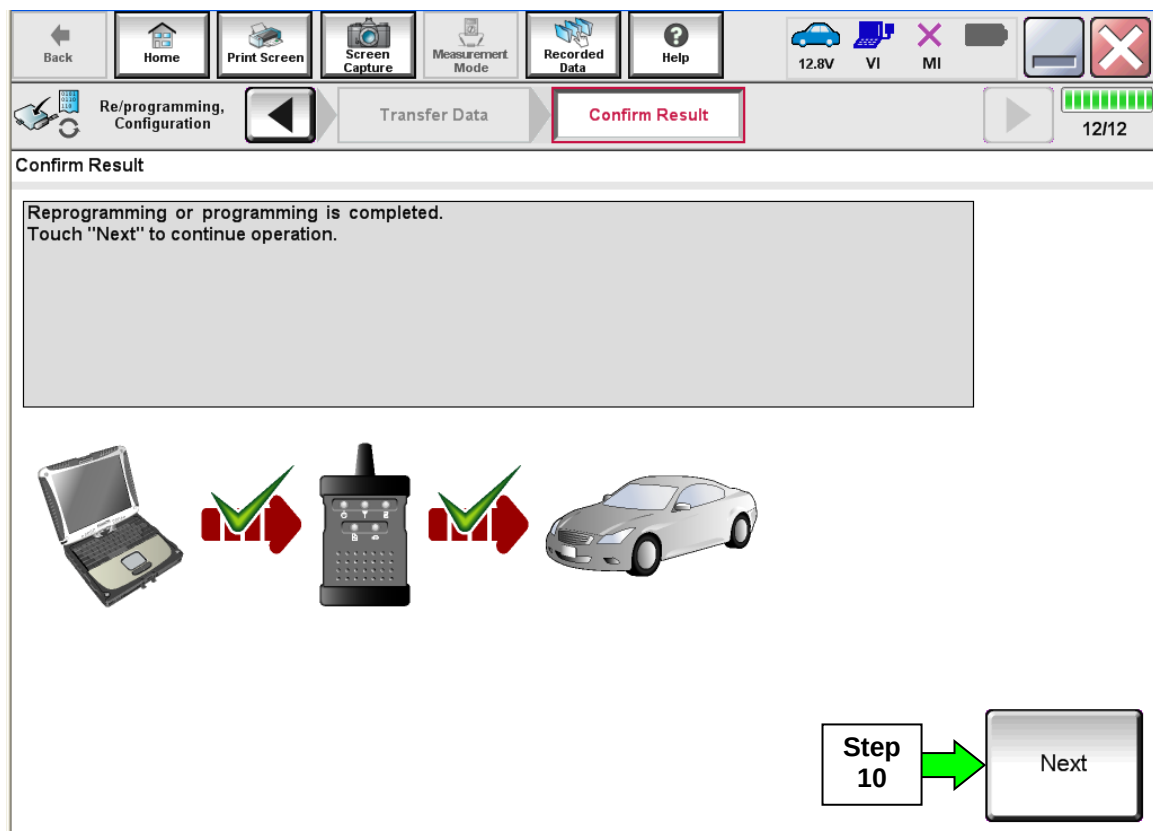
8. When the screen in Figure 4 displays, reprogramming is complete.

**NOTE:** If the screen in Figure 4 does not display (indicating that reprogramming did not complete), refer to ECM recovery on the next page.

9. Disconnect the GR8 (battery charger) from the vehicle.

10. Select **Next**.

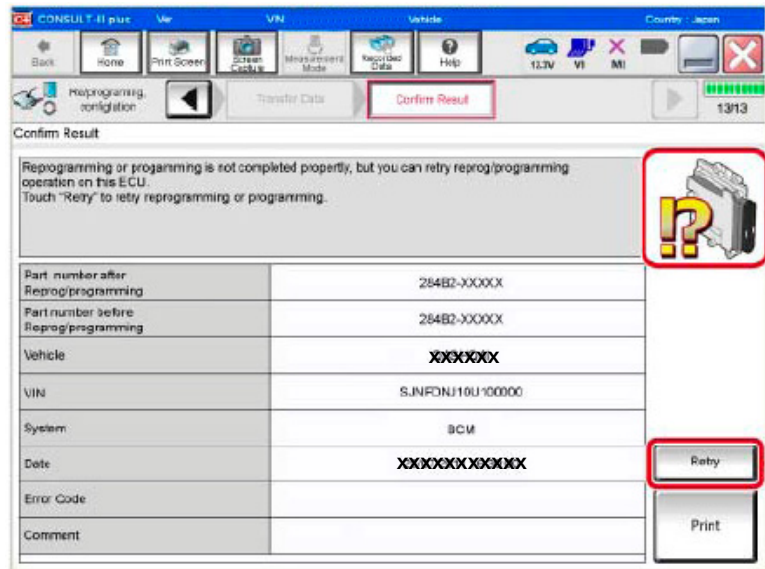
Figure 5

If reprogramming does not complete and the “!?” icon displays as shown in Figure 5:

- Check battery voltage (12.0 - 15.5 V).
- Ignition is ON, engine OFF.
- External Bluetooth® devices are OFF.
- All electrical loads are OFF.
- **Select retry and follow the on screen instructions.**
- “Retry” may not go through on first attempt and can be selected more than once.

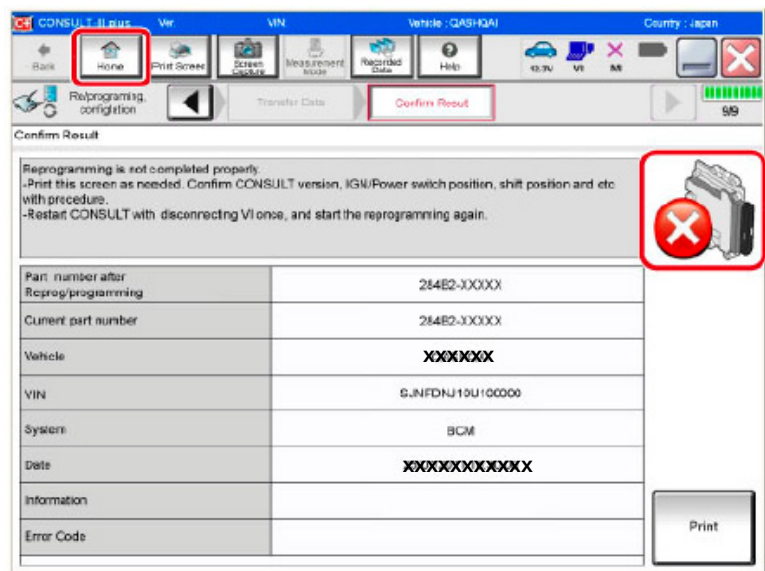
Figure 6

If reprogramming does not complete and the “X” icon displays as shown in Figure 6:

- Check battery voltage (12.0 - 15.5 V).
- CONSULT A/C adapter is plugged in.
- Ignition is ON, engine OFF.
- Transmission is in Park.
- All C-III plus / VI cables are securely connected.
- All C-III plus updates are installed.
- **Select Home, and restart the reprogram procedure from the beginning.**

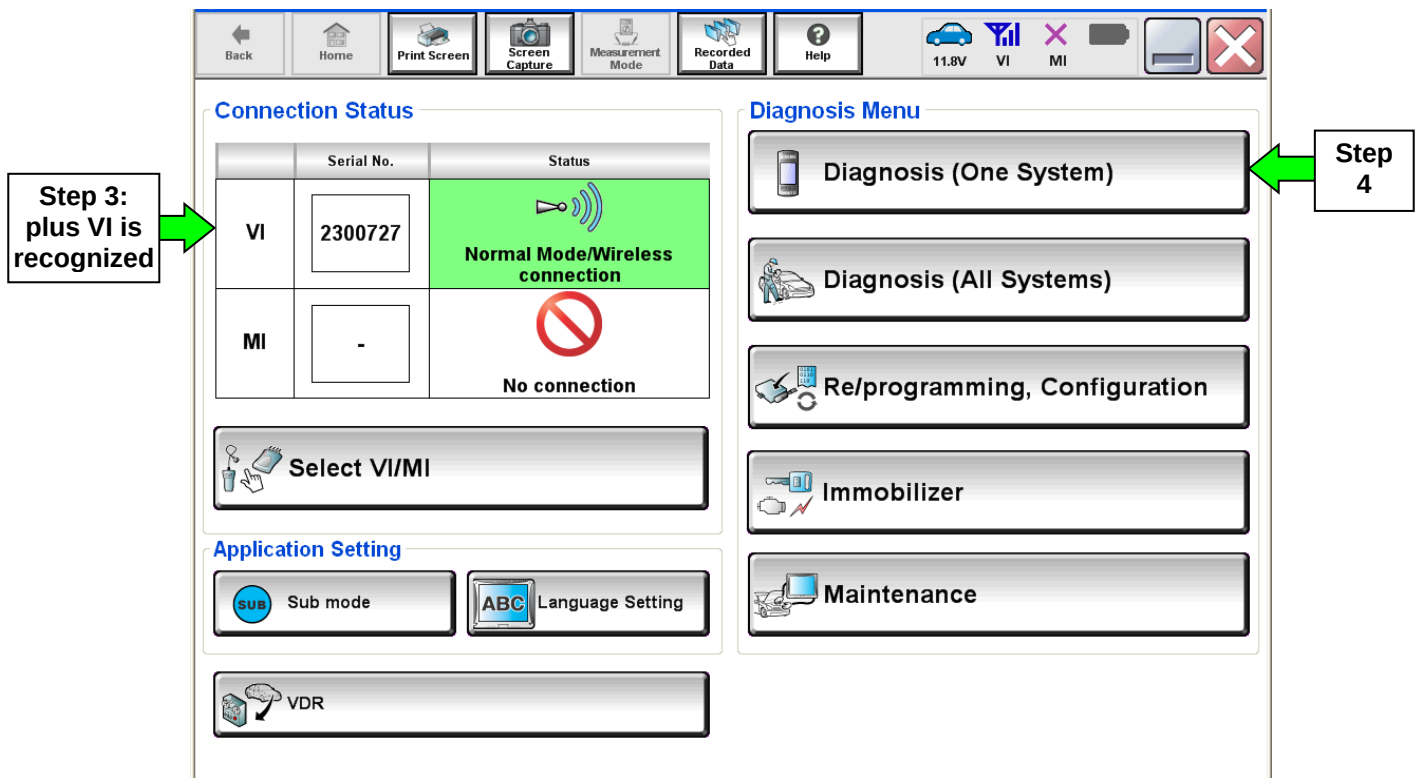
Figure 1A

1. Return to the C-III plus Home screen (see Figure 1A).
2. Confirm the ignition is ON, with engine OFF.
3. Confirm the plus VI is recognized.
  - The **Serial No.** will display when the plus VI is recognized.
4. Select **Diagnosis (One System)**.

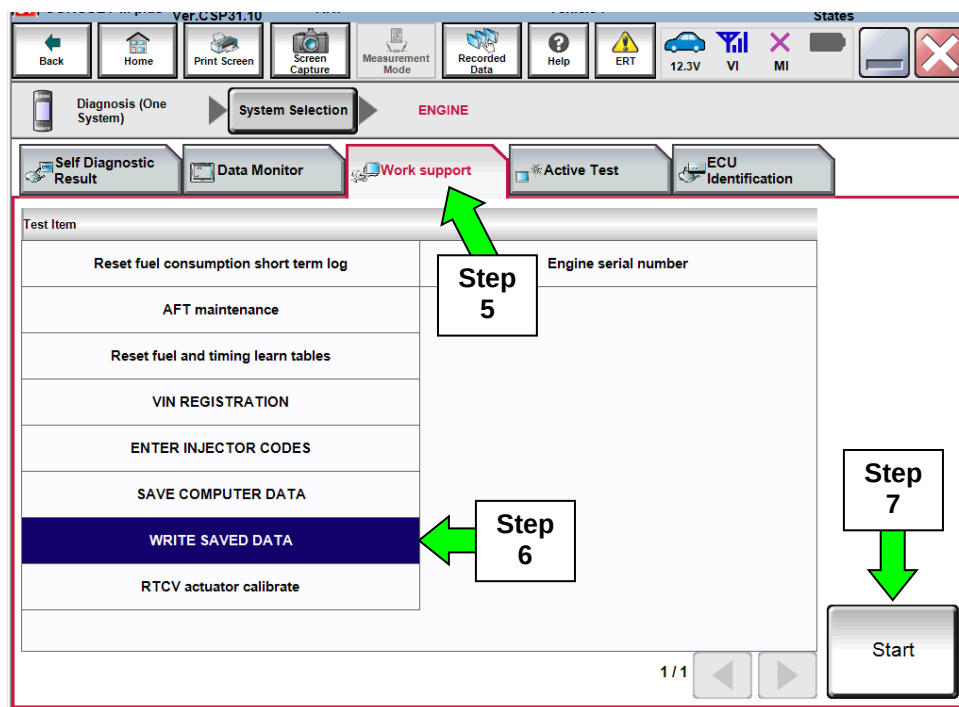
Figure 2A

5. Navigate C-III plus to ENGINE > Work support (see Figure 2A).
6. Select **WRITE SAVED DATA**.
7. Select **Start**.

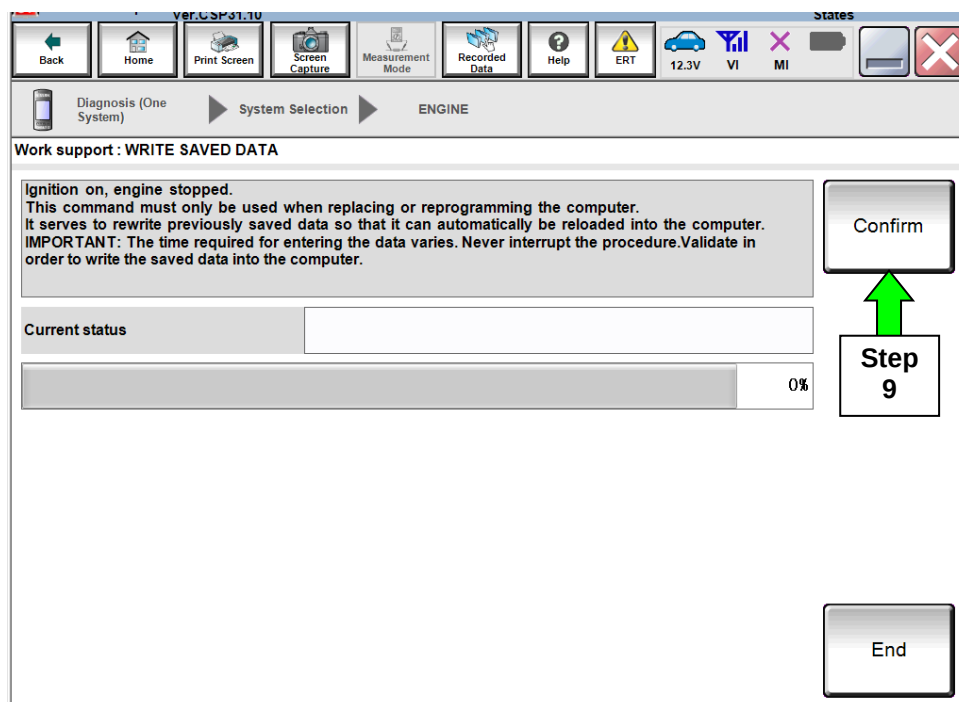
Figure 3A

8. Make sure the ignition is ON and the engine is OFF (engine not running).
9. Select **Confirm**.

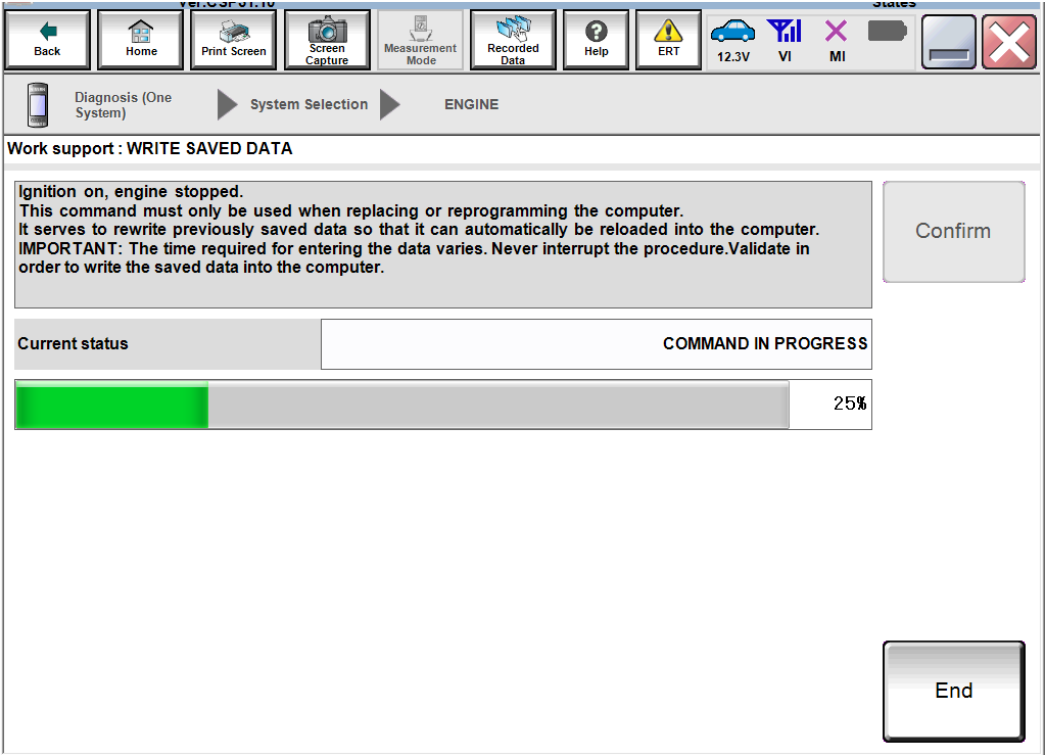
Figure 4A

10.Wait for the procedure to complete.

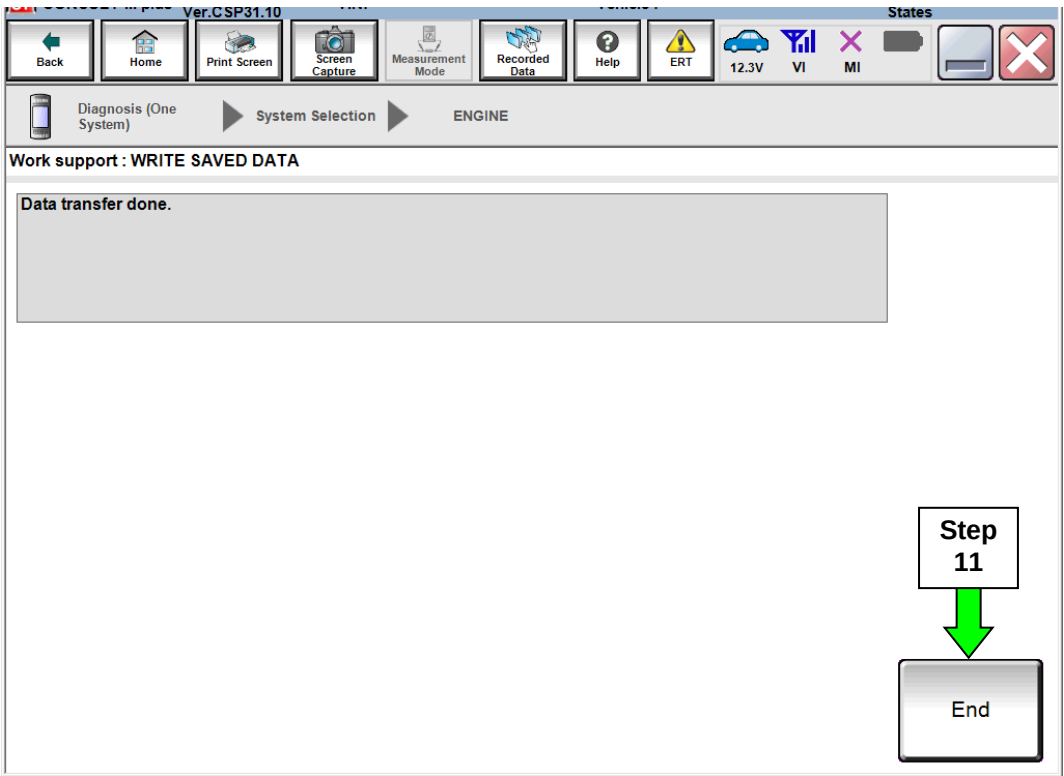
Figure 5A

11. Select **End**.
