| | GROUP<br><b>Fuel System</b> | MODEL<br><b>2011-2012MY Optima (TF/QF) Turbo<br/>2011-2012MY Sportage (SL) Turbo</b> |
| | NUMBER<br><b>025</b> | DATE<br><b>September 2013</b> |
| <b>TECHNICAL SERVICE BULLETIN</b> | | |
| <b>SUBJECT:</b> SERVICE ACTION: ECM UPGRADE – MIL ON WITH DTC<br>P0300 AND/OR P0301, P0302, P0303 AND P0304 (SA151) | | |

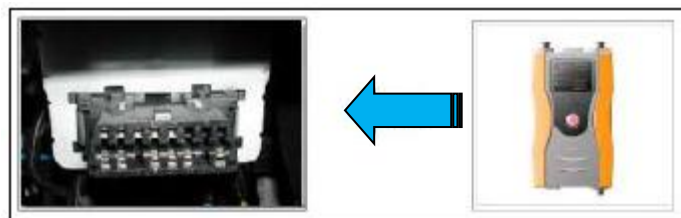
4. Connect the Main 16-pin DLC cable (GHDM – 241000) to the OBD-II connector, located under the driver's side of the instrument panel.

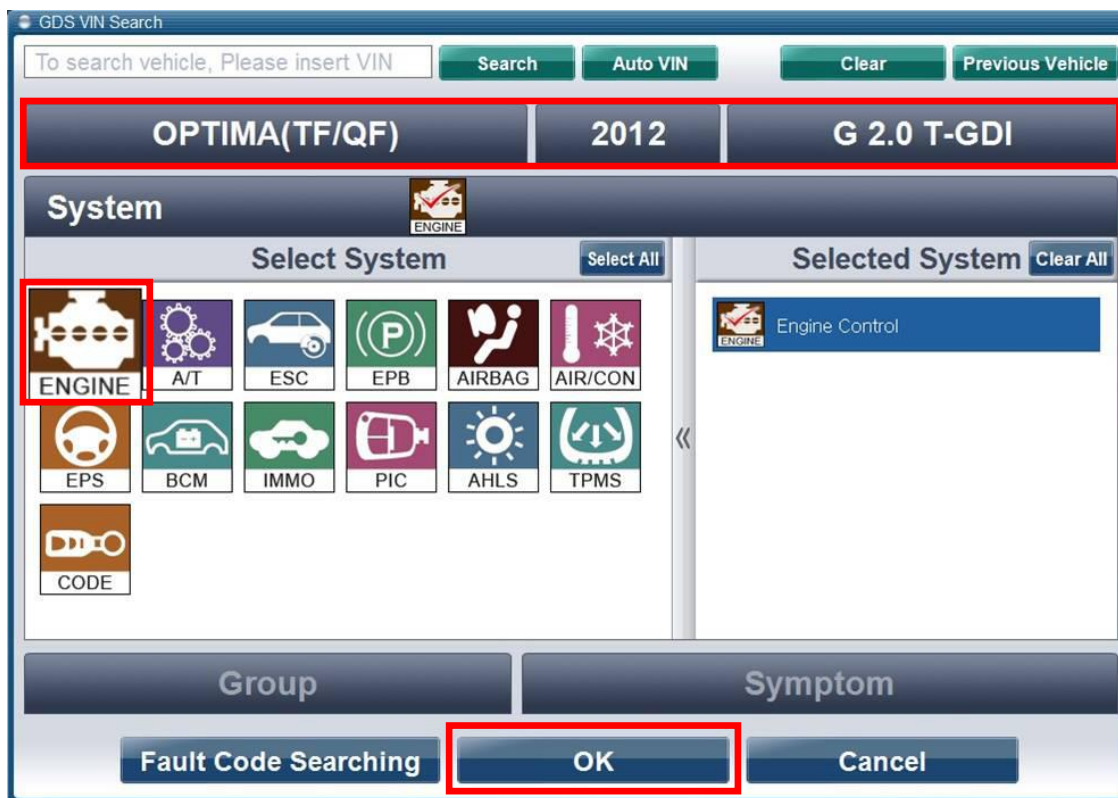
5. With the ignition key ON, turn ON the VCI and GDS tool. Access the GDS vehicle identification number (VIN) screen and configure the vehicle using the VIN AUTO DETECT Function.
