07214 Version 1

## Audio Unit May Display “USB Not Responding.”

### AFFECTED VEHICLES

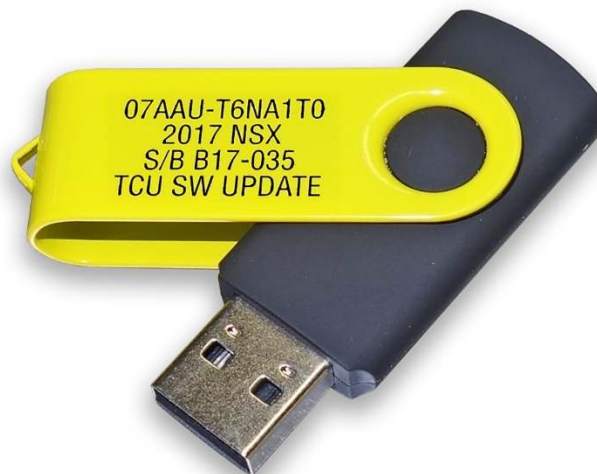
| Part Name | Part Number | Quantity |
|---|---|---|
| Telematics Control Unit (TCU) Software Update USB | 07AAU-T6NA1T0 | 1 |

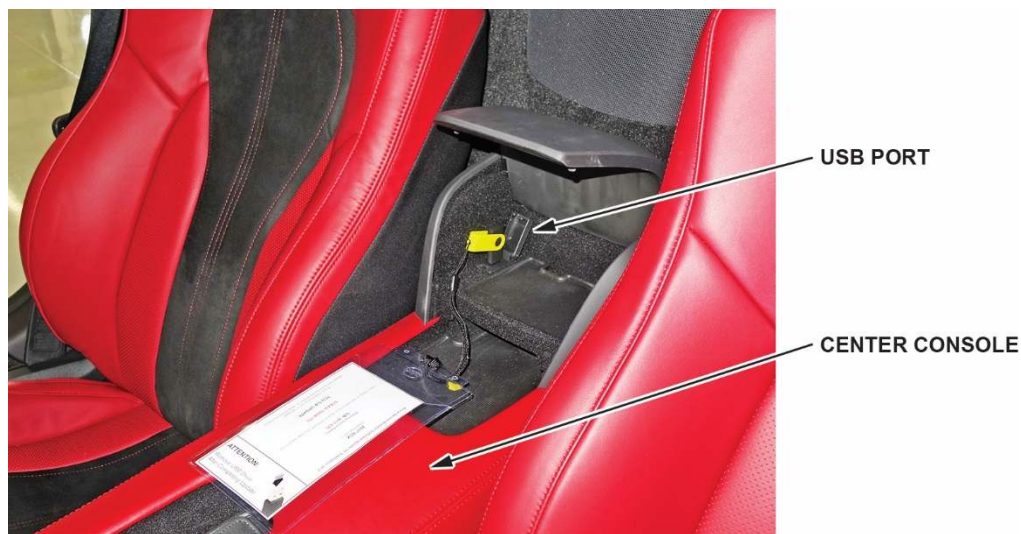
1. Connect a GR8 battery charger and set the battery type to AGM, or connect a fully charged jumper battery to the vehicle and leave it connected during the entire update procedure to maintain a steady voltage.
2. Connect the USB update device into the USB port located in the center console.

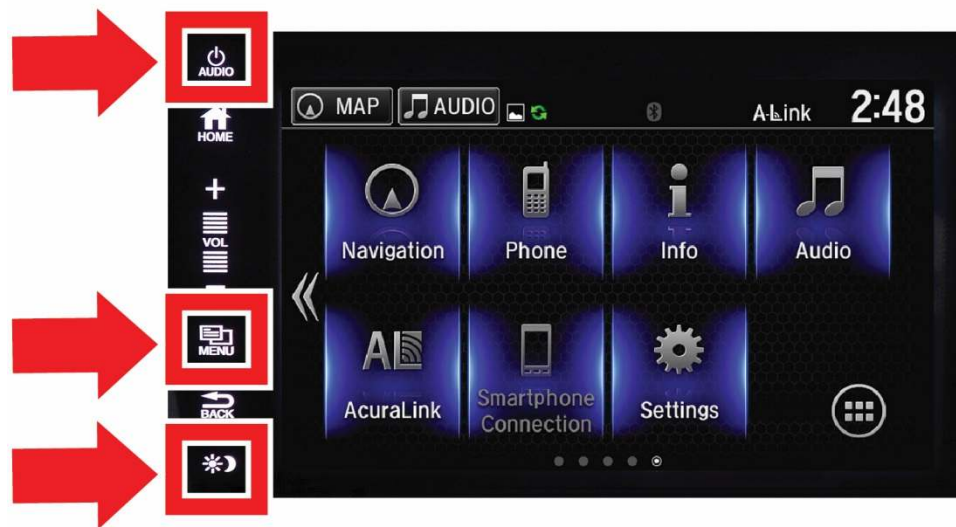
3. Turn the ignition to ON.
4. Press and hold the **AUDIO power** button, **MENU** icon, and the **Brightness** icon at the same time for 3 seconds to enter the diagnosis menu.

NOTE: Make sure to press and hold all 3 at the same time to enter the diagnosis menu.

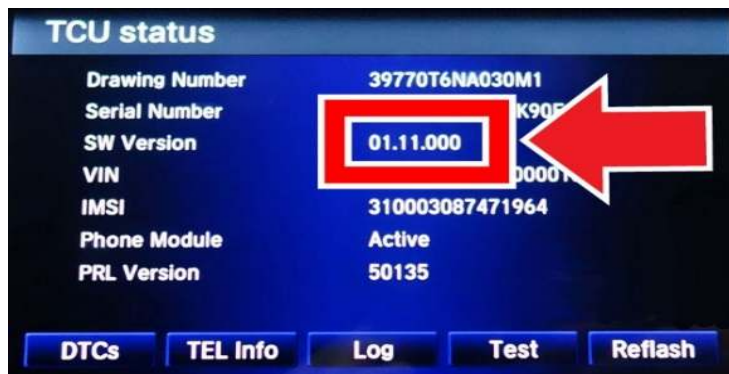
7. Make sure **SW Version** is **01.11.000**.

NOTE: Only update vehicles within the affected VIN range. Vehicles outside of the VIN range will have a different SW Version.

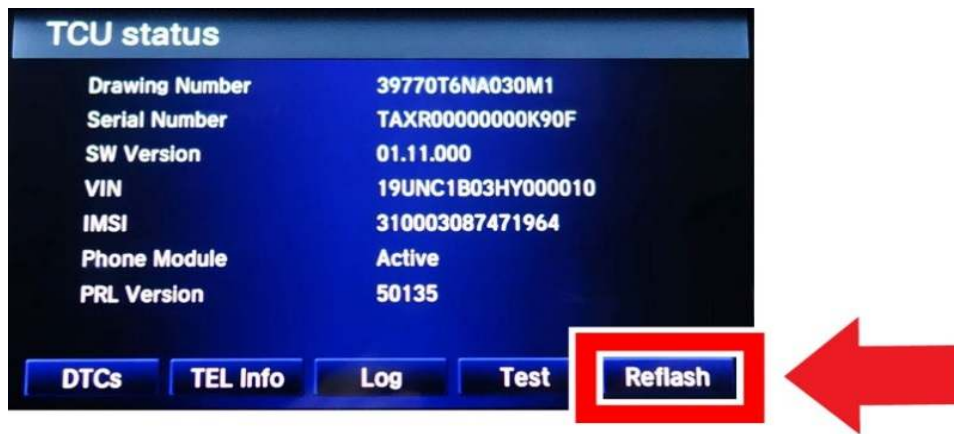
8. Select **Reflash**.

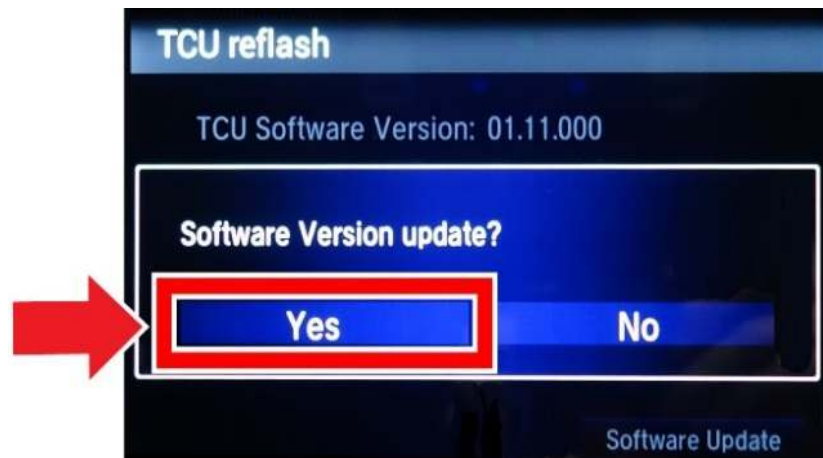
10. Select **Yes** to start the update.

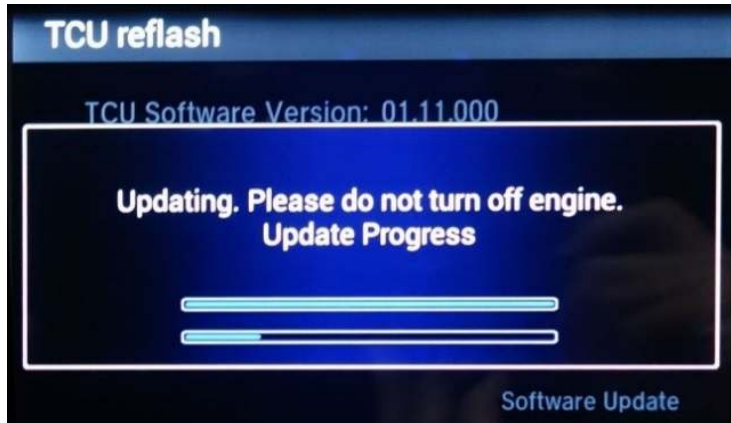
11. The software update will begin.

NOTE: The software update will take approximately 10 minutes, you do not need to stay with the vehicle.

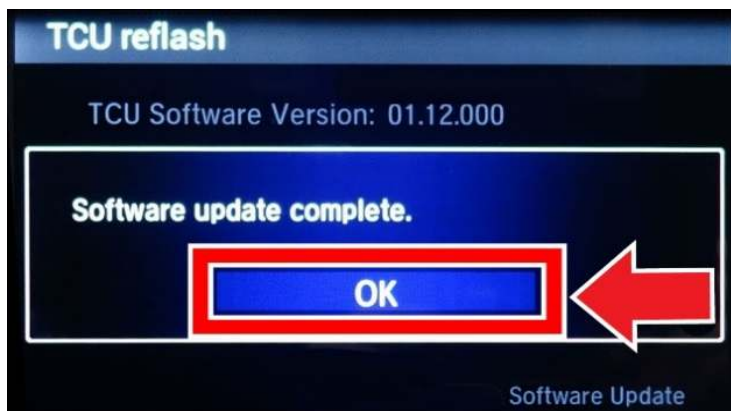
12. Select **OK** when the update is complete.

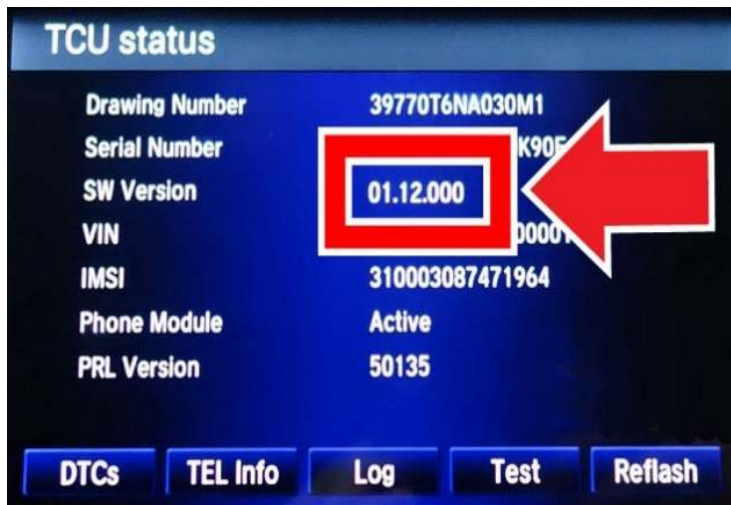
13. Remove the USB update device from the USB port.

14. Repeat steps 3 thru 5 to confirm the **SW Version** is **01.12.000**.
