# Technical Service Bulletin

## 01 MIL on (P0300 and/or P0301- P0308, P1923)

01 13 12 2030478/2 July 2, 2013. Supersedes Technical Service Bulletin Group 24 number 12-37 dated August 20, 2012 for reasons listed below.

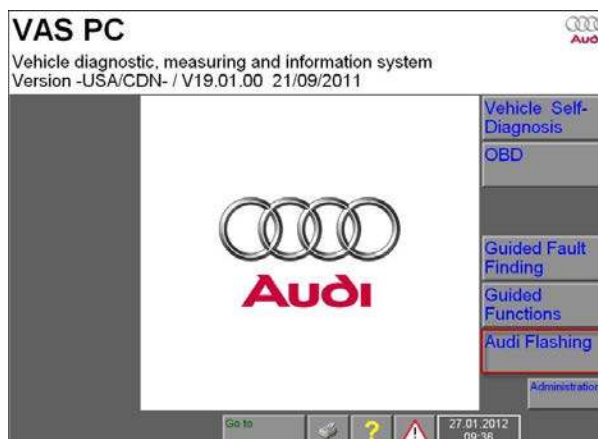
- Turn off any appliances with high electromagnetic radiation (such as mobile phones).
  - If communication with a module cannot be properly established, appropriate repairs must be made before attempting SVM. If the tester cannot communicate with a module, the tester cannot flash software onto the module.
5. Enter the SVM code into the User Test Plan by selecting the **Audi Flashing** option at the main tester screen, unless otherwise directed by the TSB or TAC Helpline.

**Figure 2.** Audi Flashing.
