## SERVICE BULLETIN

EC16-033

### 2016 TITAN XD; MIL ON WITH DTC P226C OR P0471

**APPLIED VEHICLES:** 2016 Titan XD (A61)  
**APPLIED ENGINE:** Cummins 5.0L V8 Diesel

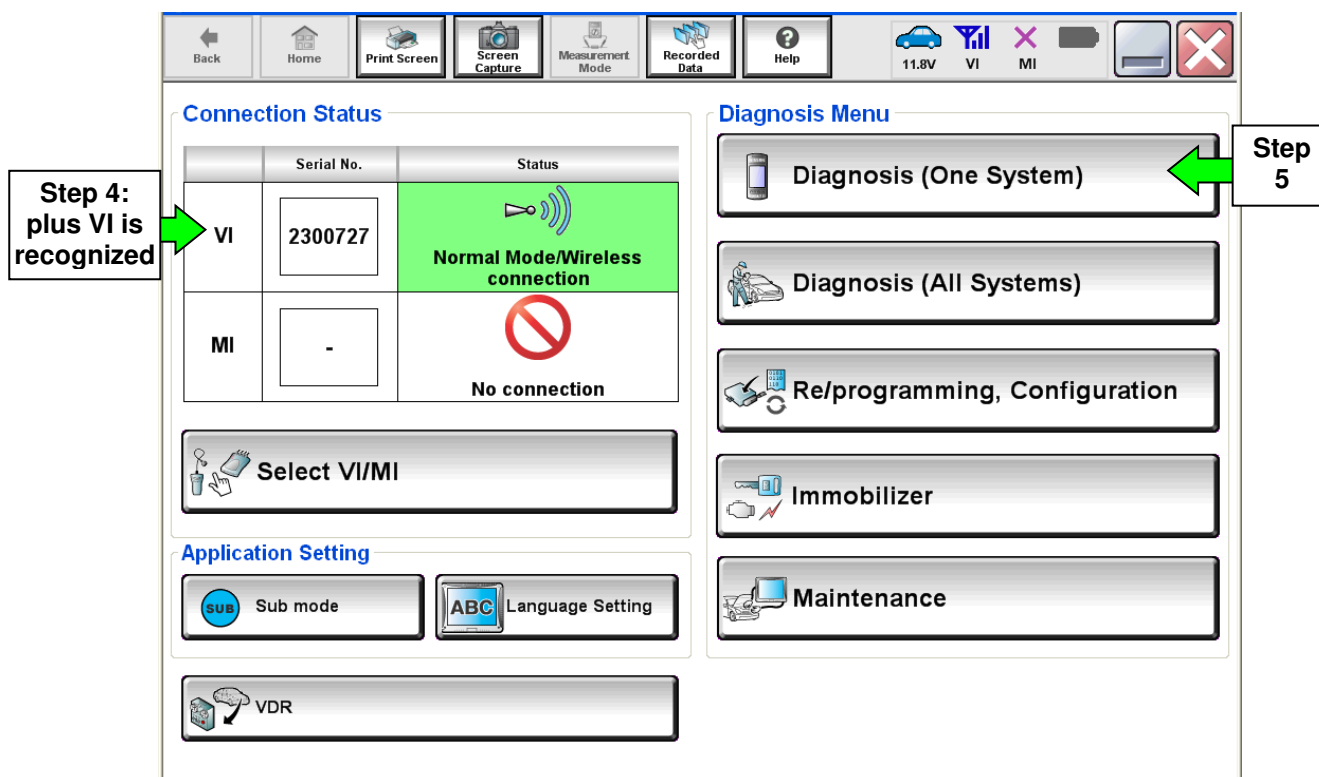
Figure A

1. Connect the CONSULT PC to the vehicle.
2. Open / start C-III plus.
3. Turn the ignition ON, with engine OFF (engine not running).
4. Wait for the plus VI to be recognized.
  - The **Serial No.** will display when the plus VI is recognized.
5. Select **Diagnosis (One System)**.

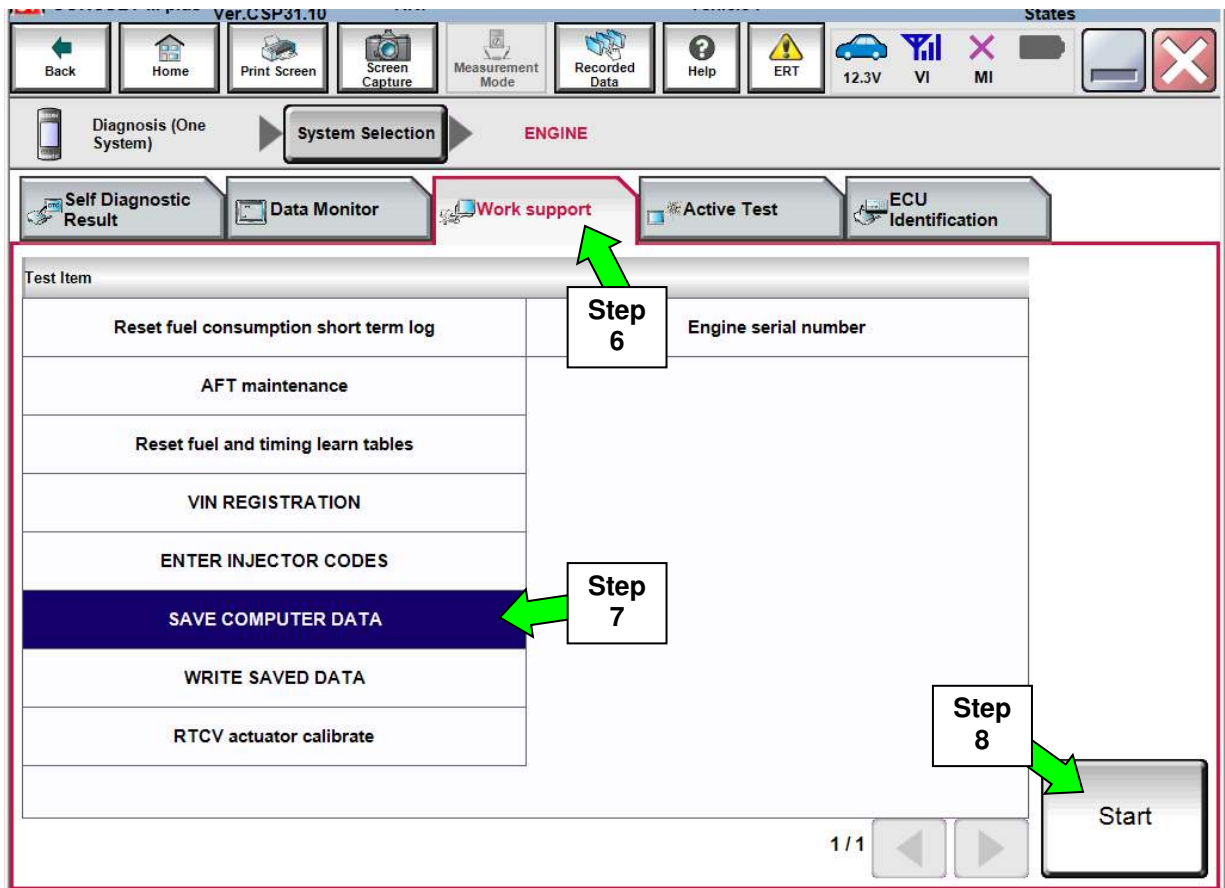
Figure B

6. Navigate C-III plus to **Engine > Work Support** (see Figure B).
7. Select **SAVE COMPUTER DATA**.
8. Select **Start**.

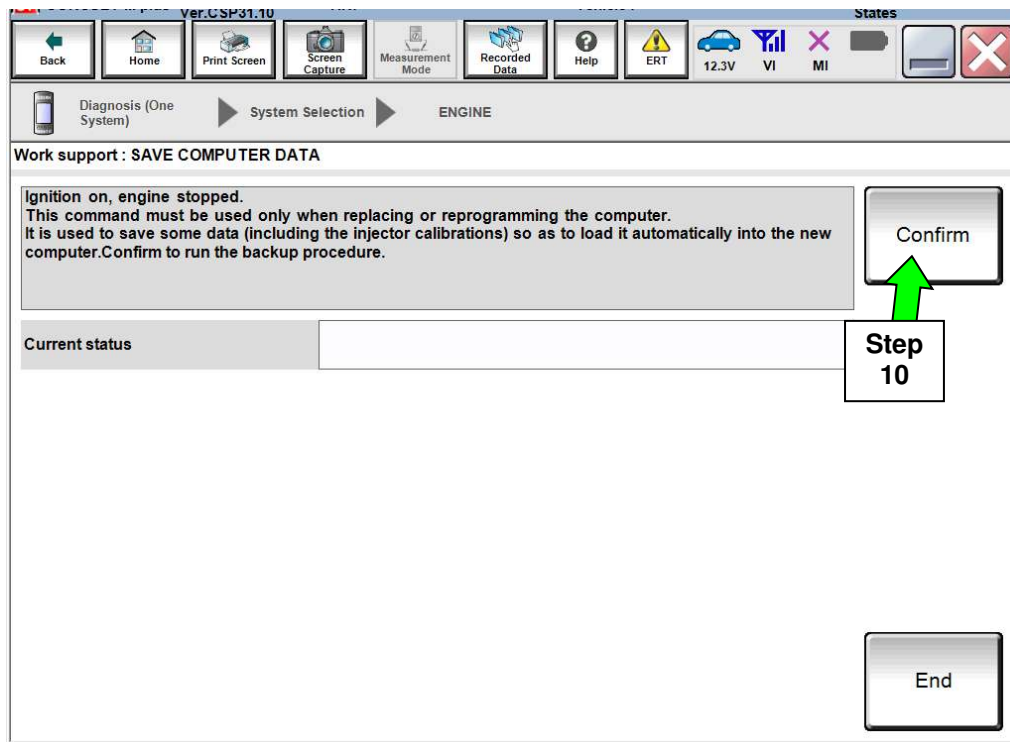
Figure C

9. Make sure the ignition is ON and the engine is OFF (engine not running).

10. Select **Confirm**.

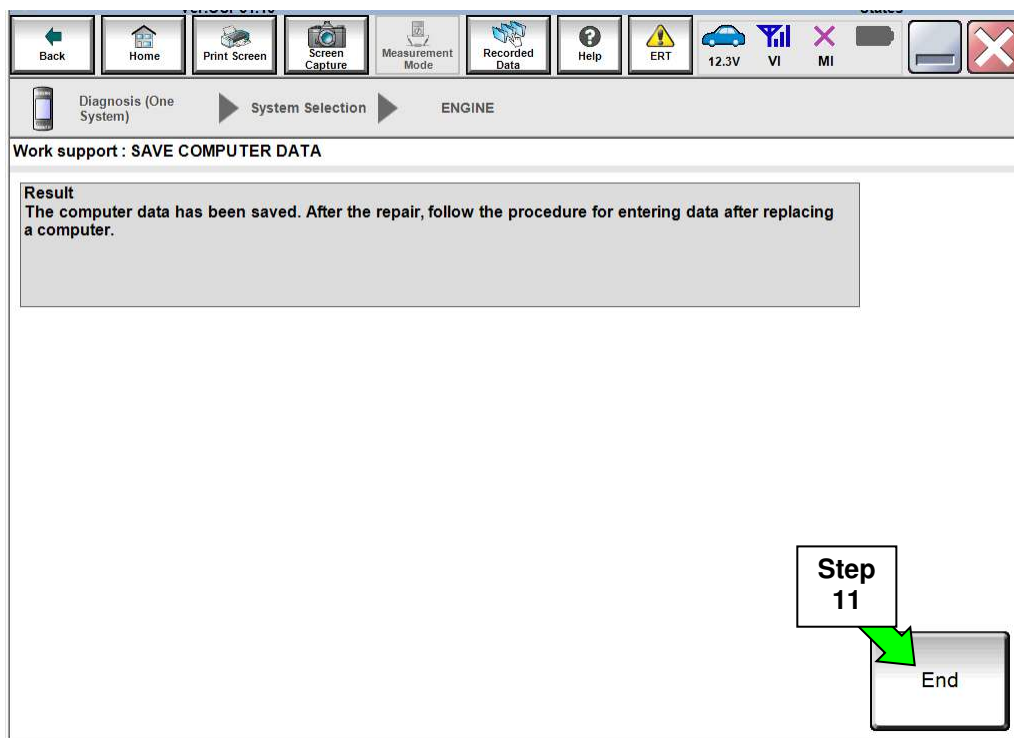
Figure D

11. Select **End**.

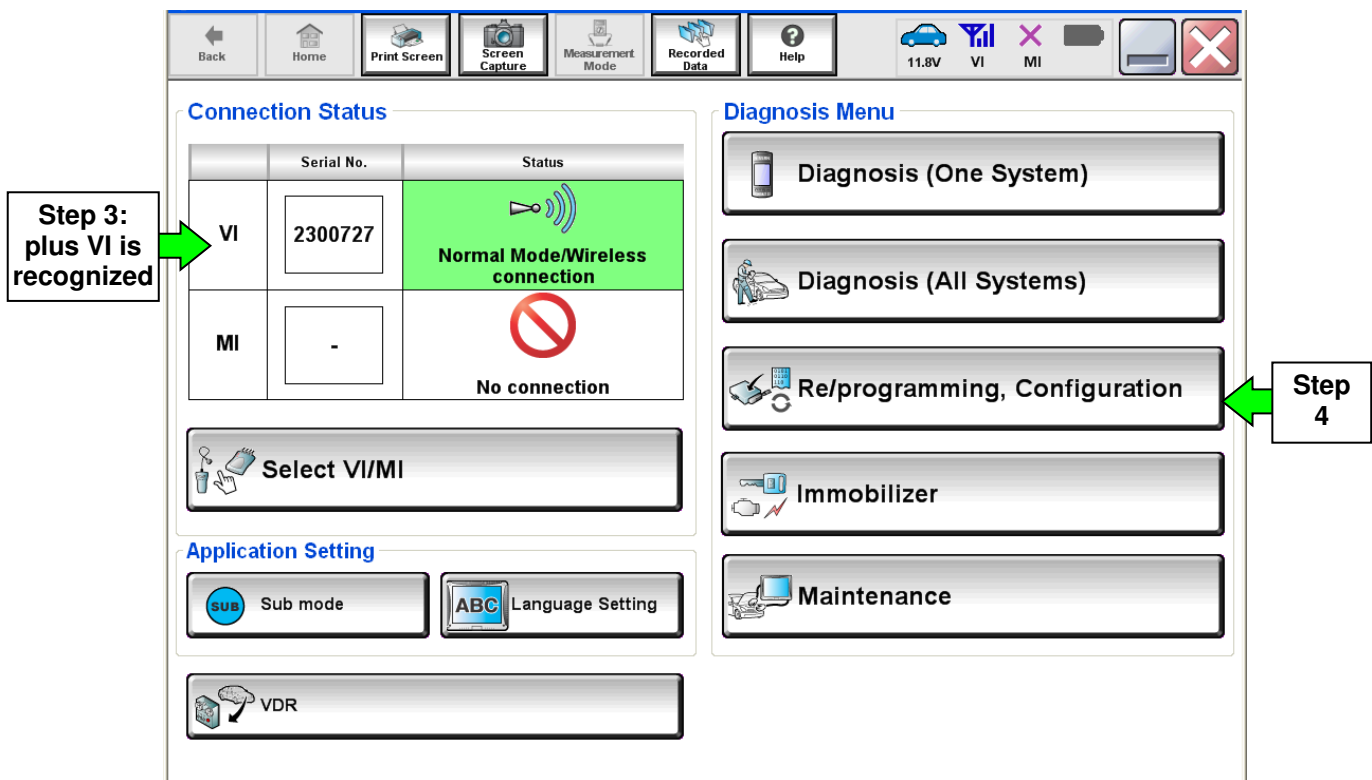
Figure 1

1. Return to the C-III- plus Home screen (see Figure 1).
2. Confirm the ignition is ON, with engine OFF.
3. Confirm the plus VI is recognized.
  - The **Serial No.** will display when the plus VI is recognized.
4. Select **Re/programming, Configuration.**

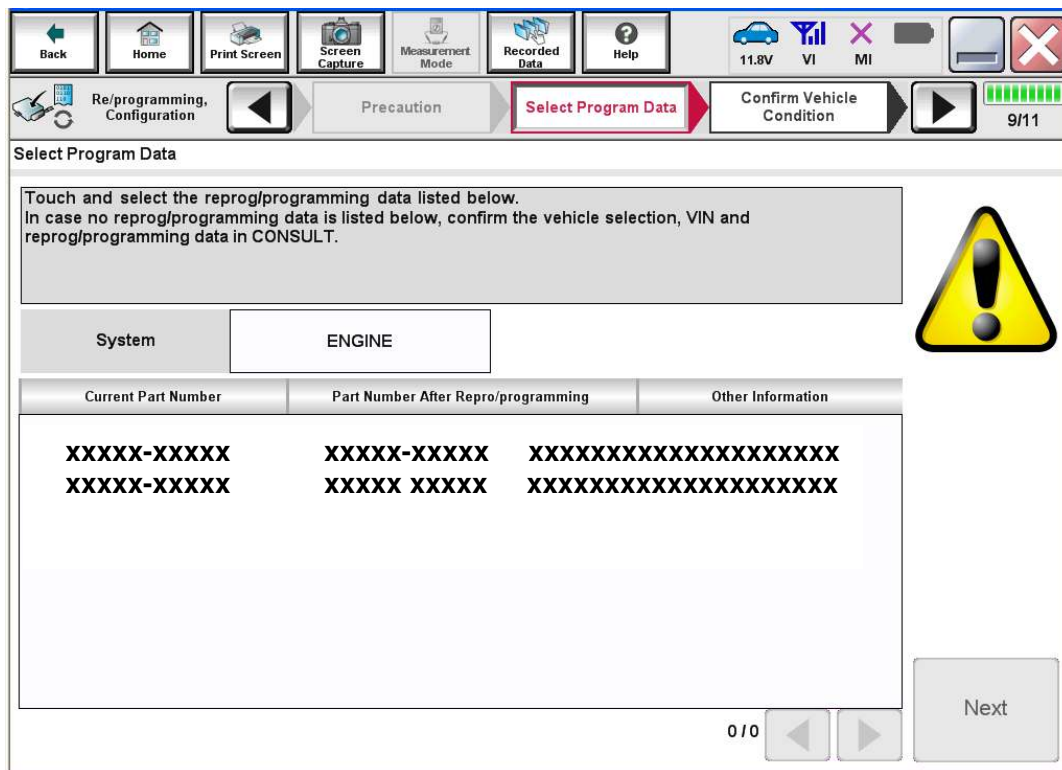
- In some cases, more than one new P/N for reprogramming is available.
  1. If more than one new P/N is available, the screen in Figure 3 displays.
  2. Select and use the reprogramming option that **does not** have the message “Caution! Use ONLY with NTBXX-XXX”.
- If you get this screen and it is blank (no reprogramming listed), it means there is no reprogramming available for this vehicle. Close C-III plus and refer back to ASIST for further diagnosis.

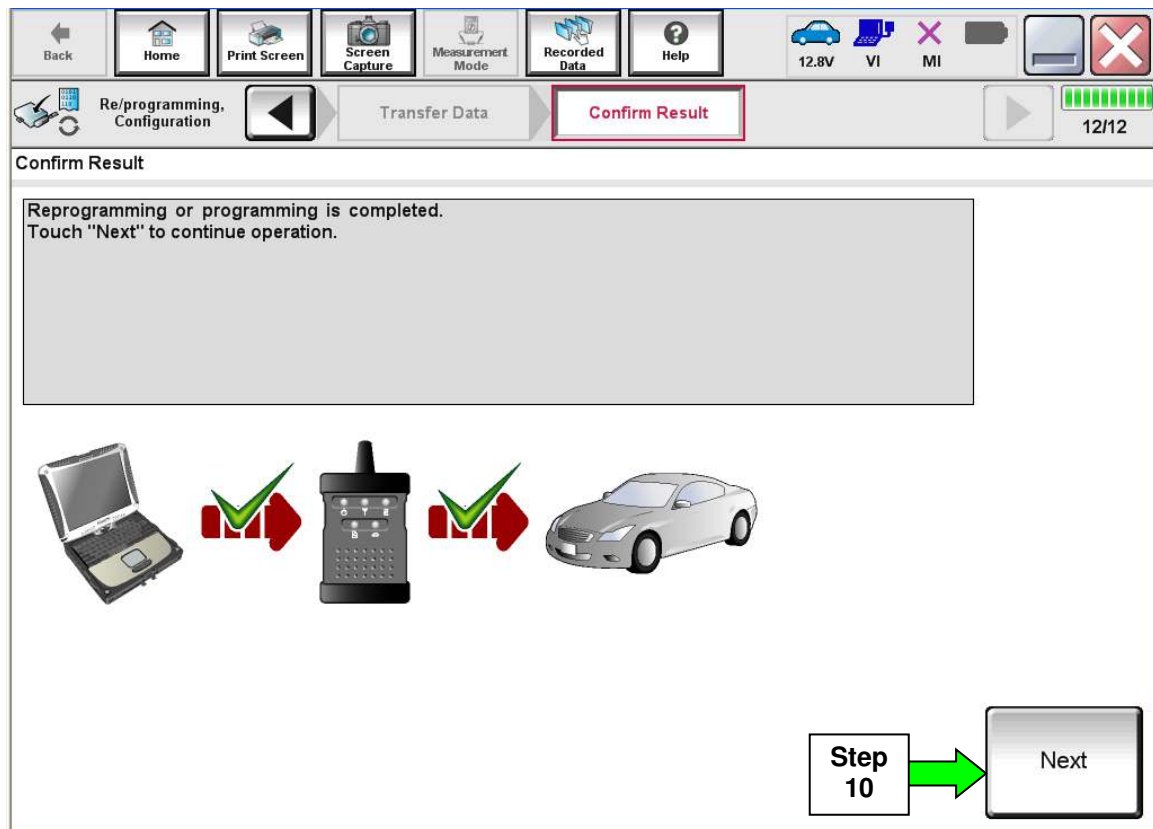
8. When the screen in Figure 4 displays, reprogramming is complete.

**NOTE:** If the screen in Figure 4 does not display (indicating that reprogramming did not complete), refer to ECM recovery on the next page.

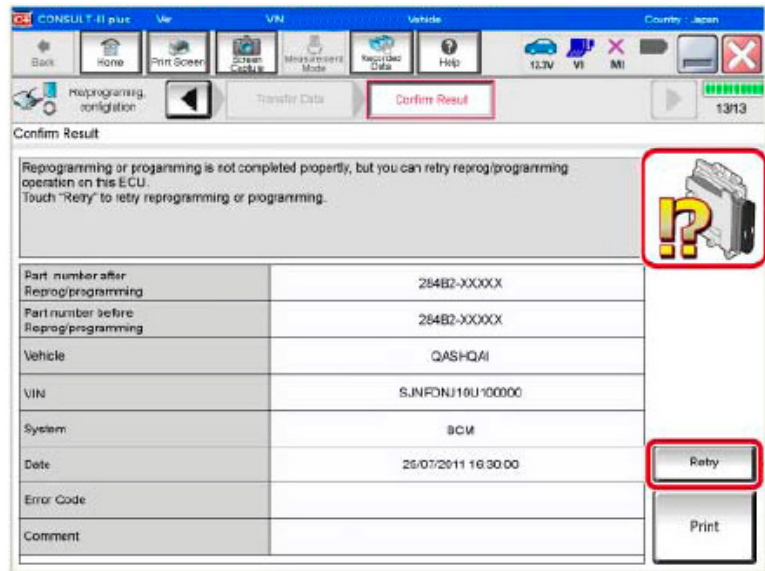
Figure 5

If reprogramming does not complete and the “!?” icon displays as shown in Figure 5:

- Check battery voltage (12.0 - 15.5 V).
- Ignition is ON, engine OFF.
- External Bluetooth® devices are OFF.
- All electrical loads are OFF.
- **Select retry and follow the on screen instructions.**
- **“Retry” may not go through on first attempt and can be selected more than once.**

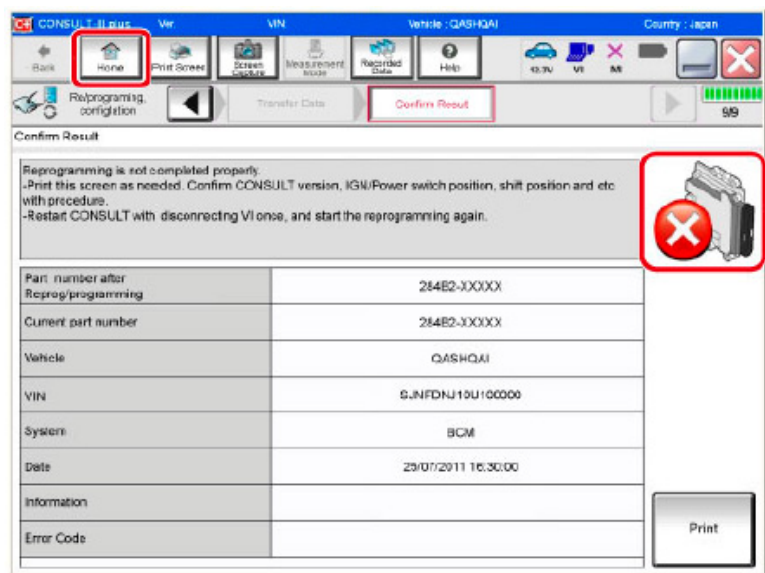
Figure 6

If reprogramming does not complete and the “X” icon displays as shown in Figure 6:

- Check battery voltage (12.0 - 15.5 V).
- CONSULT A/C adapter is plugged in.
- Ignition is ON, engine OFF.
- Transmission is in Park.
- All C-III plus / VI cables are securely connected.
- All C-III plus updates are installed.
- **Select Home, and restart the reprogram procedure from the beginning.**

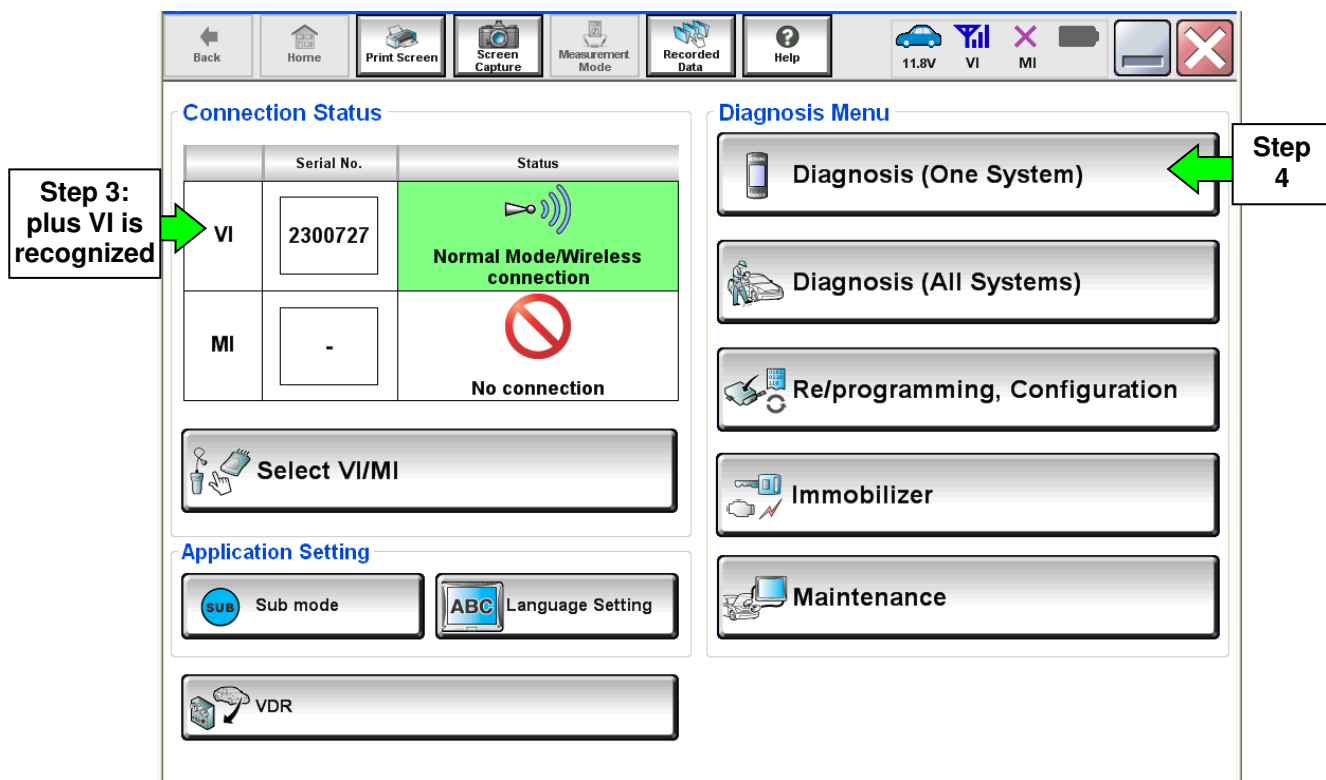
Figure 1A

1. Return to the C-III- plus Home screen (see Figure 1A).
2. Confirm the ignition is ON, with engine OFF.
3. Confirm the plus VI is recognized.
  - The **Serial No.** will display when the plus VI is recognized.
4. Select **Diagnosis (One System)**.

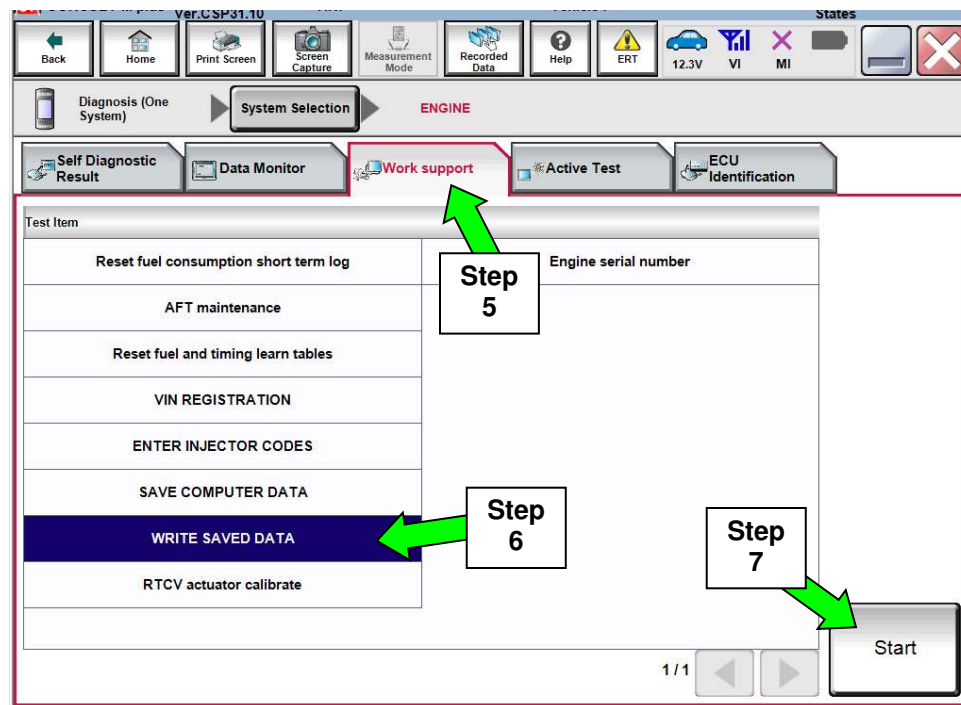
Figure 2A

5. Navigate C-III plus to **ENGINE > Work support** (see Figure 2A).
6. Select **WRITE SAVED DATA**.
7. Select **Start**.

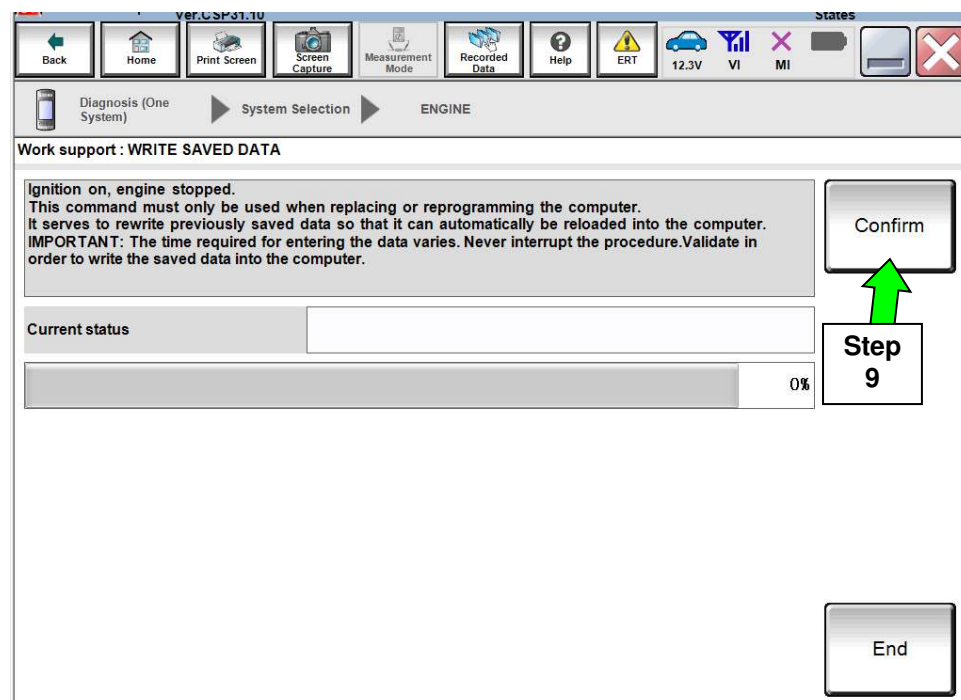
Figure 3A

8. Make sure the ignition is ON and the engine is OFF (engine not running).
9. Select **Confirm**.

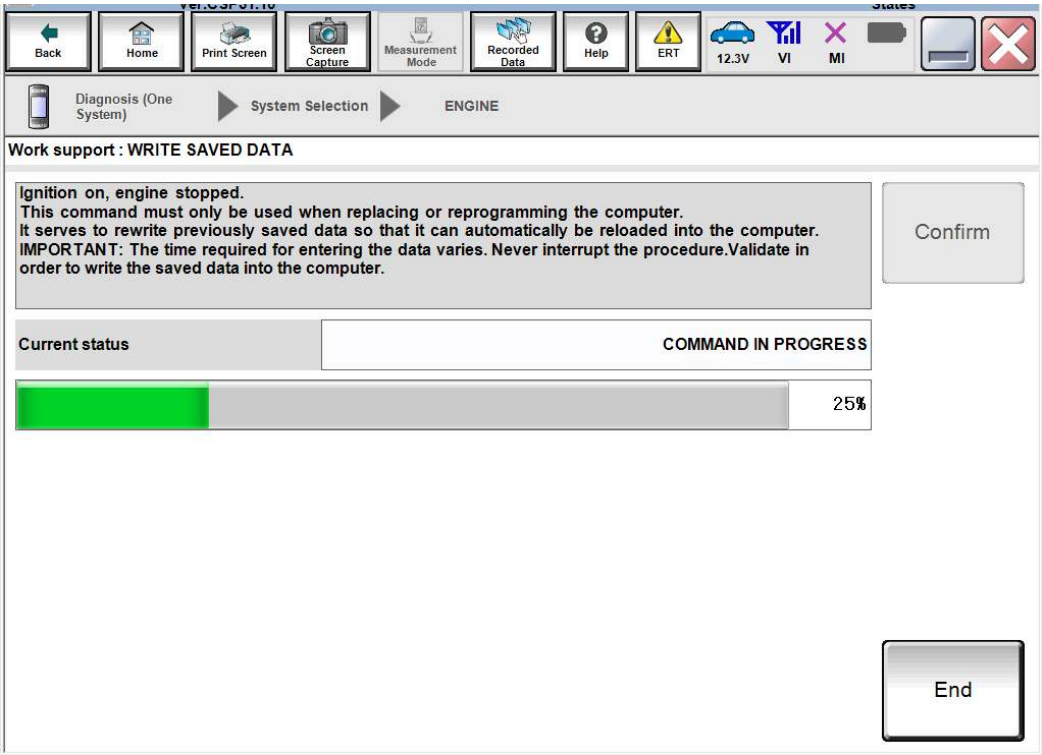
Figure 4A

10.Wait for the procedure to complete.

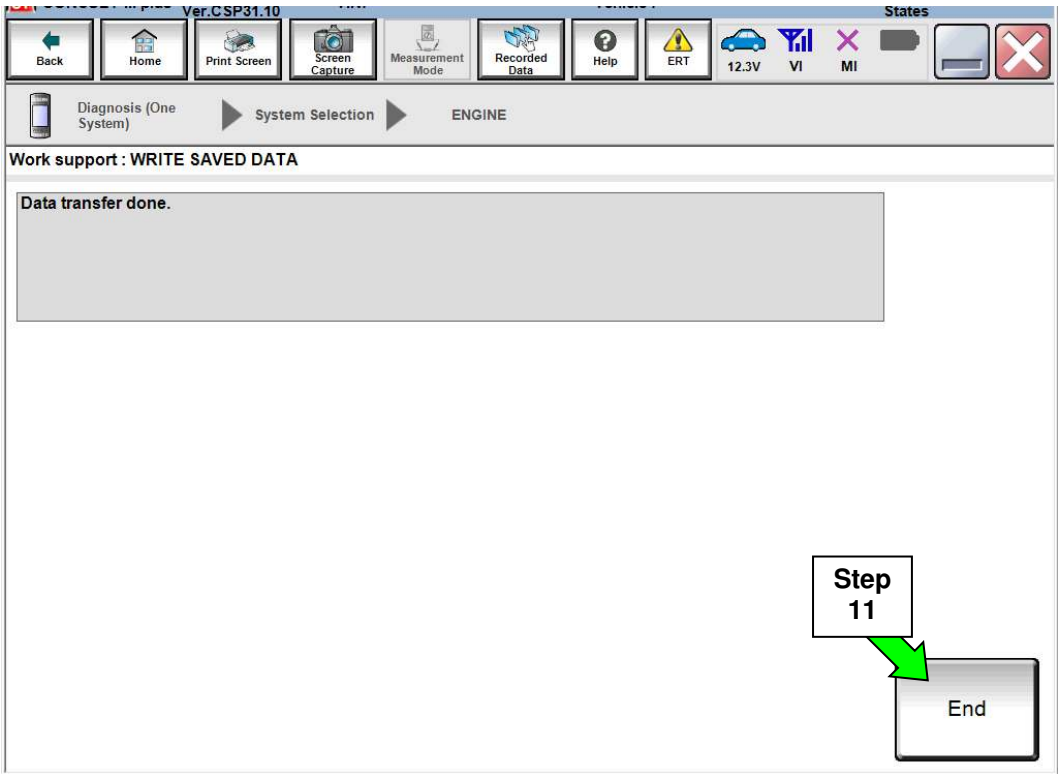
Figure 5A

11.Select **End**.
