JTB00534NAS

# TECHNICAL BULLETIN

Windows Will Not Lower/Raise

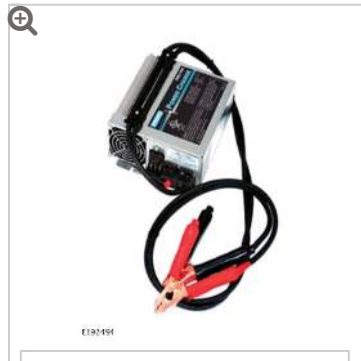
Jaguar Land Rover-  
approved Midtronics  
battery power  
supply

- A Jaguar Land Rover-approved Midtronics battery power supply must be connected to the vehicle battery during diagnosis / module programming.
- Make sure all ignition ON/OFF requests are carried out; failure to perform these steps may cause damage to control modules in the vehicle.

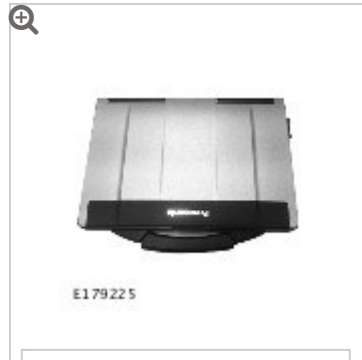
Jaguar Land Rover-  
approved diagnostic  
tool with latest SDD  
software, Calibration  
File

- 3 Connect the Jaguar Land Rover-approved diagnostic tool to the vehicle and begin a new session.
- 4 Follow the on-screen prompts, allowing the diagnostic tool to read the VIN, identify the vehicle, and initiating the data collect sequence.
- 5 Select **Diagnosis** from the Session Type screen.
- 6 Select the **Selected Symptoms** tab and then select:
  - **Body - Glass panels - Glass movement**
- 7 Select **continue**.
- 8 Select the **Recommendations** tab.
- 9 Select **Run** to perform the '**Configure existing module - Driver door module**' option.
- 10 Follow all on-screen instructions to complete this task, ensuring all Diagnostic Trouble Codes (DTC) are cleared.
- 11 When all tasks are complete, select the **Session** tab and then select the **Close Session** option.
- 12 Disconnect the diagnostic tool and battery power supply from the vehicle.
