**NUMBER:** 08-007-17 REV. G

**GROUP:** 08 - Electrical

UAS, UCQ, UDQ, UJQ and UAQ Radio Enhancements

This bulletin involves inspecting and if required, updating the radio software.

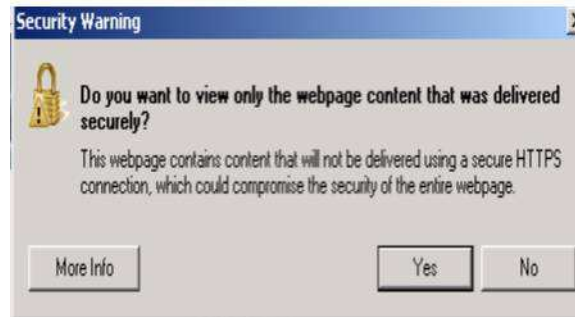
Fig. 2  
Pop-Up Security Message

3. If a security message appears “Do you want to view only the web page content that was delivered securely?” (Fig. 2) . Press “No” to continue.

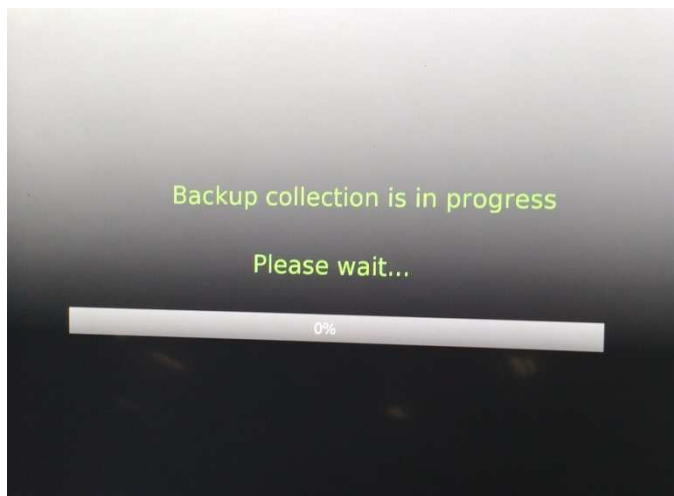
Fig. 8  
Backup Collection Screen

- **DO NOT** cycle the ignition or touch the radio during the update process.
  - If the software update process is interrupted, aborted or failed, the process should be restarted.
13. Once the update process is completed, the Backup Collection screen will appear (Fig. 8) . Backup collection takes about five minutes.
