| | GROUP<br><b>TRA</b> | MODEL<br><b>2019MY<br/>Sorento (UMa)</b> |
| | NUMBER<br><b>082</b> | DATE<br><b>May 2019</b> |
| <b>SUBJECT:</b> <b>SERVICE ACTION: 3.3 GDI 8AT TCU<br/>LOGIC IMPROVEMENT FOR DTC P0741 (SA387)</b> | | |

This bulletin provides the procedure to improve logic of the TCU (Transmission Control Unit) software on some 2019MY Sorento (UMa) 3.3L vehicles produced from January 24, 2018 to March 26, 2019, which may experience a malfunction indicator lamp (MIL) ON with DTC P0741. To correct this concern, apply the improved logic to the TCU using the KDS ECU Upgrade function as described in this bulletin. For confirmation that the latest reflash has been applied to a vehicle you are working on, verify the ROM ID using the table on page 2 of this bulletin. Before conducting the procedure, verify that the vehicle is included in the list of affected VINs.

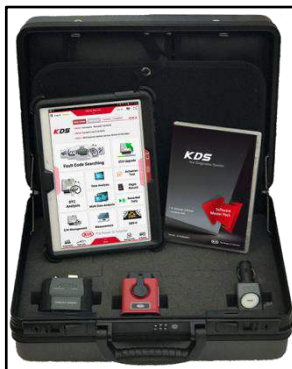
Kia Diagnostic System (KDS)

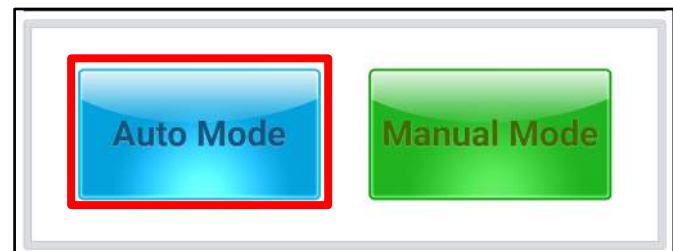
6. Select **Auto Mode**.

Do NOT attempt to perform a Manual Mode upgrade UNLESS Auto Mode fails. Always follow the instructions given on the KDS in either Auto or Manual mode.

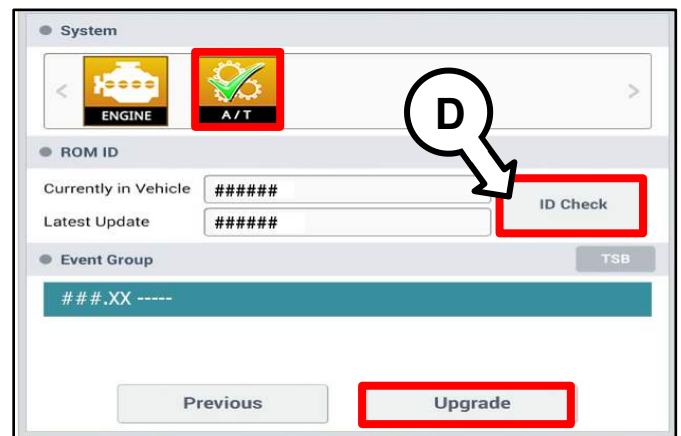
7. Select the **A/T** system under the System selection menu.

Touch **ID Check (D)** and confirm that the latest update is available.

Select **Upgrade Event #420** and select **Upgrade** to continue.
