EC19-017

ITB19-012

**2019 QX50; MIL ON WITH DTC P0448**

APPLIED VEHICLE: 2019 QX50 (J55)

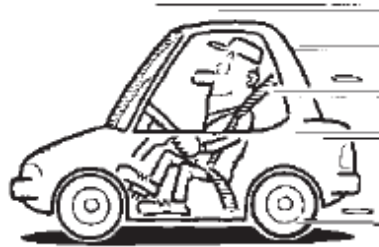
Figure A

- If you are not familiar with the reprogramming procedure, *click here*. This will link you to the "CONSULT- III plus (C-III plus) ECM Reprogramming" general procedure.
- Take the vehicle for a 10 minute drive in order to meet the following Idle Air Volume Learn (IAVL) conditions:
  - Engine coolant temperature: 70 -100°C (158 -212°F)
  - Battery voltage: More than 12.9V (At idle)
  - Transmission: Warmed up
- After reprogramming is complete, you will be required to perform Throttle Valve Closed Position, Idle Air Volume Learn, Accelerator Closed Position, and DTC erase.
