| | GROUP<br><b>ENG</b> | MODEL<br><b>2017-2018MY<br/>Forte (YDm)</b> |
| | NUMBER<br><b>208</b> | DATE<br><b>June 2019</b> |
| <b>SUBJECT:</b> ECU LOGIC IMPROVEMENT FOR P0300, P0301, P0302,<br>P0303, P0304 AND/OR P219C00, P219D00, P219E00, P219F00 | | |

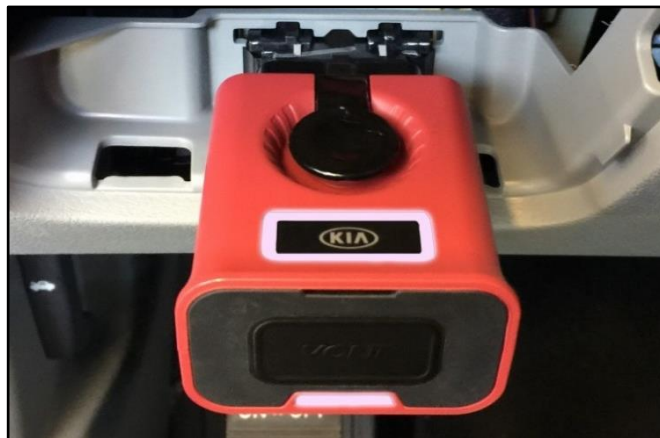
1. Connect the VCI-II to the OBD-II connector, located under the driver's side of the instrument panel.

The ECU upgrade function on KDS operates wirelessly. It is not necessary to perform the upgrade via USB cable.

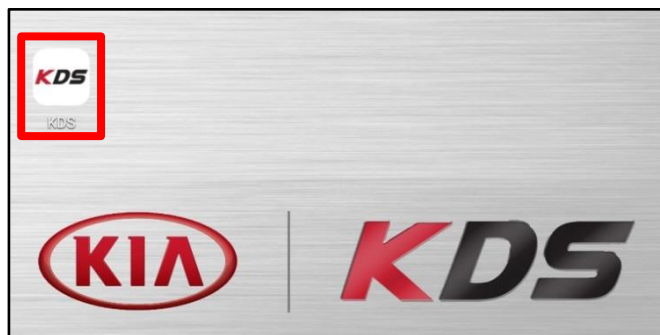
2. With the ignition ON, turn ON the KDS tablet. Select **KDS** from the home screen.

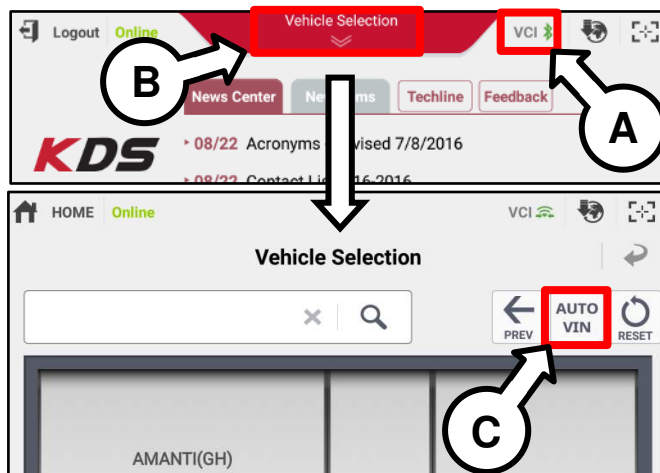
3. Confirm communication with VCI (A) and then configure the vehicle (B) using the **AUTO VIN** (C) feature.

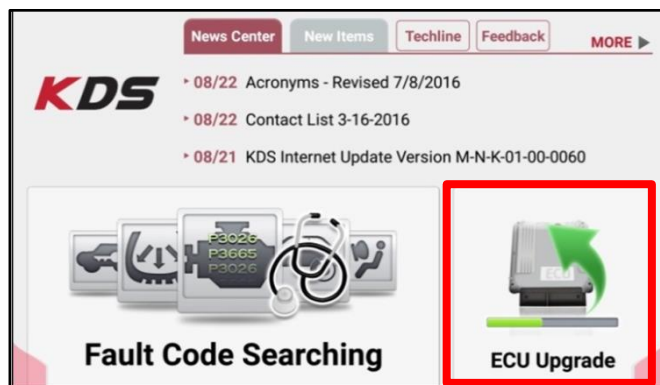
4. Select **ECU Upgrade**.

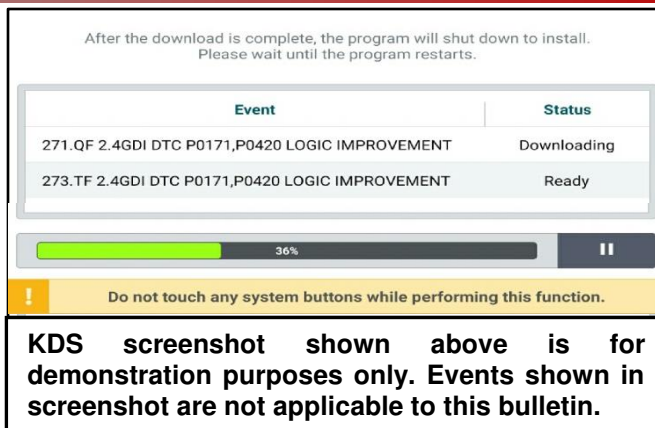
5. The KDS will check the server for recently uploaded Events and then automatically download **Upgrade Event #430**.

The vehicle must be identified in Vehicle Selection to download an Event for that vehicle.

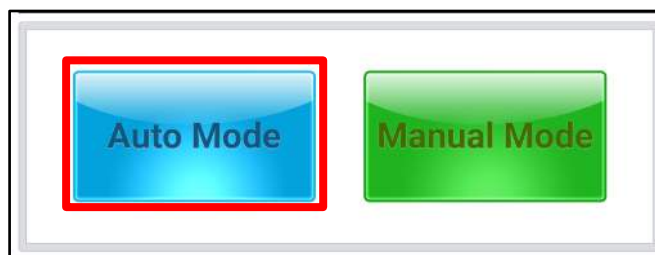
6. Select **Auto Mode**.

Do NOT attempt to perform a Manual Mode upgrade UNLESS Auto Mode fails. Always follow the instructions given on the KDS in either Auto or Manual mode.

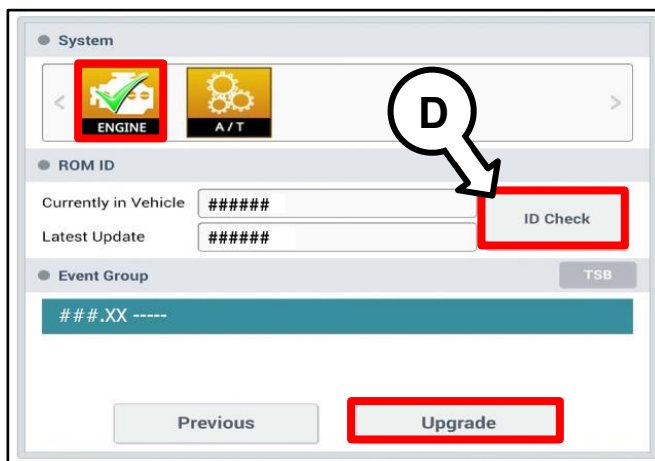
7. Select the **ECU** system under the System selection menu.

Touch **ID Check** (D) and confirm that the latest update is available.

Select **Upgrade Event #430** and select **Upgrade** to continue.

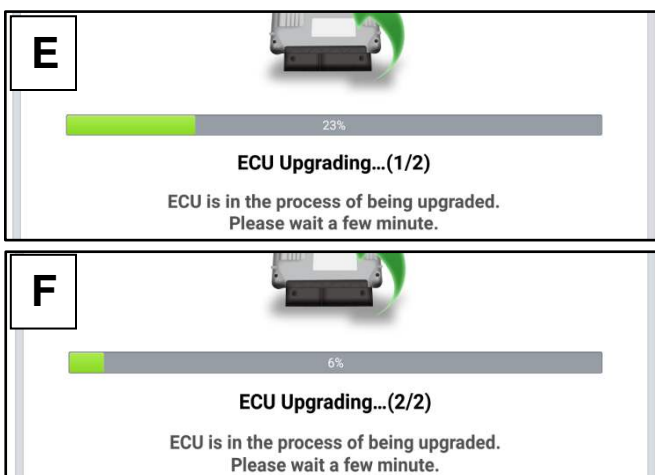
8. The ECU upgrade will begin and the progress of the upgrade will appear on the bar graph. Upgrade part (1/2) (E) will download the upgrade event to the VCI-II. Upgrade part (2/2) (F) will upgrade the ECU.

Do not touch the system buttons (like 'Back', 'Home', 'etc.') while performing ECU Upgrade.

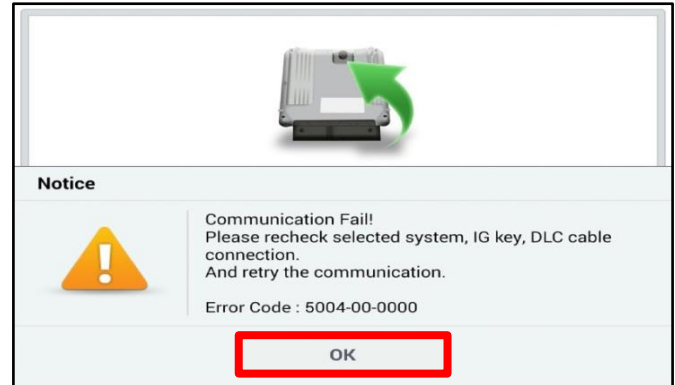
9. If a "Communication Fail" screen appears, verify that the VCI-II and KDS are communicating properly. Touch **OK** and restart the procedure from step 4.

If an error notice continues to appear or if the upgrade cannot be performed, **DO NOT** disconnect the KDS/VCI-II. Contact GIT America Help Desk at (888) 542-4371 or Techline.

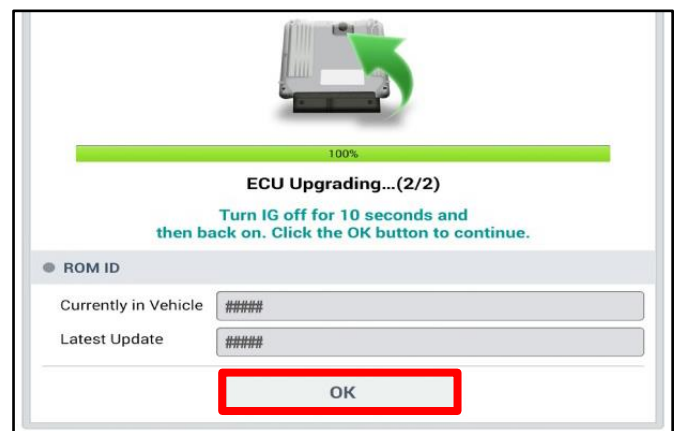
10. When instructed on the KDS, turn the ignition **OFF** for ten (10) seconds then back on. Touch **OK** to continue.

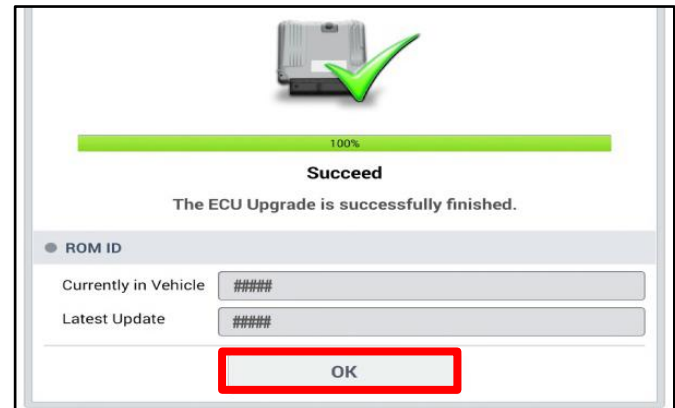
11. Once the upgrade is complete, touch **OK** to finalize the procedure.

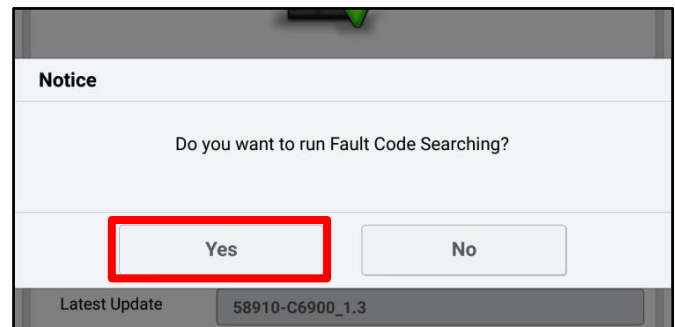
12. When prompted, select **YES** to check for Diagnostic Trouble Codes (DTC) and erase any DTCs stored such as EPS, ESC, and TPMS that may have been set during the upgrade.
