# Service Update

## N192266750 Incorrect Driver Display Message for Diesel Exhaust Fluid

**Release Date:** October 2019

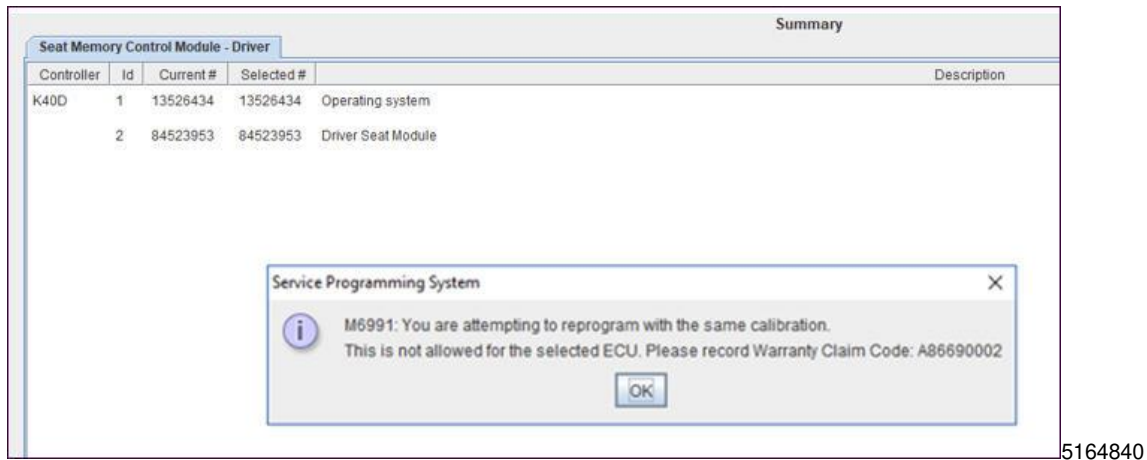
**Note:** If the Same Calibration/Software Warning is noted on the SPS Summary screen, record the warranty claim code (WCC) and select OK and follow screen instructions. After a successful programming event, the WCC is located in the Service Programming System dialogue box of the SPS Summary screen. No further action is required. Refer to the Warranty section of the bulletin.
