| | NUMBER<br><b>PI1803W/X (Rev 5, 11/07/2019)</b> | DATE<br><b>November 2018</b> |
| <b>PRODUCT IMPROVEMENT CAMPAIGN</b> | | |
| <b>SUBJECT:</b> ENGINE REPLACEMENT INSTRUCTIONS<br>FOR DTC P1326 (PI1803W/X) | | |

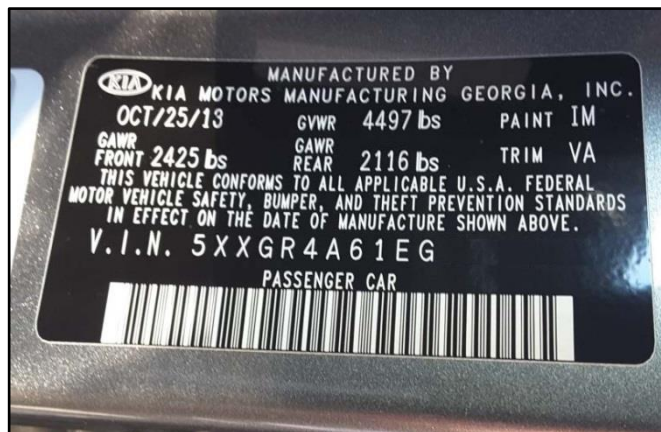
6. Start by recording the VIN. Ensure sun glare is not reflecting off windows or other objects.

Without stopping the recording, capture the area of the vehicle displaying the issue. i.e.;

- Engine Noise – record the engine.
- Hole In Block – record the side of the engine with the damage.
- Seized Engine – record a technician trying to turn the engine over with a breaker bar.
