| REFERENCE: | TSB: 08-003-26<br>GROUP: 08 - Electrical | Date: | January 8, 2026 | REVISION: | 08-192-25 REV. B |
| VEHICLES AFFECTED: | 2025 (LB) Dodge Charger<br>This bulletin applies to vehicles equipped with Drive eXperience Recorder (Sales Code JFC) and Drive eXperience Recorder Prep (Sales Code JGB). | | | MARKET APPLICABILITY:<br><div><input checked="" type="checkbox"/> NA<input type="checkbox"/> MEA</div> <div><input type="checkbox"/> SA<input type="checkbox"/> IAP</div> <div><input type="checkbox"/> EE<input type="checkbox"/> CH</div><br><b>NOTE:</b> This bulletin applies to the North America market. | |
| CAUSE: | "MIM software" | | | | |

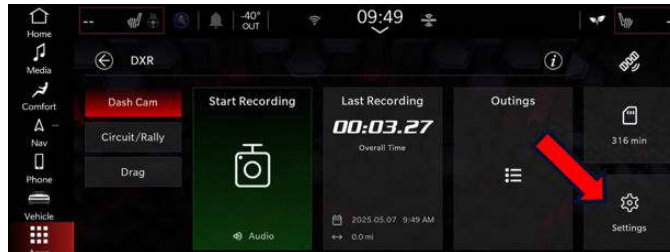
**Fig. 4**  
Settings

9. Click the Settings button to open the settings menu [Fig. 4](#).

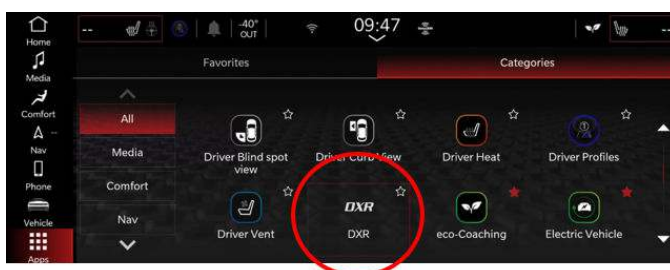
**Fig. 10**  
DXR

27. Locate the DXR tile and select it [Fig. 12](#).
