| REFERENCE: | TSB: 08-005-26<br>GROUP: 08 - Electrical | Date: | January 8, 2026 | REVISION: | 08-191-25 REV. B |
| VEHICLES AFFECTED: | 2024 (LB) Dodge Charger<br>This bulletin applies to vehicles equipped with Drive eXperience Recorder (Sales Code JFC) and Drive eXperience Recorder Prep (Sales Code JGB). | | | MARKET APPLICABILITY:<br><div><input checked="" type="checkbox"/> NA<input type="checkbox"/> MEA</div> <div><input type="checkbox"/> SA<input type="checkbox"/> IAP</div> <div><input type="checkbox"/> EE<input type="checkbox"/> CH</div><br><b>NOTE:</b> This bulletin applies to the North America market. | |
| CAUSE: | "MIM software" | | | | |

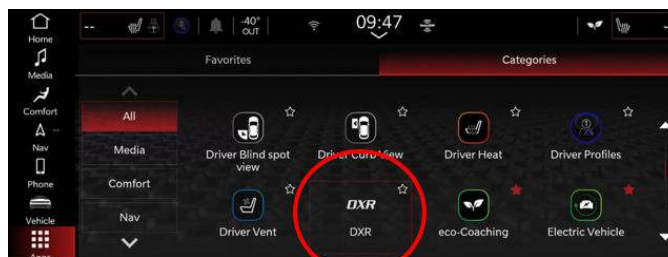
**Fig. 2**  
DXR

7. Locate the DXR tile and select it [Fig. 2](#).

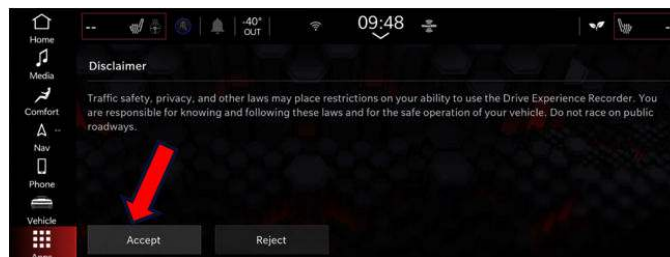
**Fig. 3**  
Disclaimer

8. If the disclaimer pops up, accept it [Fig. 3](#).

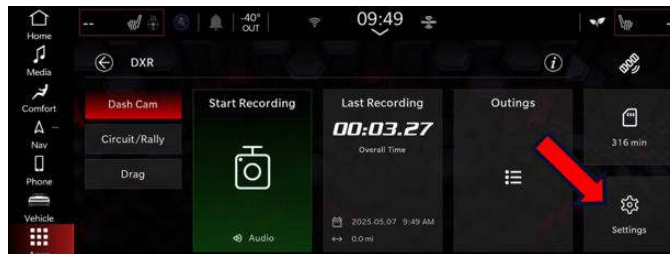
**Fig. 4**  
Settings

9. Click the Settings button to open the settings menu [Fig. 4](#).

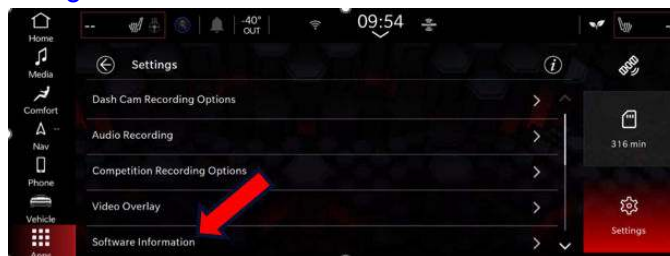
**Fig. 5**  
Software Information

10. Click on Software Information [Fig. 5](#).

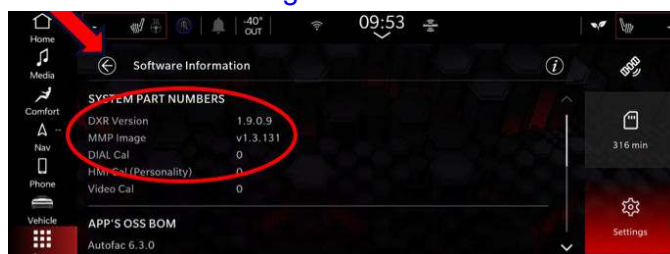
**Fig. 6**  
Version

11. Check if the software version is above 1.4.160 [Fig. 6](#).

12. Was the Multi Media Platform (MMP) firmware version at or above 1.4.160?

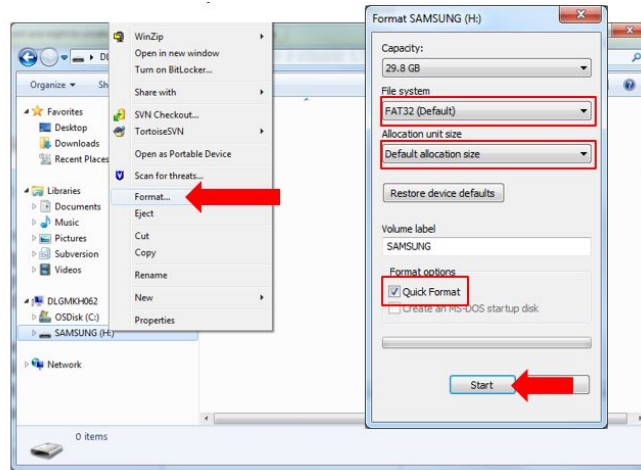
**Fig. 7**

14. Perform the following steps to format the USB flash drive [Fig. 7](#).

- Select “exFAT” format.
- Select “Default allocation size” under Allocation Unit Size.
- Select “Quick Format” under Format Options.
- Click “Start”.

Formatting The USB Flash Drive

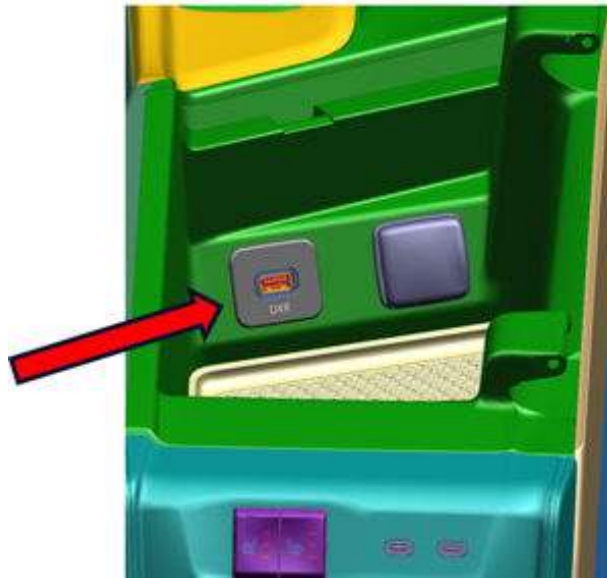
**Fig. 8**  
DXR USB

24. Install a 12v battery charger and insert the USB flash drive into the DXR USB port [Fig. 10](#).

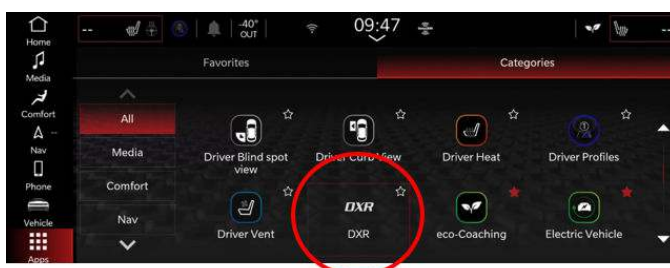
**Fig. 10**  
DXR

27. Locate the DXR tile and select it [Fig. 12](#).

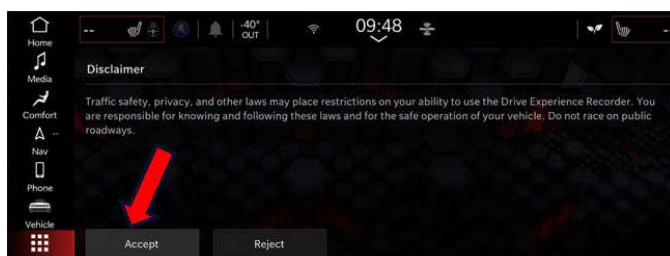
**Fig. 11**  
Disclaimer

28. If the disclaimer pops up, accept it [Fig. 13](#).

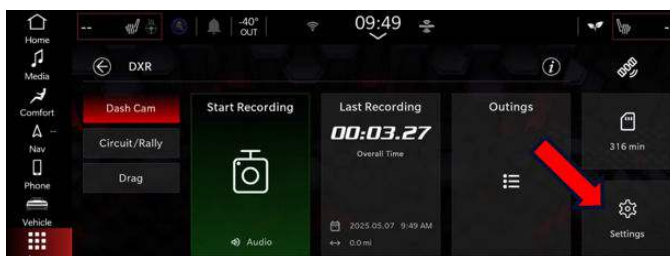
**Fig. 12**  
Settings

29. Click the Settings button to open the settings menu [Fig. 14](#).

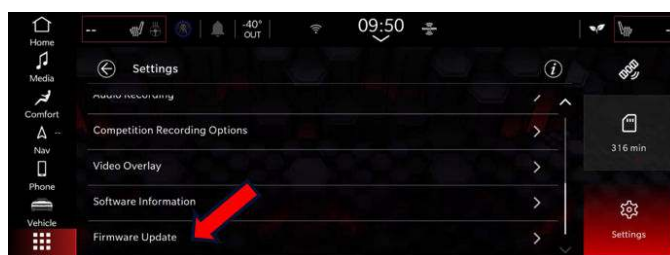
**Fig. 13**  
Firmware Update

30. Click on Firmware Update [Fig. 15](#).

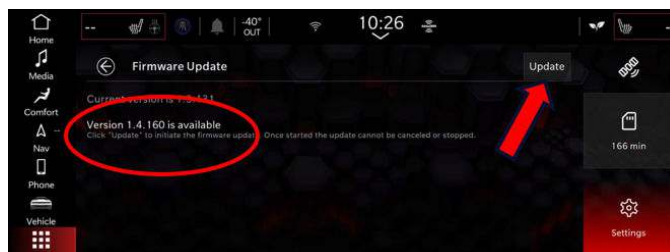
**Fig. 14**  
Update

31. Click on Update [Fig. 16](#).

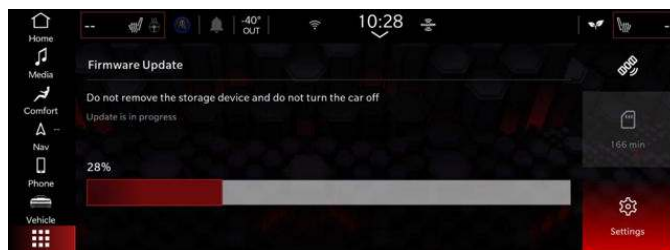
32. The update will take approximately 2-3 minutes [Fig. 17](#).

**Fig. 15**  
Update In Progress Screen

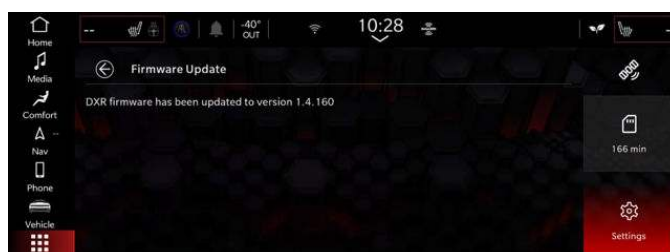
33. This message will be displayed when the update is complete [Fig. 18](#).

**Fig. 16**  
Software Updated Screen
